MONTGOMERY
INDEPENDENT
SCHOOL DISTRICT

FACILITIES ASSESSMENT VOL. I

MAY 2021

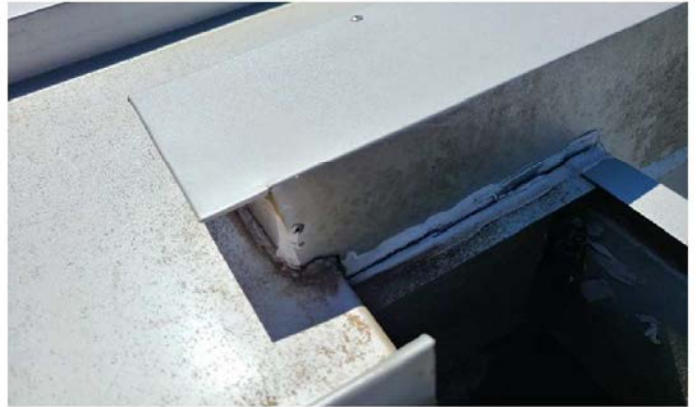
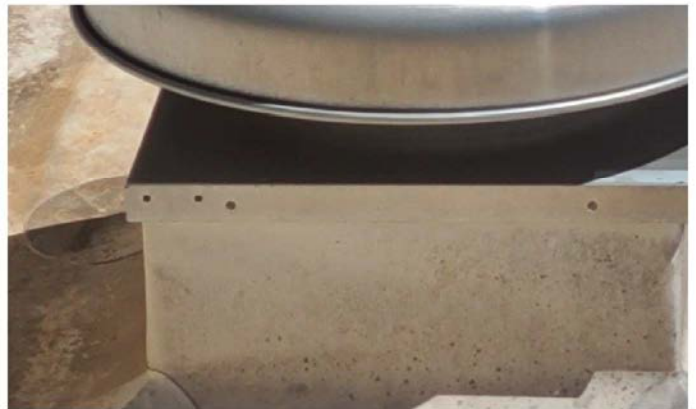
The Keenan elementary school roof appears to consist of various roof levels and areas consisting primarily of standing seam metal roof systems and low sloped single-ply roof membrane. Deficiencies observed in the standing seam metal roof sections appeared to include cracked sealant at a transition between a gutter system and an adjoining wall. Deficiencies observed in the single-ply roof areas appeared to include one exhaust fan lacking proper fastener placement. The standing seam metal roof areas appeared to be in overall good condition and has a remaining effective service life of approximately fifteen years, and the single-ply roof membrane appeared to be in overall good condition and appeared to have a minimum remaining effective service life of approximately ten years.

- + Replacement of the deficient sealant to prevent moisture ingress is recommended.
- + Install additional fasteners to this location to ensure proper mechanical attachment of the exhaust fan to the curb.

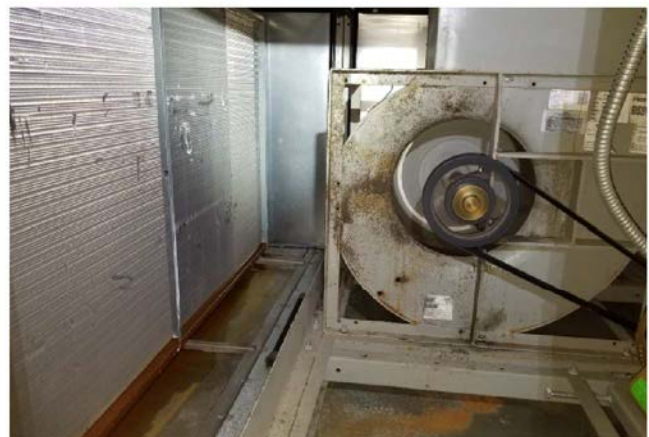
The building cooling is provided by two (2) 5-year-old 280-ton Carrier air-cooled chillers. They appear to be in good condition. The chilled water pumps serving the chillers are in good condition. The building heating is provided by two (2) 5-year-old 3,000 MBH RBI XLF condensing boilers. They appear to be in good condition. The hot water pumps serving the boilers are in good condition. The library, common, gym, and kitchen areas are served by 4-pipe single zone air handling units with outside air pretreatment. They are in good condition. However, outside air is being introduced into building when school is not occupied. Also, pretreatment section condensate drain lines are not insulated. All the classroom spaces are served by 4-pipe multi-zone air handling units. They are in good condition. However, the one outside air supply fans serving these units are located above the computer lab is very noisy. The admin area is served by chilled water single zone VAV air handling unit with auxiliary DX-split. Unit is in good condition, but fan is moldy. The condensing unit on the roof is in good condition, but refrigerant piping insulation is deteriorating. The building automated system (BAS) is by ALC and in good condition.

- + Recommission outside air delivery sequence of operation for all the AHU's to ensure that it is not activated when school is not occupied for energy saving purpose.
- + Provide new outside air supply fans with VFDs to help control noise problem.
- + Clean interior of air handling unit.
- + Replace refrigerant line insulation and provide aluminum jacketing.
- + Insulate all pretreatment section condensate drain lines.

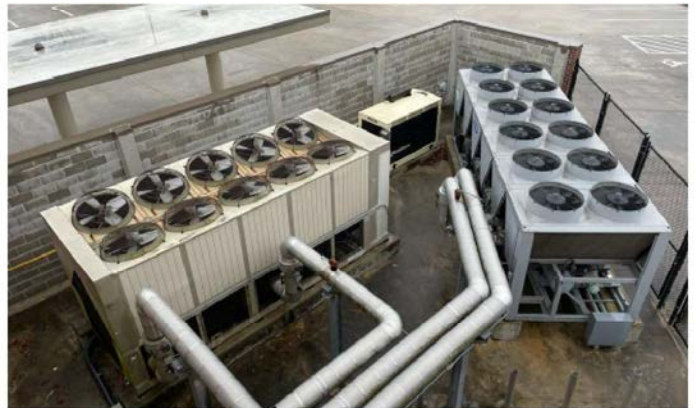
The library, common, gym, and kitchen areas are served by 4-pipe single zone Carrier air handling units. Classroom areas are served by 4-pipe VAV Carrier air handling units. They are about 14 years old and are in good condition, however the interior is dirty. VAV boxes are in good condition. Building heat is being provided by one (1) 14-year-old Rite boiler. It is in good condition, however, does not meet current energy codes. Hot water pumps appear to be in good condition. Chilled water pump is dirty and rusted. Chilled water piping insulation is fiberglass. There are signs of previous condensation issue at many locations and insulation at the central plant and mechanical rooms is in poor condition. All fans and vents appear to be in good condition. Gym supply air grilles are damaged. A 16-year-old Liebert condensing unit on the roof is old and in bad condition. The BAS is by Automated Logic. The control modules are in good condition.

- + Replace McQuay chiller with new.
- + Clean dirty coils, drain pans, motors, and fans for all air handling units.
- + Replace chilled water piping fiberglass insulation with new phenolic foam insulation.
- + Clean chilled water pump.
- + Replace/repair damages supply air grilles at gym.
- + Replace Liebert condensing unit with new.

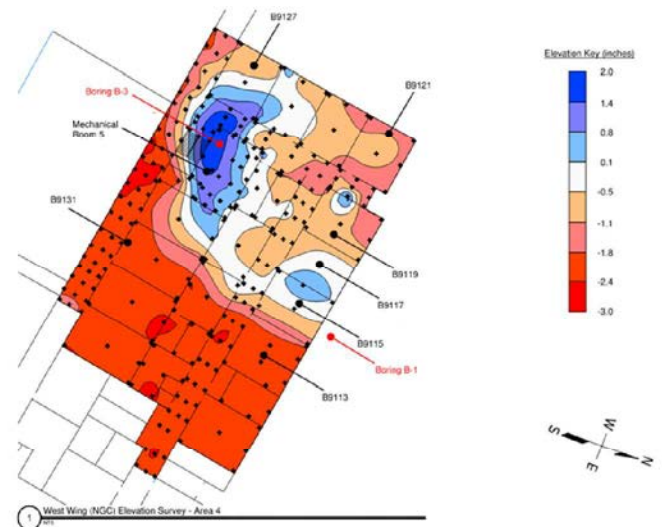
Based upon this information, it appears isolated areas of the slab on ground, principally away from the exterior walls, has continued to move. We would anticipate that future foundation movement is possible within the Ninth Grade Center.

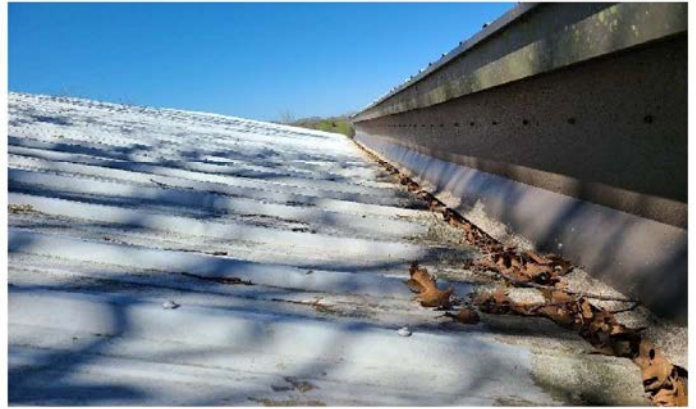
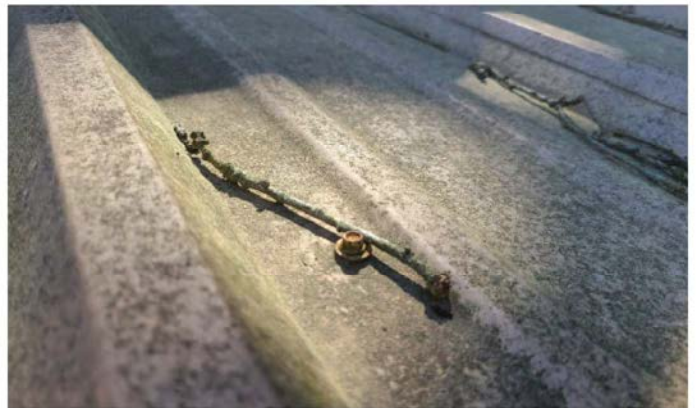
- + Gutter joints are loose allowing water to leak, thus staining concrete pavements and bricks below. Downspouts are missing splash blocks or drains to direct water away from the building. Due to water collecting under downspouts, concrete pavements and bottom brick courses are stained at several locations.
- + It appears that the gutters need to be cleaned, and plant-life removed.
- + Repair the roof penetrations to minimize potential points of moisture ingress, and perform a water leak test to determine the cause of the reported interior leaks to make repairs and prevent moisture ingress until plans can be made to replace the existing roof systems.
- + Install counter-flashing to locations where termination bar was exposed, and applying sealant to the transitions and penetrations at the metal wall panels to prevent moisture ingress.
