MONTGOMERY
INDEPENDENT
SCHOOL DISTRICT

FACILITIES ASSESSMENT VOL. I

MAY 2021

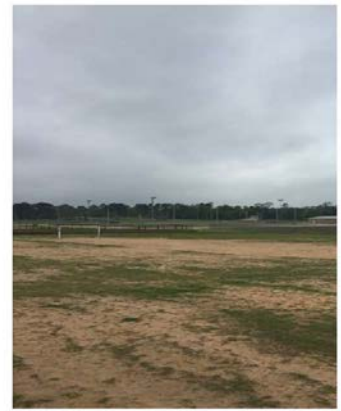
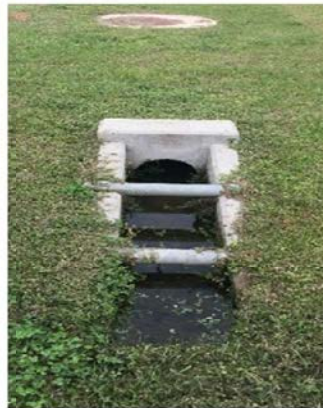
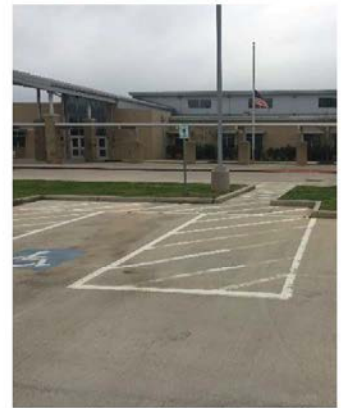
Upon review of the site conditions at the Keenan Elementary School, it appears that the site is in a relatively good condition, but the detention facility on the site needs maintenance. There are other areas along the boundary that show signs of erosion. There are small areas in the parking lots which show evidence of ponding water and sedimentation build up.

- + The pond seems to severely eroded along most banks with minimal sodding and maintenance apparent. The erosion is especially severe along the southeast bank, where it would most accurately be described as a washout.
- + Add wheel stops for all ADA stalls that are missing them.
- + Fill eroded areas and provide maintenance for the detention facility.
- + Change grate inlet tops east of the building to better accommodate small children. Currently, wider grate tops are in use.
- + Consider re-striping of the parking lot within 3-5 years.

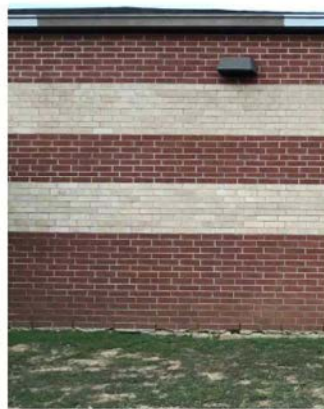
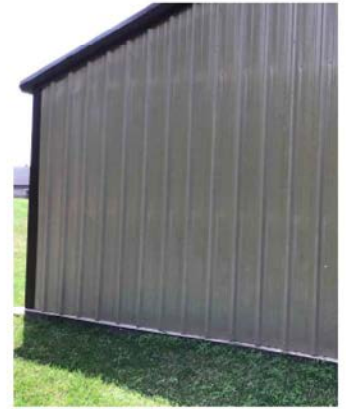
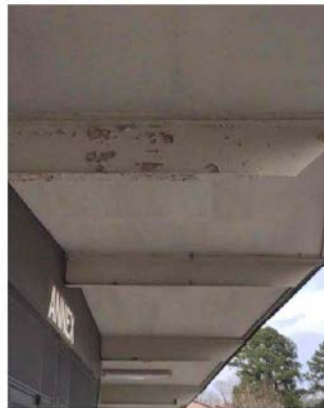
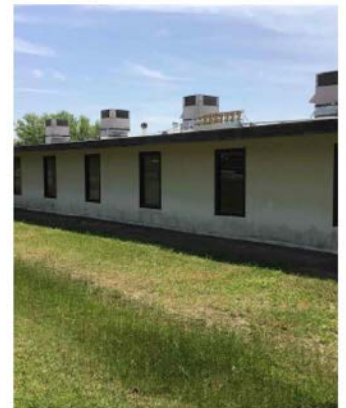
Annex: Multiple deficiencies were observed with the exterior walls.

- + Exterior walls should be tested for water infiltration, and proper remediation should be performed. Based on visual observations the exterior wood wall system of the building may need to be removed and replaced in its entirety.
- + Rot board around the building should be removed and replaced.
- + Replacement of dried and cracked sealant, as well as power washing the brick is recommended.
- + Exposed steel members should be re-mediated as they are currently exposed to the elements and experiencing corrosion.

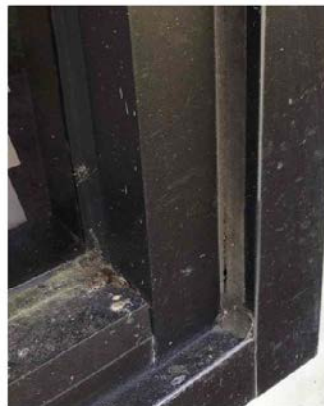
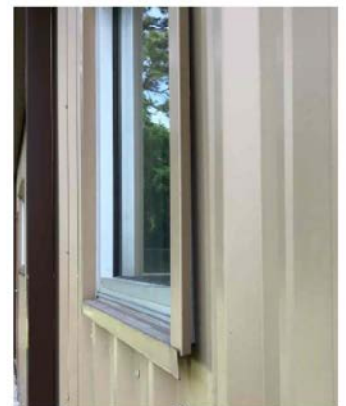
Gym: Deficiencies observed in window systems include improper installation at the head, jamb, and sill.

- + The window systems should be removed and replaced in their entirety.

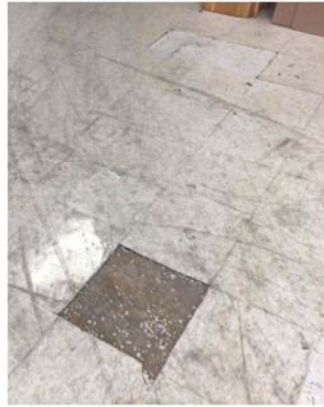
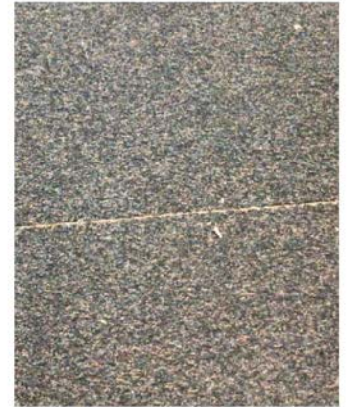
Annex: It appears the building has been used as a storage building for large equipment, and the floors throughout the building have sustained substantial damage.

- + The VCT throughout the building should be removed and replaced.
- + The carpet within some rooms seems to be in moderate condition. However there are many spaces where tears at seams, and rips were observed. Replacement of carpet is recommended.

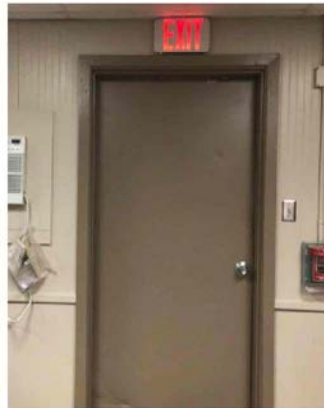
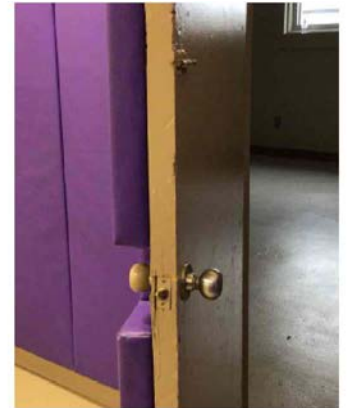
Gym: The door swing clearances need to be reviewed in multiple locations as they do not comply with TAS.

- + Recommend replacement of the doors and frames throughout the interior of the building.
- + Exterior doors are in fair condition, however the doors will need to be modified to receive new hardware to comply with TAS and IBC.

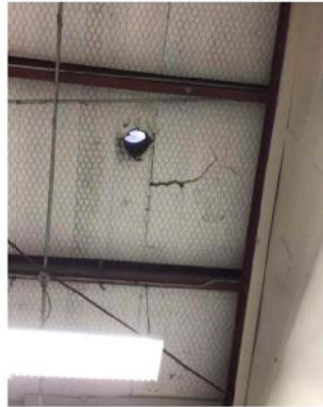
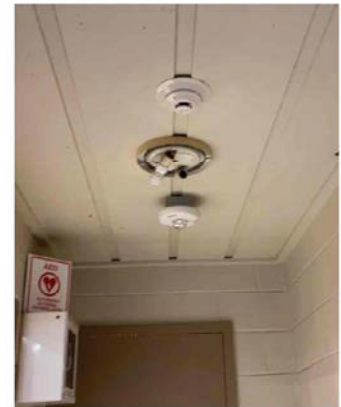
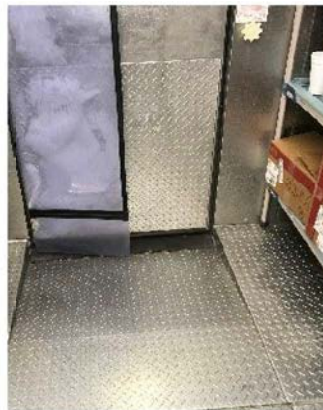
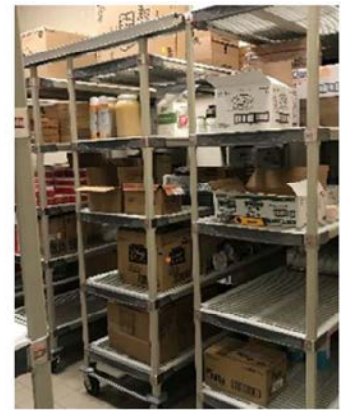
Gym: In areas that have ceilings the grids, and ceiling systems seem to have exceeded their expected use and should be removed and replaced. Where old roof penetrations exist and are used they should be patched to prevent water infiltration.

Annex: The ceiling throughout the building seems to be damaged due to water infiltration. The ceiling grid and ceiling tile should all be removed and replaced.

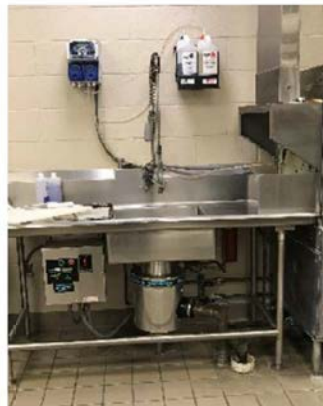
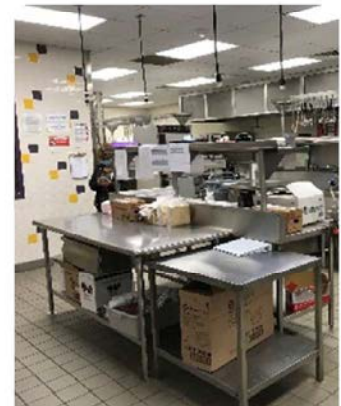
Throughout the kitchen and servery many pieces of equipment were noted to be reaching or at the end of their useful life cycle. Replacement of many pieces is recommended. The floors, walls, and ceiling seem to be in general compliance with current health codes.

- + Provide smooth transition from kitchen into cooler and freezer compartments. Kitchen staff and carts impeded by ramp in freezer.
- + Dry storage size is insufficient and should be expanded.
- + Exhaust hoods were noted to not be properly functioning and should be repaired or replaced.
- + Re-work the serving counter to be at a lower height for the age group being served.
- + Replace grate at Tilt Braising Pan, as spacing is too wide and cart wheels get stuck. Grating bars to be spaced 0.4" apart per TAS requirements.
- + Recommend replacement of kitchen equipment within 0-5 years.

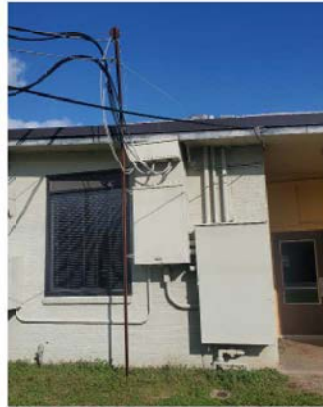
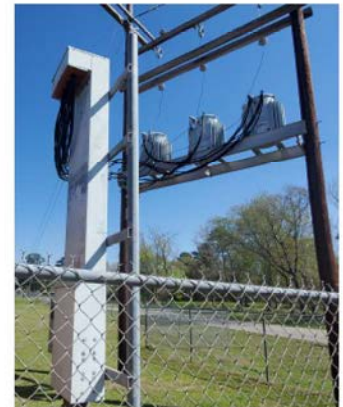
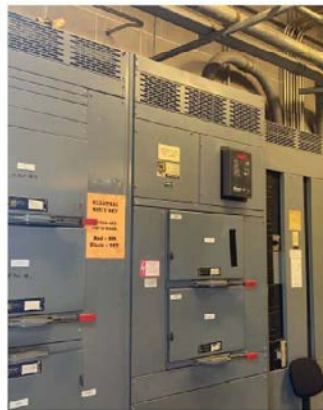
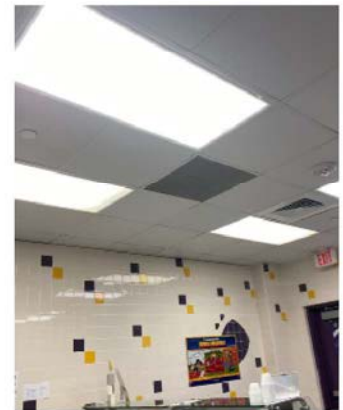
Electrical service is fed via pole mounted transformer to outdated, deteriorating panelboards.

Fire Alarm system appears outdated and does not have voice evacuation capabilities. A small IT rack is handling all technology items. Security cameras were not observed.

With regard to **Technology** there is a small wall mounted IT rack that does not appear to be functioning. Security cameras were observed but appear to be outdated.

In order to bring the Gym and Annex up to code, and prolong the useful life of the building, the following recommendations are made for both facilities:

- + Replace all other outdated and damaged pieces of equipment throughout the buildings. Provide rewiring where needed.
- + Replace all interior lighting with new LED fixtures.
- + Replace all remaining exterior lighting with new LED fixtures.
- + Replace all existing lighting controls with new controls in compliance with energy code.
- + Replace IT equipment and racks where needed.

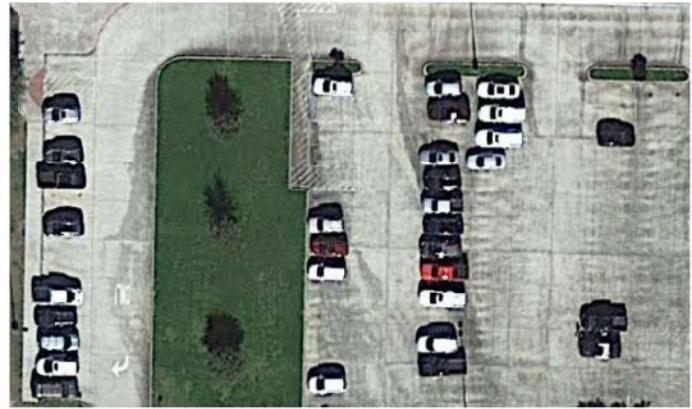
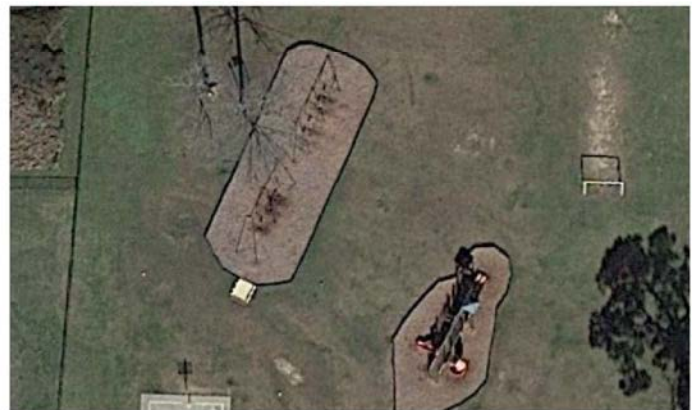
Upon review of the site conditions at the Lone Star Elementary School, it appears that the site is in a relatively fair condition. The overall drainage infrastructure is unclear. The fence needs maintenance. There are areas in the field that show signs of erosion, and minor areas in the parking lot that show evidence of ponding. There is staining and possible ponding on the sidewalk in a small area south of the building. There is minor concrete joint failure in the pavement due west of the building. The fence along the north/west boundary along the unnamed street is in poor condition/. There seems to be minor erosion in the playground areas to the north/east of the building. Immediately southeast of the building, there is an apparent low spot with no drain present. While this is off-site, there is severe erosion present along the ditch banks to the west of the site adjacent to the unnamed street.

- + Replace joint sealants where necessary.
- + Repair fence in areas where it is damaged.
- + Fill in eroded areas.

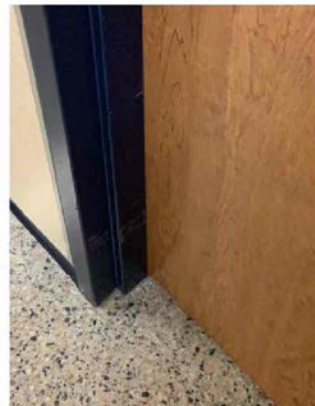
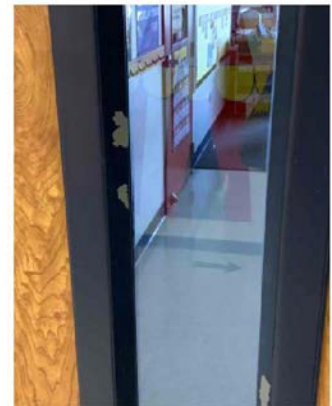
The door hardware observed throughout the campus seems to be in general compliance with TAS, and in fair condition. Some closers were observed to be dysfunctional.

- + General maintenance of door closers is recommended.
- + Recommend the review of classroom hardware sets to conform with district standards.

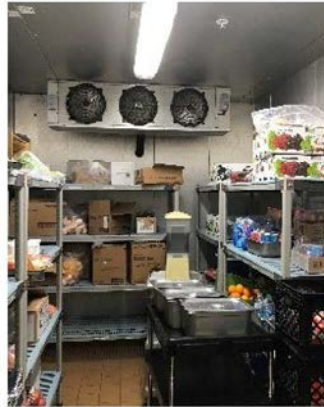
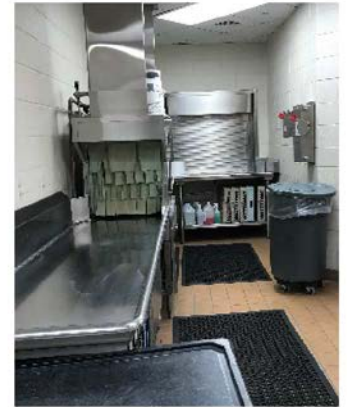
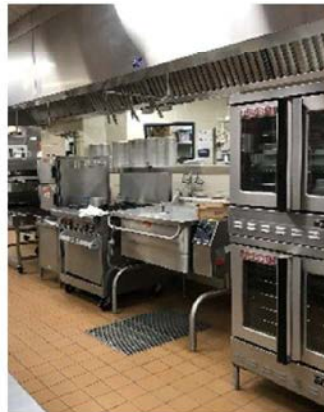
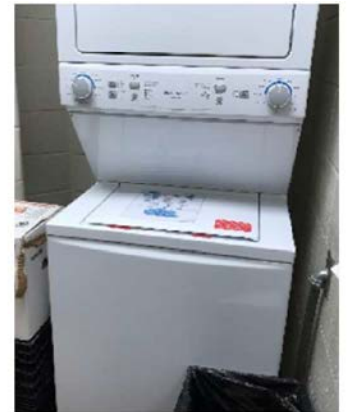
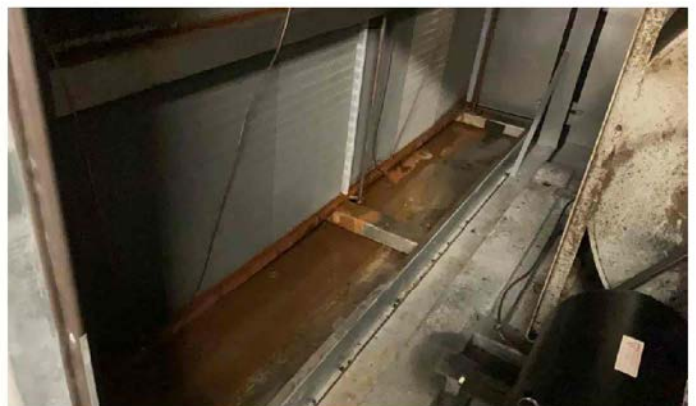
The building cooling system is provided by one (1) 14-year-old 180-ton McQuay air-cooled chiller and one (1) 5-year-old 180-ton Carrier air-cooled chiller. The McQuay chiller is old and in bad condition. The Carrier chiller is in good condition.

The library, common, gym, and kitchen areas are served by 4-pipe single zone Carrier air handling units. Classroom areas are served by 4-pipe VAV Carrier air handling units. They are about 14 years old and are in good condition, however the interior is dirty. VAV boxes are in good condition. Building heat is being provided by one (1) 14-year-old Rite boiler. It is in good condition, however, does not meet current energy codes. Hot water pumps appear to be in good condition. Chilled water pump is dirty and rusted. Chilled water piping insulation is fiberglass. There are signs of previous condensation issue at many locations and insulation at the central plant and mechanical rooms is in poor condition. All fans and vents appear to be in good condition. Gym supply air grilles are damaged. A 16-year-old Liebert condensing unit on the roof is old and in bad condition. The BAS is by Automated Logic. The control modules are in good condition.

- + Replace McQuay chiller with new.
- + Clean dirty coils, drain pans, motors, and fans for all air handling units.
- + Replace chilled water piping fiberglass insulation with new phenolic foam insulation.
- + Clean chilled water pump.
- + Replace/repair damages supply air grilles at gym.
- + Replace Liebert condensing unit with new.

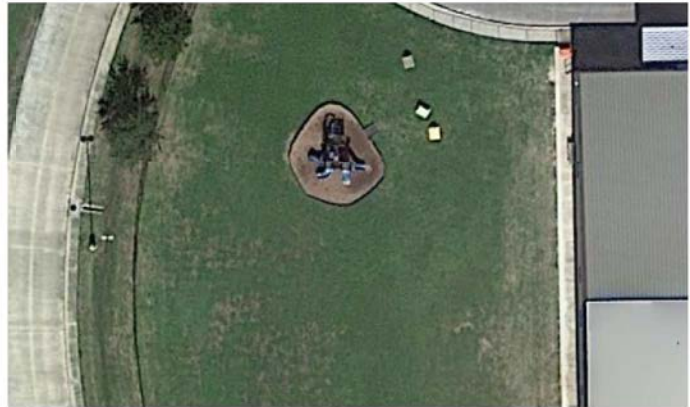
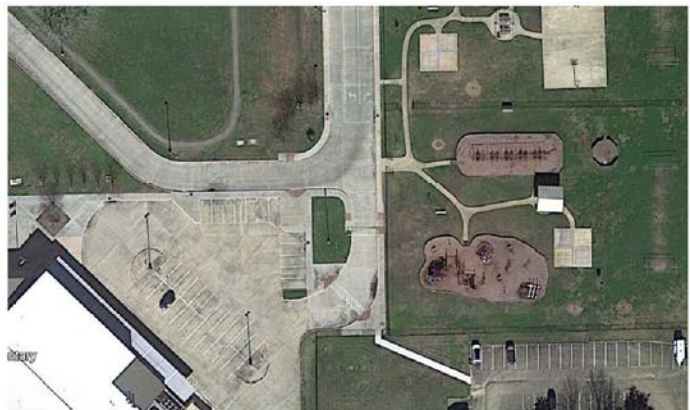
Accessibility within Madeley Ranch Elementary School seems to be in general compliance with TAS. Toilet rooms seem to be relatively new and are in good condition. The building is equipped with a fire suppression system and appears to be in good condition.

- + In 2020 Montgomery County began to require the provision of a radio response system testing of educational facilities which will be required by the Fire Marshal.
- + The existing building is fire sprinklered with 8" fire main. System appears to be in good working condition.
- + ADA Access should be provided to athletics fields, and playgrounds. Consider Secured access to playgrounds.
- + The fire alarm system is an addressable system but could not be observed. Booster power supplies are located throughout the building. It appears the system does not have voice evacuation. Smoke detectors appear to be outdated type. AHJ should be consulted if a renovation is completed.

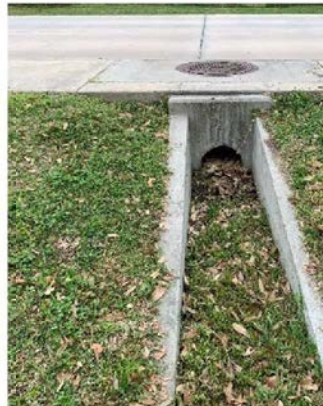
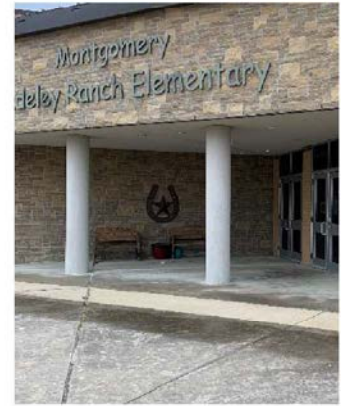
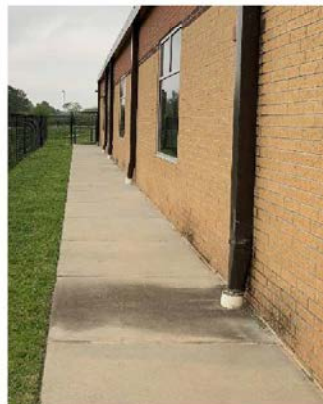
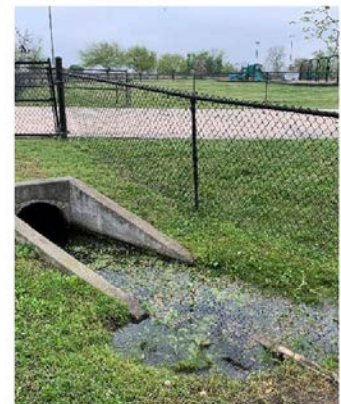
Upon review of the site conditions at Madeley Ranch Elementary School, it appears that the site is in a relatively good condition. The site appears to have good drainage conveyance overall, but maintenance is required to attend to some partially clogged and obstructed pipes. Parking lot and fire lane striping appears to need to be repainted throughout. There are areas where the joint sealant is in disrepair throughout the site. The fire lane, parking stall, and traffic arrow paint is faded throughout the site. There is water staining at the main entrance and along the south and west faces of the building. There is water staining due to improper drainage located near a canopy downspout on the south side of the building. There is debris/vegetation located in the trench drain to the east of the main entrance. Grass is overtaking a manhole located near the maintenance area. The soils are washing out in the playground area near the western gate. There is ponding in the southwest drainage ditch at a drainage structure. The ROW culverts along the western portion of Madeley Ranch Road are clogged with grass clippings/vegetation. Some of the ROW culverts along the western portion of Madeley Ranch Road also have standing water/ponding issues. There is sedimentation build-up in the parking lot curb cut that leads to the ROW ditch.

There is a sanitary cleanout with a missing lid. Along the front of the school, the landscape drain inlets are clogged with debris. There is a damaged Type E inlet nearing the walking track. The walking track pavement is worn down.

- + Power wash water stained sidewalk.
- + Clean out drainage inlets and trench drain.
- + Maintain southern drainage ditch and clear the vegetation from it and the ROW culverts.
- + Regrade east driveway to mitigate ponding issue.
- + Restripe the parking lots and replace joint sealants.
- + Restripe the fire lane and the traffic arrows.
- + Replace joint sealants where necessary.
- + Repair fence in areas where it is damaged.
- + Fill in eroded areas.

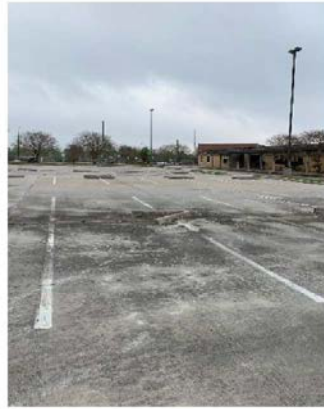
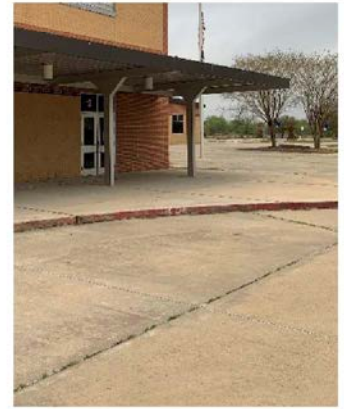
Some of the brick facades seem to have near the base which may have to do with the vapor-barrier, or issues with the gutter system. Some exterior walls do not have control joints located along openings, which creates issues related to building movement, cracking in exterior brick was observed.

- + It is recommended that the stone wall is repaired.
- + Consider the installation of additional control joints within the masonry walls.
- + Pressure wash the masonry

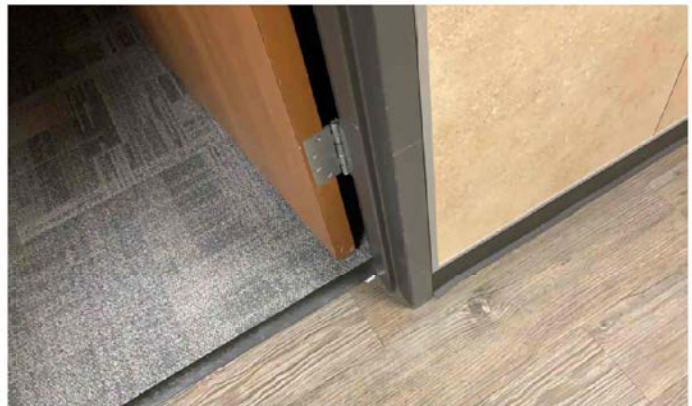
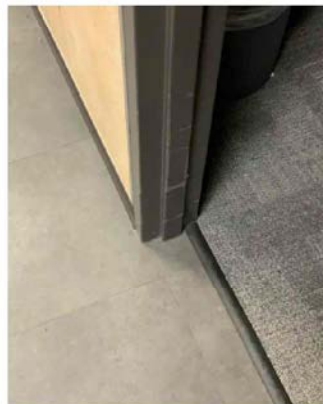
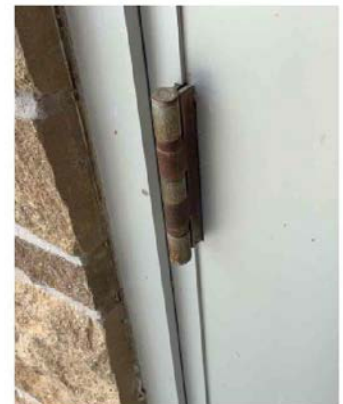
The door frames throughout the campus seem to have experienced damage over the years. Doors appear to be PLAM clad, and have also sustained damage.

The door hardware observed throughout the campus seems to be in general compliance with TAS, and in fair condition.

- + Recommend the repainting and repair of hollow metal frames.
- + Recommend the patching and repair of PLAM doors as needed.

- + Recommend the review of classroom hardware sets to conform with district standards.
- + Replacement of some exterior door hardware is recommended due to rusting.

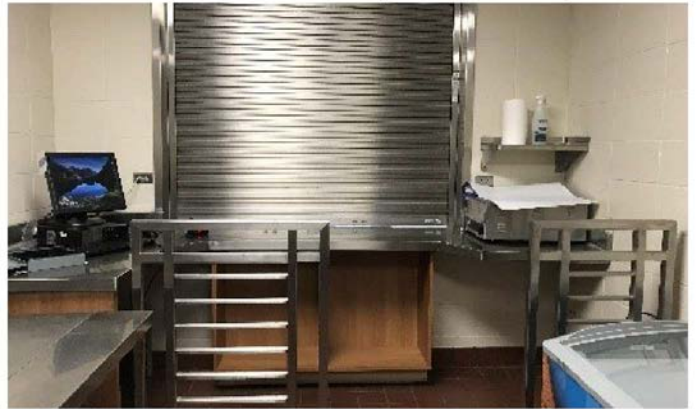
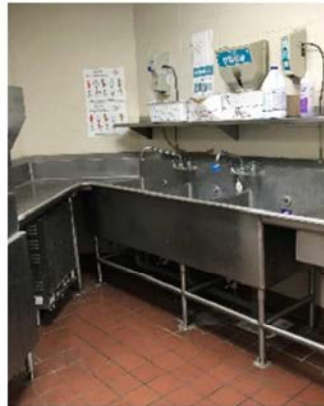
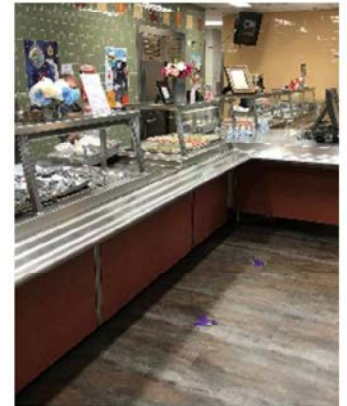
Within the kitchen and server of Madeley Ranch Elementary School the floors, walls, and ceiling seem to be in general compliance with current health codes. The finishes within the kitchen and servery include Quarry tile and Ceramic Tile on the floors, CMU and Tile walls, as well as vinyl lay in ceiling tiles. There is evidence of structural settlement within the floors, and transferring into the walls. It was noted by staff that floor finishes were recently replaced to accommodate the settling of the structure. It was noted that the warewash space is pinched at three compartment sink / dish machine table junction.

- + Increase Cold Storage to a minimum of 388 sq. feet
- + In lieu of the option above, the MISD could increase delivery frequency.
- + Stackable washer and Dryer within kitchen do not appear to be compliant with TAS. Recommend replacement with side by side units.
- + In general the Kitchen and servery seem to be undersized and should be expanded to 3,500 square feet to accommodate the overall potential occupant load of the building.
- + It is recommended that the warewash area is enlarged
- + The kitchen equipment is beginning to reach its expected life cycle and will need to be replaced within the next 5 years.

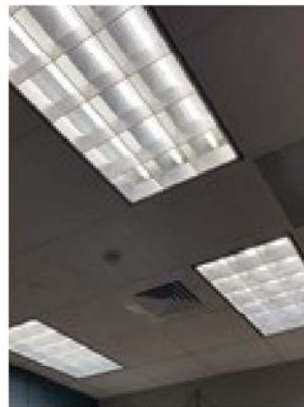
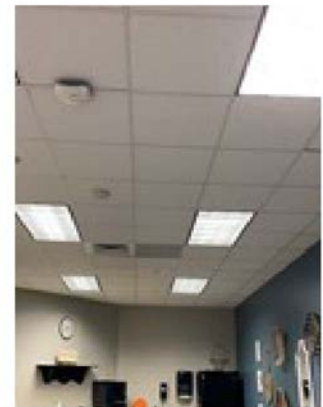
The electrical service is fed via pad mounted utility transformer at the exterior of the building, which is connected to 2000A, 277/480V, 3-phase, 4-wire main switchboard located in the main electrical room. This main switchboard feeds additional distribution boards and panelboards throughout the building. The distribution boards provide mechanical equipment circuiting. The 277/480V panelboards are utilized for lighting, small mechanical equipment, and feeding 120/280V panelboards via stepdown transformers. The 120/208V panelboards are connected to small mechanical equipment, receptacle loads, and miscellaneous loads throughout the building. Some equipment is aging and require replacement. There is a 500kW diesel generator on the exterior of the building feeding all life safety and emergency loads via (2) ATSs and are in good condition. Lighting on the interior of the building consists of fluorescent 2x4 fixtures, 1x4 fixtures, and recessed cans throughout, with strip fixtures in mechanical areas. Exit signs appear to be fluorescent and outdated. Exterior lighting consists of old surface mounted HID lighting at the canopy, while all other areas appear to be new LED fixtures with some non-functional downlights at entrance. Parking lot have outdated HID fixtures. Lighting controls appear to be controlled via toggle switches and do not meet current energy codes. The intercom and clock system could not be observed but all devices indicate a newer system except for few illegible clocks.

- + Replace all other outdated and damaged pieces of panels and equipment throughout the buildings.
- + Replace all interior lighting and Exit signs with new LED fixtures.
- + Replace all remaining exterior lighting with new LED fixtures.
- + Replace all parking lot lighting with new LED fixtures.
- + Replace all existing lighting controls with new controls in compliance with energy code.

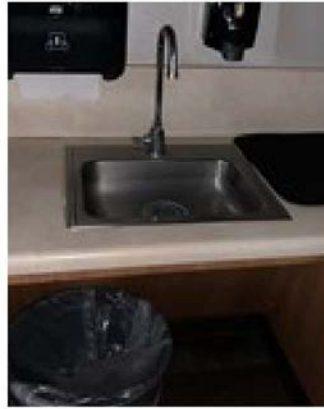
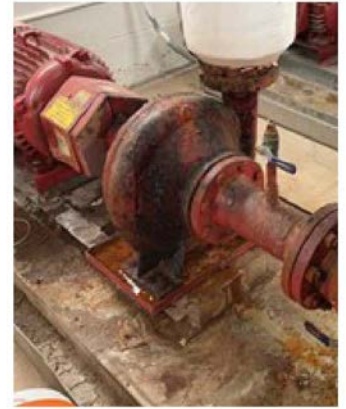
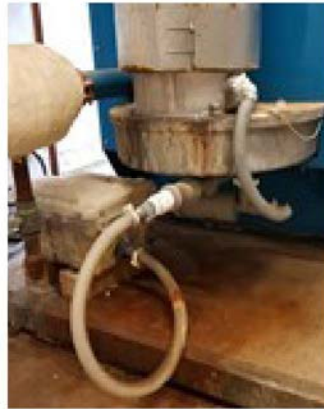
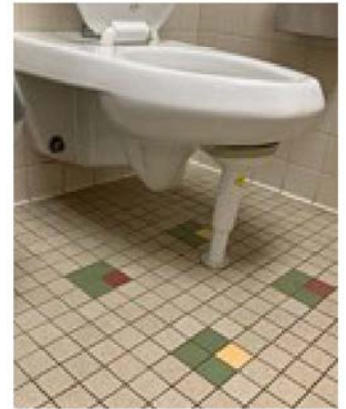
Most existing plumbing fixtures (drinking fountains, toilets, flush valves, lavatories, faucets, sinks, etc.) are relatively new and in good condition. Some water closets in staff restrooms are broken. Wash fountains at gang restrooms are CW only. Gas water heaters for kitchen and admin area. Electric water heaters are located throughout building for associated areas. All water heaters are relatively new and in good working condition. Gas water heater does not have combustion air installed. No HW circulator pump for water heater in CUST 2. Sanitary waste and vent piping is no-hub cast iron above grade and PVC below grade. Piping is in relatively good condition. Roof was drained primarily via gutters and downspouts. Only one primary and one overflow roof drain was observed. Roof drain piping is no-hub cast iron above grade and PVC below grade. Piping is in relatively good condition. Gas piping is in black steel and in good condition. Gas pressure at gas meter is 5-psig. Wall hydrants around exterior of building are in good condition. No solids interceptors servicing art sinks. No HW service to Kindergarten sinks. Domestic water piping is copper and in relatively good condition. No water softener for building.

- + Repair damaged water closets and flush valves.
- + Add HW to gang restroom wash fountains.
- + Install HW circulator pump at electric water heater in CUST 2.
- + Install solids interceptors for art sinks.
- + Add HW and thermostatic mixing valve to Kindergarten sinks.
- + Add water softener for gas water heater system.

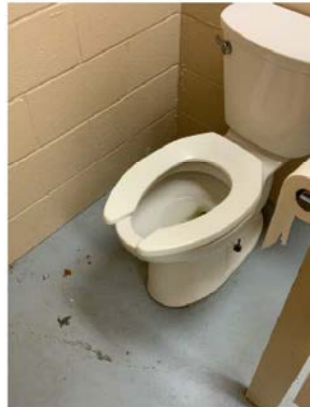
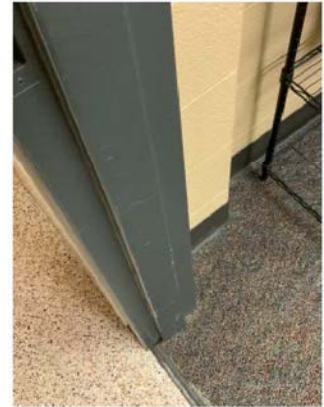
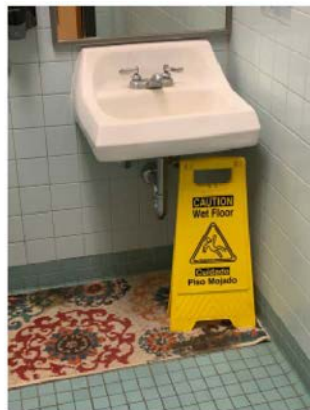
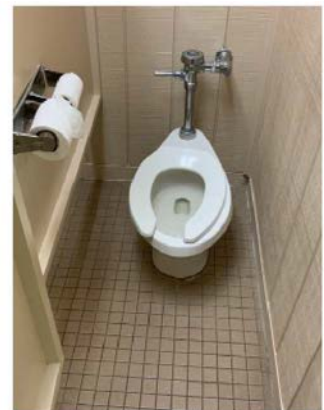
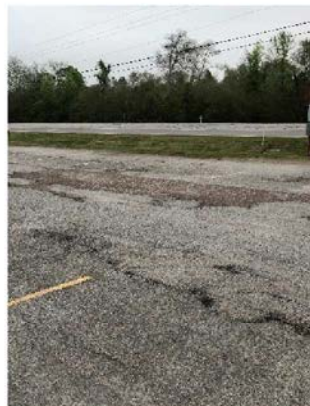
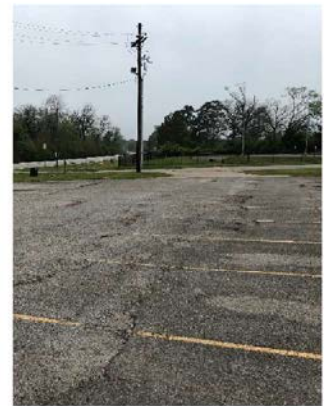
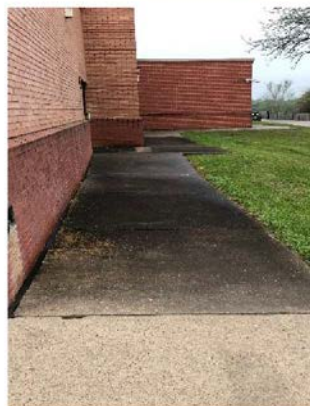
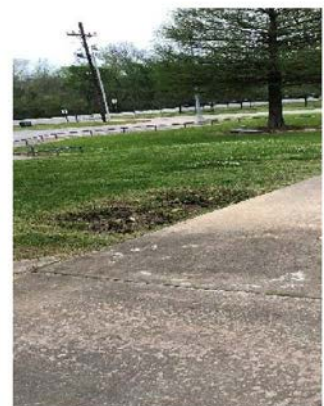
Accessibility within Montgomery Elementary School seems to be in general compliance with TAS. Toilet rooms seem to be relatively new and are in good condition, except within the Gym. The building is equipped with a fire suppression system and appears to be in good condition.

- + The existing building is fire sprinklered with 8" fire main. System appears to be in good working condition.
- + The band hall is not sprinklered. If a renovation is completed addition of fire sprinkler may be required by the Fire Marshal.

- + Toilet rooms within the Gym should be brought into compliance.

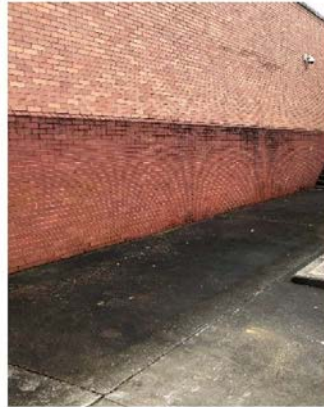
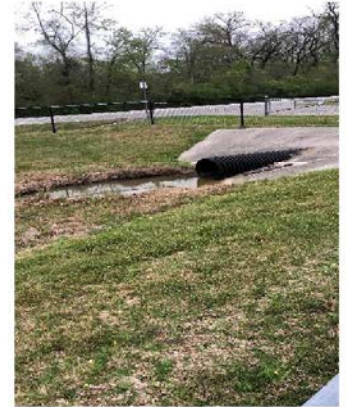
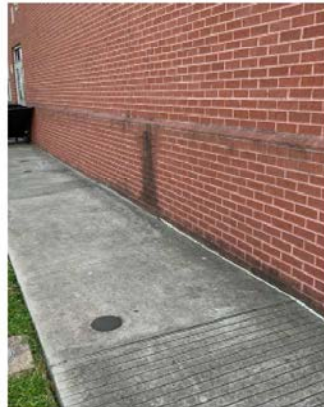
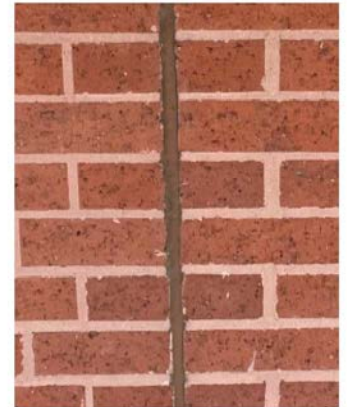
Upon review of the site conditions at Montgomery Elementary School, it appears that the site is in a relatively fair condition, but the asphalt pavement on the site is in need of maintenance, and repair. The bus and parent drive aisles appear to be in good condition and overall it appears that the site drains well, there just may be areas of erosion that need to be addressed before they become problems in the future. There is evidence of rust and deterioration of the parking rail along the parking stalls in the front parking lot. The sidewalk in the front of the school appears to drain back to the building in areas and does not appear to have proper slope away from the building. There is evidence of water staining on the sidewalks surrounding the building which is indicative of poor drainage conditions. The drainage swale along the southern property has deterioration of the baffling devices and has evidence of erosion on the side banks and sedimentation build up in the concrete slope paving sections.

- + Mill and overlay the asphalt in the front parking lot and repair any weakened sub-grade material. Seal and stripe the area when done.
- + Replace joint sealants between concrete panels.

- + Re-stripe the ADA Accessible parking space in the front of the school and look to bring area up to compliance with current standards for sloping.
- + Perform maintenance on drainage structures and conveyance paths to rebuild side slopes, remove blockages obstructing pipes, and clear sedimentation and vegetative growth buildups.

- + Establish better drainage patterns for paved areas adjacent to the buildings to help prevent against water buildup at the building walls.
- + Pressure wash the sidewalks around the building.

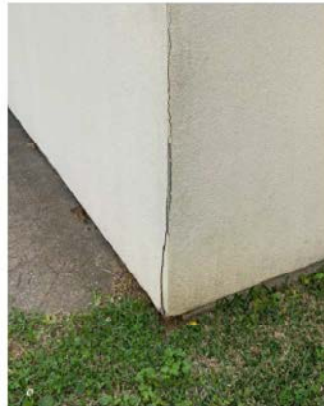
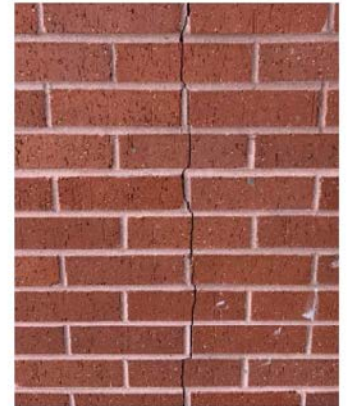
A majority of the brick facades seem to have discoloration that may be due to water leaks from gutters. There seems to be some efflorescence which can be caused by issues with the vapor barrier. There are some areas where cracking of brick was observed, and appears to be due to settlement of the building's structure. Plaster facade is dirty, and is showing signs of cracking.

- + Pressure wash the masonry
- + Remove and replace exterior sealant.
- + Patch and repair Plaster

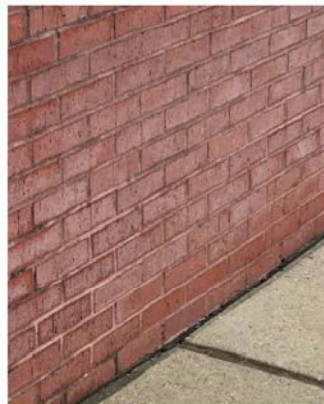
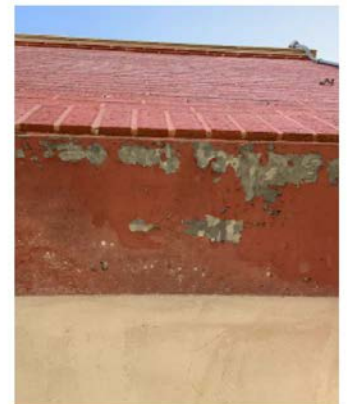
Window systems around the building seem to be in good condition. It appears that some sealant around windows is beginning to crack. Some lintels are being exposed to the elements.

- + Recommend the replacement of window sealant throughout the campus.
- + Paint Lintels throughout the campus.

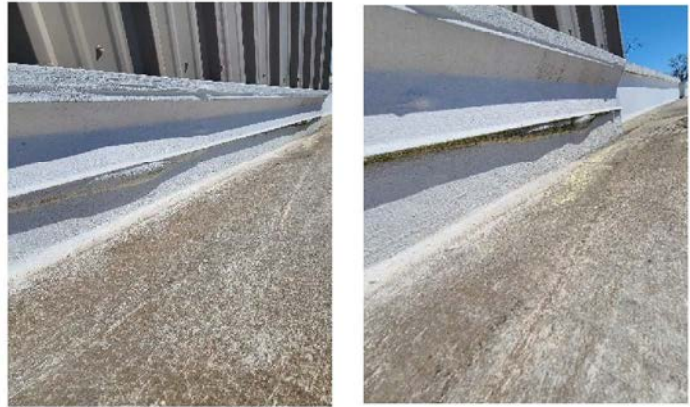
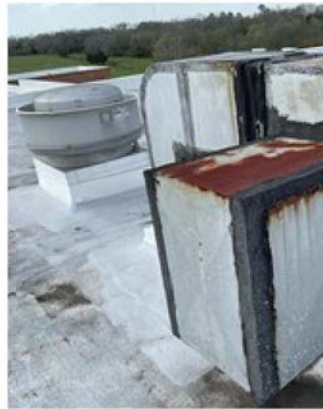
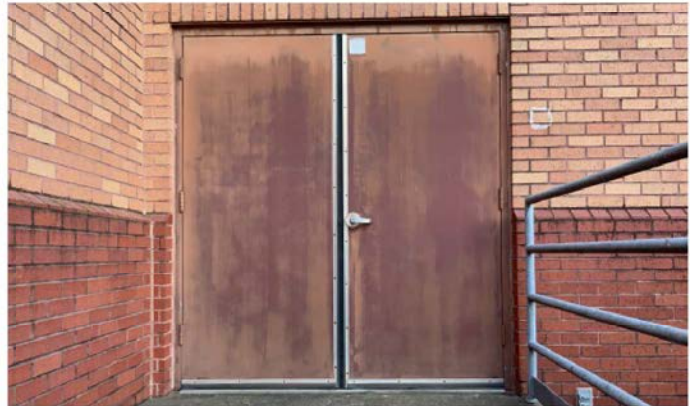
Montgomery elementary appeared to consist of a main building with a Hydro Stop roof coating system, a gymnasium with a metal panel roof system, and a band hall with a metal panel roof system. The main building appeared to consist of a low-sloped coated roof system, deficiencies observed in this location appeared to include water-filled blisters in the base flashing along an adjoining wall in the east quadrant. The main building roof system appeared to be in overall good condition and appeared to have a minimum remaining service life of eight years with proper repairs and maintenance. The gymnasium roof that appeared to consist of a metal panel roof system with a coating applied to its surface appeared to be in overall good condition with no deficiencies observed. The gymnasium roof appeared to have a remaining effective service life of approximately eight years. The band hall appeared to consist of a metal panel roof system. Deficiencies observed at the band hall roof appeared to include rusted fasteners and poorly sealed roof penetrations.

- + It is recommended that a qualified contractor cuts into the blisters to drain the water, patching the location. It is further recommended that a water test is performed to determine the source of moisture infiltration.
- + It appears that the band hall roof is near the end of its effective service life and should be replaced or coated in the near future.

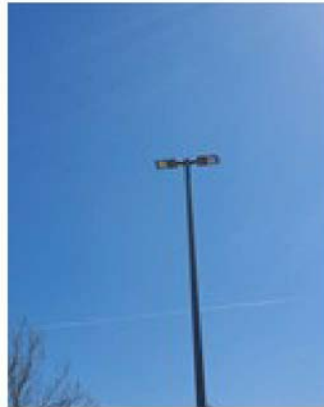
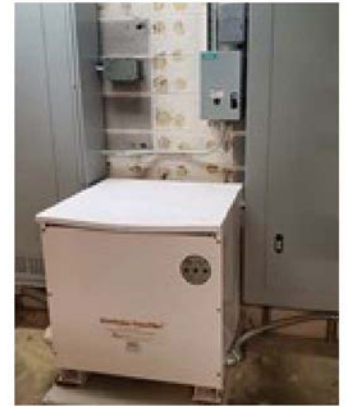
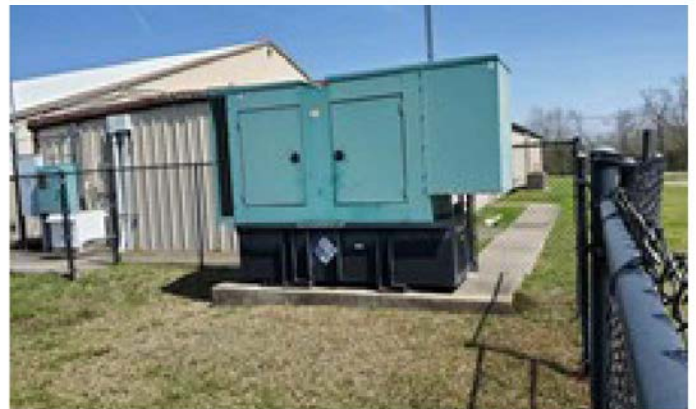
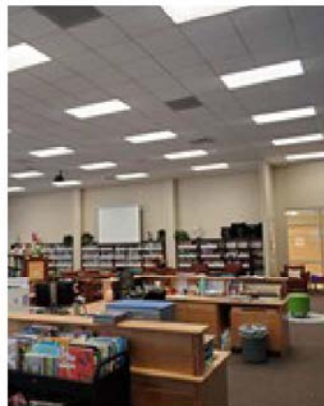
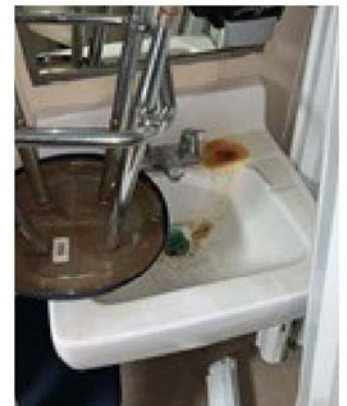
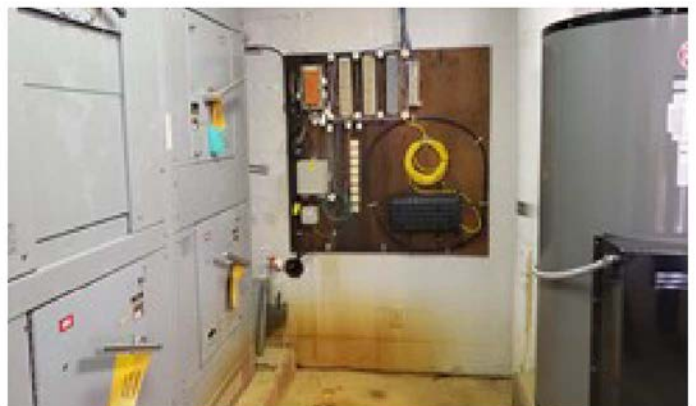
The electrical service is fed via pad mount transformer at the exterior of the building, which is connected to a wireway and 200A, 277/480V, 3PH, 4W service disconnect, which steps down via a step-down transformer and then to 120/208V, 3-PH panelboards. Lighting on the interior of the building consists of fluorescent 2x4 fixtures, 1x4 fixtures, with strip fixtures in mechanical areas. Exit signs appear to be fluorescent. Lighting controls appear to be controlled via toggle switches and do not meet current energy codes. The security system appeared to be outdated but headend equipment was not observed. IT racks appear to be in working condition, but the building appeared unused and could not be checked for function. The camera system could not be observed but all cameras indicate a newer system.

- + Replace all interior lighting with new LED fixtures.
- + Replace all existing lighting controls with new controls in compliance with energy code.
- + Tie building into existing main building security system.

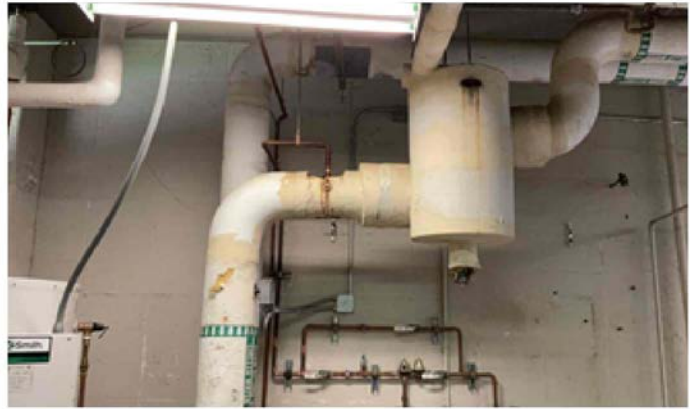
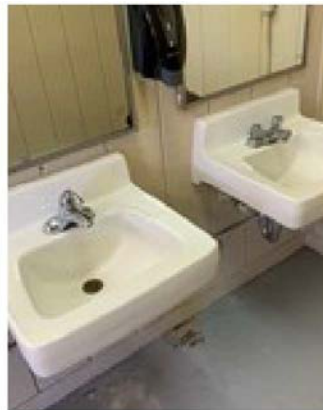
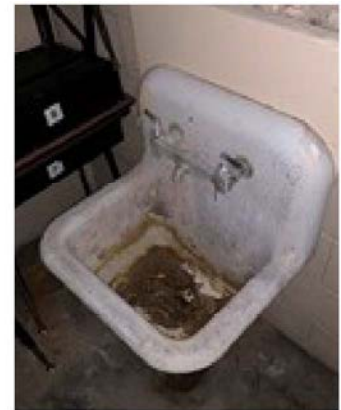
Most existing plumbing fixtures (drinking fountains, toilets, flush valves, lavatories, faucets, sinks, etc.) are relatively new and in good condition. Plumbing fixtures in Gymnasium and choir hall are old and damaged. Kindergarten sinks are CW only. Electric water heaters are located throughout building. All are relatively new and in good condition. No gas water heaters were observed in building. No gas piping was observed on site. Sanitary waste and vent piping is cast iron and in relatively good condition. All plumbing piping in gymnasium and choir hall is in poor condition. Roof was drained via roof drains and overflow scuppers. Roof drains were in decent condition. Roof drain piping is no-hub cast iron above grade and PVC below grade. Piping is in relatively good condition. Sanitary waste and vent piping is no-hub cast iron above grade and PVC below grade. Piping is in relatively good condition. Wall hydrants around exterior of building are in decent condition.

- + Replace all plumbing fixtures and plumbing piping in gymnasium and choir hall.
- + Add HW to kindergarten sinks.
- + Add hosebibbs and drains in mechanical rooms.

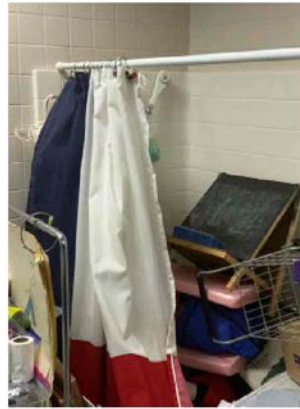
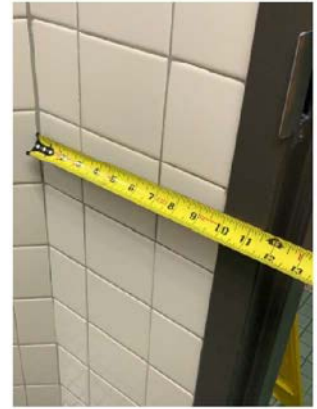
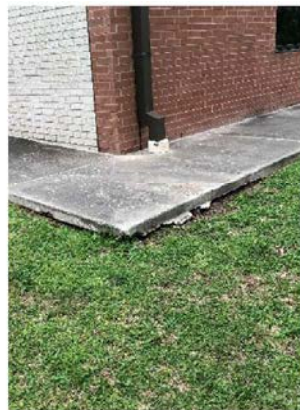
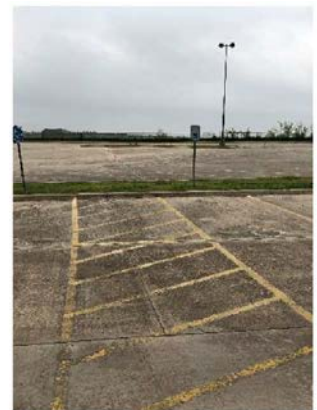
Accessibility within Stewart Elementary School seems to be in general compliance with TAS. Toilet rooms seem to be in fair condition. There are showers within the facility that are non-compliant. There are a few areas throughout the facility that do not have the required clear floor area. The building is equipped with a fire suppression system and appears to be in good condition.

- + In 2020 Montgomery County began to require the provision of a radio response system testing of educational facilities which will be required by the Fire Marshal.
- + Replace existing showers with accessible showers.
- + ADA Parking and access should be re-striped.
- + The fire alarm system is an addressable system but could not be observed. Booster power supplies are located throughout the building. It appears the system does not have voice evacuation.
- + The existing building is fire sprinklered with 8" fire main. System appears to be in good working condition.

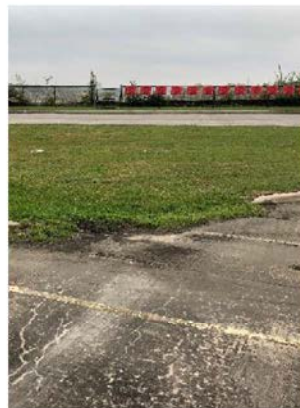
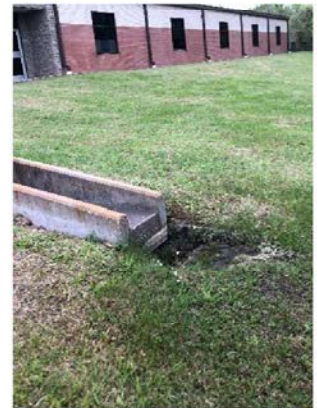
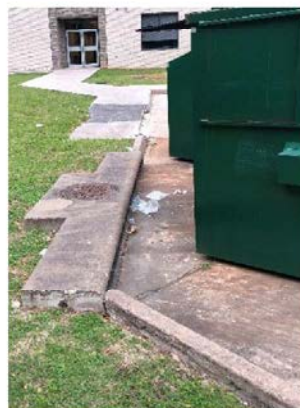
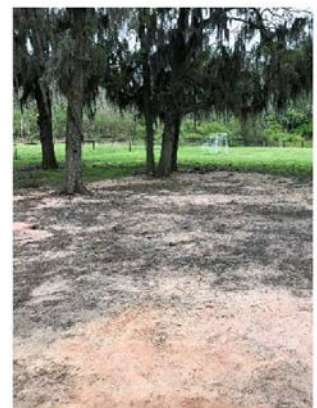
Upon review of the site conditions at Stuart Creek Elementary School, it appears that the site is in a relatively good condition. There are few areas on site with evidence of erosion or sedimentation building up which may impact drainage in the future. The dumpsters are located in an area that could potentially impede storm water runoff on the site or lead to trash building up in the storm sewer system over time. The ADA ramp behind the dumpsters is starting to exhibit cracking along the sloped curb and the joint connecting the ramp and landing pad with the drive pavement is starting to crack and spall. There are sections of sidewalk along the west building edge that is beginning to have erosion underneath the pavement. The drainage headwalls along the back of the building have erosion at the bottom of the concrete flume which is causing small pockets of standing water and is leading to erosion of the drainage path as it flows down the grass hill. There is staining of the concrete along the back side (west and north) of the building due to limited drainage across the sidewalk. The Type E inlet in the car-rider drop off lane has two curb cuts to allow pavement drainage in. These curb cuts have vegetative growth that is starting to obstruct water from leaving the parking lot which will result in ponding water in the drive lane and parking stalls. It appears that water is not properly drainage and may be seeping out of the downspout leads and onto the sidewalk.

- + Place rip-rap at the bottom of the concrete channel flumes along the back of the school to help attenuate higher velocity flows to help protect against further erosion.
- + Establish vegetative cover in open dirt areas to help prevent sedimentation runoff in large storm events.
- + Clear a drainage path from the curb cuts to the Type-E inlet to allow for better drainage in the parking lot and parent drop-off drive.

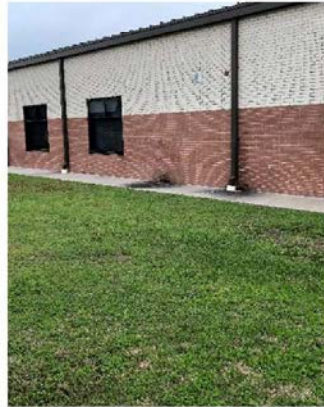
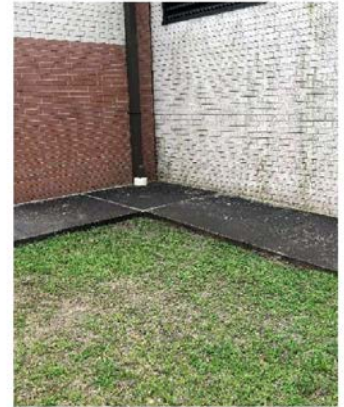
Some of the brick facades seem to have discoloration that may be due to water leaks from gutters. Exterior walls do not have control joints located along openings, which creates issues related to building movement. In areas where stone is placed the displacement of stone, and cracking of stone was observed. There is evidence of efflorescence which could be indicative of an issue with the vapor barrier.

- + Consider the installation of additional control joints within the masonry walls.
- + Pressure wash the masonry
- + Remove and replace exterior sealant.
- + Replace expansion joint caulk around the building.

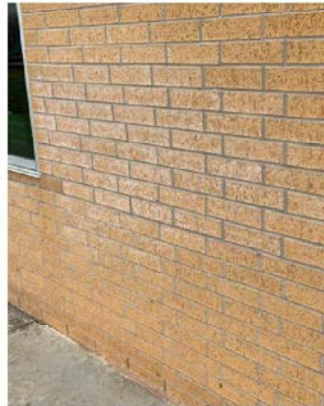
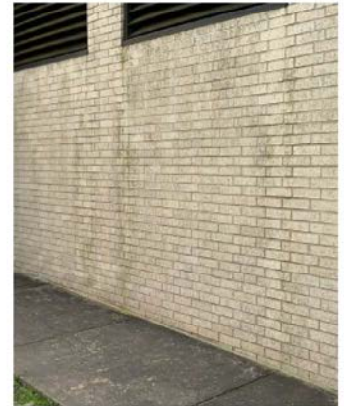
Window systems around the building seem to be in fair condition. As mentioned above the Masonry walls do not have control joints. It appears that some sealant around windows is beginning to crack.

- + Recommend the replacement of window sealant throughout the campus.
- + Consider the installation of control joints at opening.

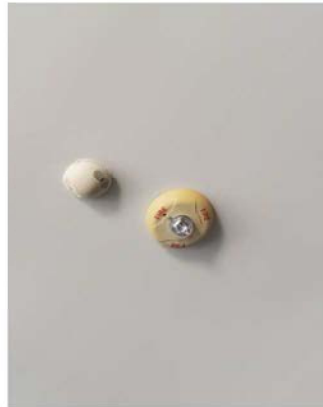
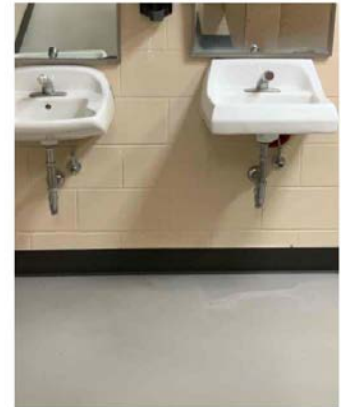
Accessibility within Montgomery Junior High School seems to be in general compliance with TAS. The building is equipped with a fire suppression system and appears to be in good condition.

- + In 2020 Montgomery County began to require the provision of a radio response system testing of educational facilities which will be required by the Fire Marshal.
- + ADA Parking and access should be re-stripped.
- + Fire Lane should be re-painted to comply with Fire Codes.
- + Within the main building smoke detectors appear to be outdated type in poor condition. Missing fire alarm notification and annunciating devices as per code.
- + Within the weight room Fire alarm system and all devices are in good condition.
- + Existing building is fire sprinklered. Fire sprinkler guards are not installed on many upright pendant sprinkler heads in mechanical rooms.
- + All sink piping throughout the facility should be wrapped.
