MONTGOMERY
INDEPENDENT
SCHOOL DISTRICT

FACILITIES ASSESSMENT VOL. I

MAY 2021

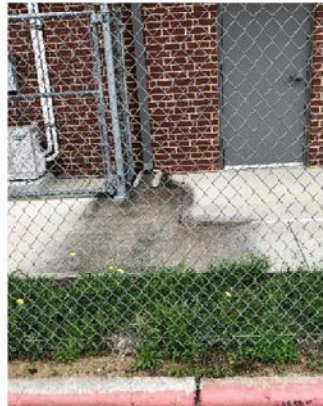
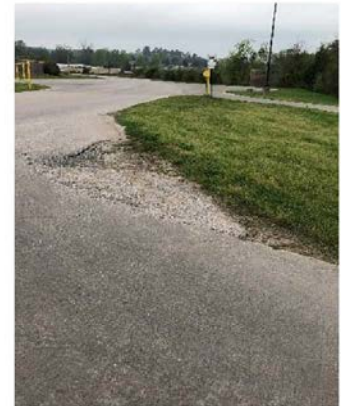
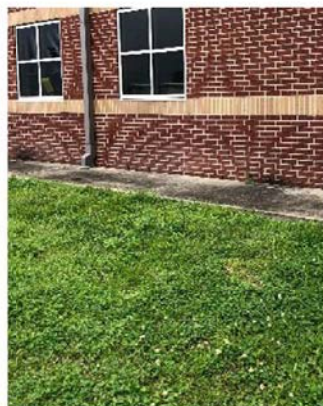
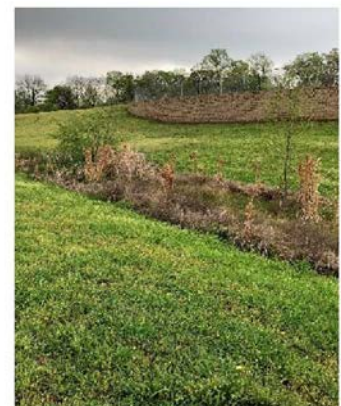
Upon review of the site conditions at Montgomery Junior High, it appears that the site is in a relatively good condition. There are areas in the detention area where sedimentation and vegetative growth have occurred over concrete drainage swales and there are some areas of water staining on sidewalk that could be indicative of poor drainage across the pavement near the building. Clean clogged inlet southwest of the building. There are sections of concrete panels beginning to heave in the parent drop-off circulation drive where the detention pond outfalls.

- + Re-stripe the crosswalk in the front parking lot.
- + Address poor drainage along the sidewalks adjacent to the building by routing roof drains below grade into an underground storm sewer network.
- + Rebuild a section of the bus loop entry into the site that is damaged.
- + Clean the concrete drainage channel in the detention pond to remove sedimentation and vegetative growth to help promote better drainage.

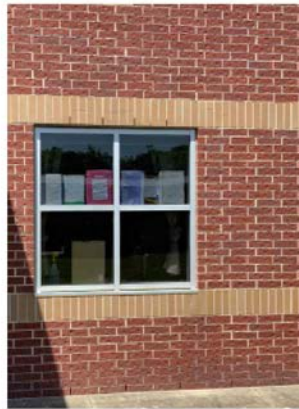
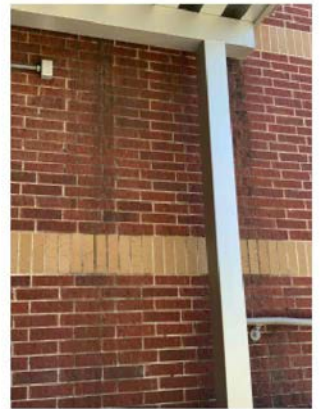
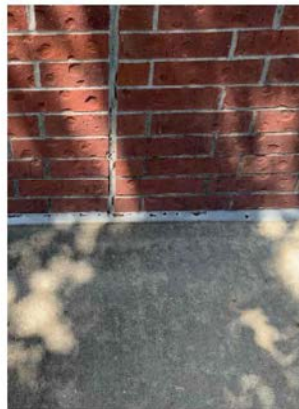
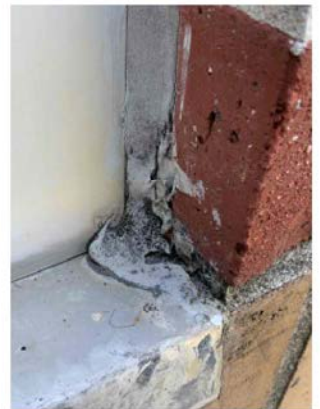
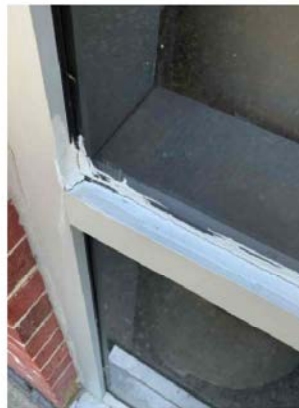
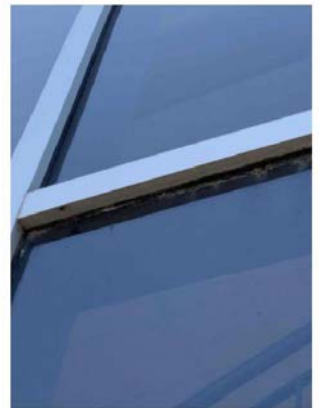
Window systems around the building seem to be in good condition. As mentioned above the Masonry walls do not have control joints. It appears that some sealant around windows is beginning to crack. Gasket for window systems have been caulked instead of properly repaired. Glass block was observed to be broken around the building.

Montgomery Junior High appeared to consist of various roof sections and levels including a main building, a weight room, and a press box for the football field which all appeared to have an existing system comprised of a single-ply roof membrane with a coating applied to its surface. The roof systems of all of the buildings on the campus appeared to be in overall good condition with very few deficiencies observed. Deficiencies observed appeared to include a poorly sealed exhaust unit in the field of a low roof area on the main building and unsealed fastener heads at a plate installed to the perimeter of a high roof section. If manufacturer recommended maintenance of the existing roof systems is continued on the campus there is a possibility that the roofs will have a minimum effective service life of approximately six years.

- + Recommend the replacement of window sealant throughout the campus.
- + Consider the installation of control joints at opening.
- + Remove and replace window system gaskets.
- + Replace broken glass block.

- + Reseal all joints in the exhaust units and the fastener heads to prevent moisture ingress and to protect the roof membrane from contact with harmful substances.

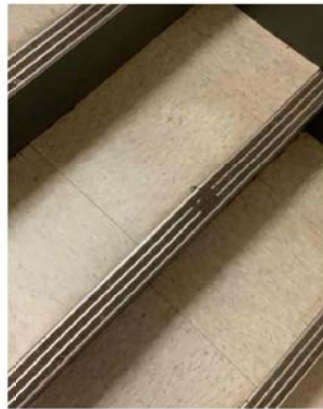
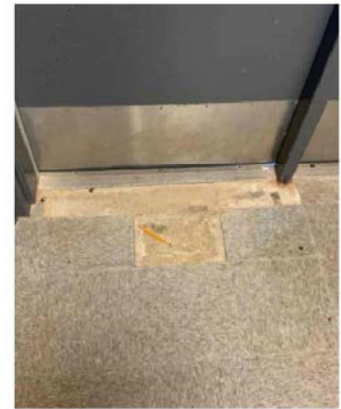
Flooring throughout the building seems to be in fair condition. High traffic areas of VCT near egress doors, storage rooms, and stairs are in need of replacement. Some areas of exposed and painted concrete were observed to have minimal damage.

- + Replace high traffic and high abuse areas of VCT.
- + Exposed concrete should be patched and painted as necessary.

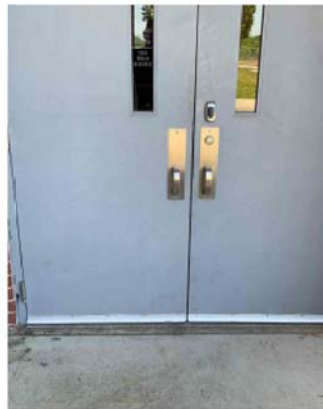
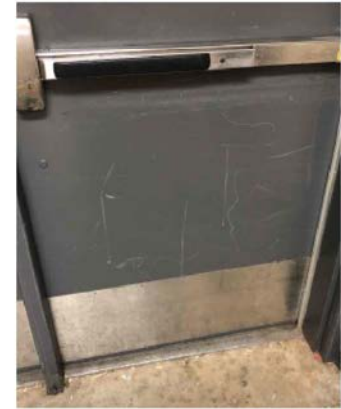
Exterior Hollow Metal door and Frames are in poor to fair condition. Interior doors consist mainly of hollow metal frames with PLAM doors, they appear to be in fair condition. Narrow lites within doors seem to be peeling and have been damaged.

- + Recommend the repainting and repairing exterior hollow metal frames.
- + Repainting of Narrow lites within interior doors is recommended.

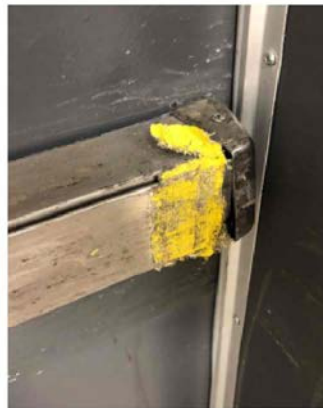
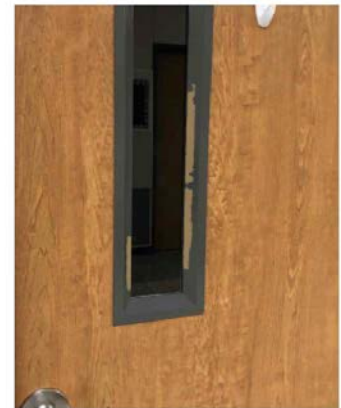
The door hardware observed throughout the campus seems to be in general compliance with TAS, and in fair condition. Exterior door hardware, and some egress doors seem to be coming to the end of their life cycle and should be replaced.

- + Replace weather stripping on exterior doors
- + Replace damaged panic hardware on egress doors.

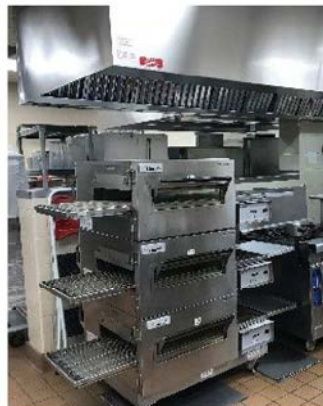
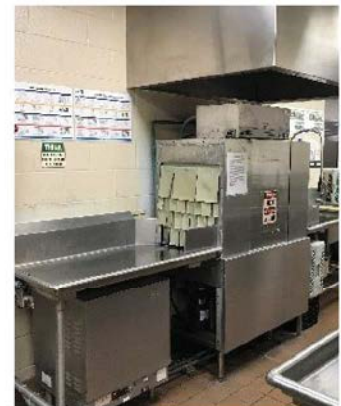
Ceilings and ceiling grid system throughout the building seem to be in good condition. There were a few areas that leaks were observed and should be monitored. There were two bulkheads that appear to need to be painted.

Within the kitchen and server of Montgomery Junior High School the floors, walls, and ceiling seem to be in general compliance with current health codes. The finishes within

the kitchen and servery include Quarry tile on the floors, CMU and Tile walls, as well as vinyl lay in ceiling tiles. The dry storage and the Cold storage are undersized, and the freezer has become a maintenance issue. Within the servery, aisle widths between sinks do not comply with Code. Overall the current kitchen layout is too small, and components within do not meet the district standards. Concession Stands seem to be in compliance.

- + Increase Cold Storage to a minimum of 684 sq. feet from 400 sq ft.
- + In lieu of the option above, the MISD could increase delivery frequency.
- + Complete Kitchen, and servery renovations are recommended. Increase the kitchen and servery to a minimum of 5,200 sq ft.
- + All of the Kitchen Equipment has reached its expected life cycle and should be replaced.
- + Hand wash stations need to be added to comply with health codes if renovations occur.
- + Stackable washer and Dryer within kitchen do not appear to be compliant with TAS. They are also at the end of their life cycle. Recommend replacement with side by side units.

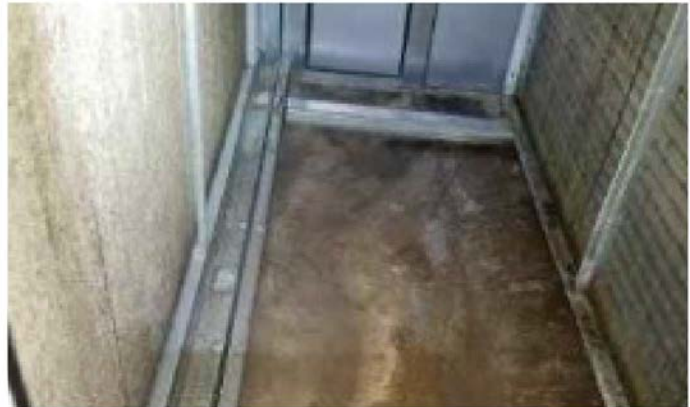
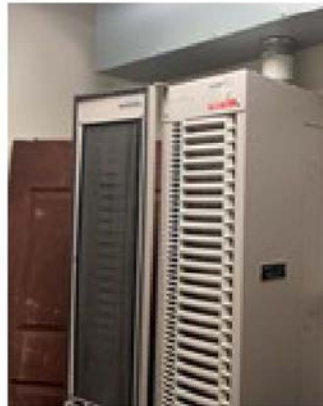
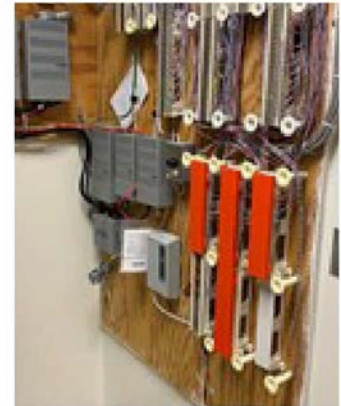
The electrical service is fed via pad mounted utility transformer at the exterior of the building, which is connected to 4000A, 277/480V, 3-phase, 4-wire main switchboard 'MSB' located in the main electrical room. This main switchboard feeds additional distribution boards and panelboards throughout the building. The distribution boards provide mechanical equipment circuiting. The 277/480V panelboards are utilized for lighting, small mechanical equipment, and feeding 120/280V panelboards via stepdown transformers. The 120/208V panelboards are connected to small mechanical equipment, receptacle loads, and miscellaneous loads throughout the building. Some equipment is aging and requires replacement. There is a 175kW gas generator on the exterior of the building feeding all life safety and emergency loads via (2) ATSS and are in good condition. Lighting on the interior of the building consists of fluorescent 2x4 fixtures, 1x4 fixtures, and recessed cans throughout, with strip fixtures in mechanical areas. Exit signs appear to be fluorescent and outdated. Interior lighting consists of old surface mounted HID lighting around the building. Parking lot have new HID fixtures and contactor controls. Lighting controls appear to be controlled via toggle switches and occupancy sensors that are outdated and do not meet current energy codes.

Cafeteria theatrical lighting and control racks are outdated. The fire alarm system is an addressable voice evacuation system. Booster power supplies are located throughout the building. The intercom and clock system could not be observed but appeared to be outdated.

- + Replace all other outdated and damaged pieces of panels and equipment throughout the buildings.
- + Replace all interior lighting and Exit signs with new LED fixtures.
- + Replace all remaining exterior lighting with new LED fixtures.
- + Replace all existing lighting controls with new controls in compliance with energy code.
- + Intercom system and clock system needs to be upgraded.

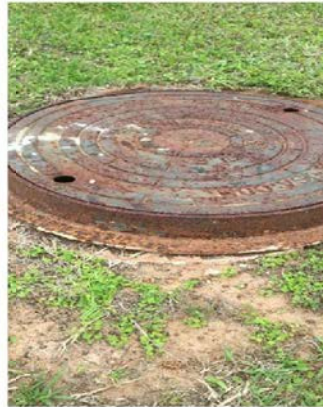
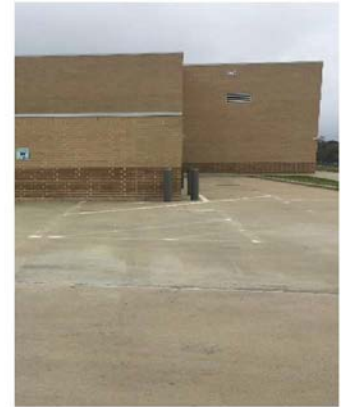
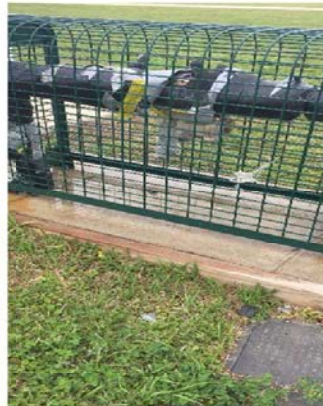
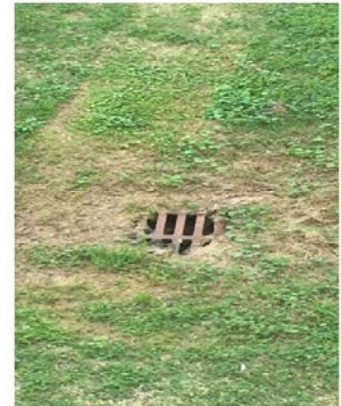
Upon review of the site conditions at the Oak Hills Junior High School, it appears that the site is in good condition, but there is evidence of erosion along the boundaries, as well as minor utility infrastructure deficiencies. There are small areas in the parking lots which show evidence of ponding water and sedimentation build up. The inlet is clogged and full of grass and trash immediately to the southwest of the building. The irrigation back-flow preventer was leaking.

- + Clean clogged inlet southwest of the building.
- + Repair broken sample well lid.
- + Raise sanitary sewer manhole rim elevation northeast of the building.
- + Fill in around inlet box to the southeast of the track to prevent further washout in the area around the structure.

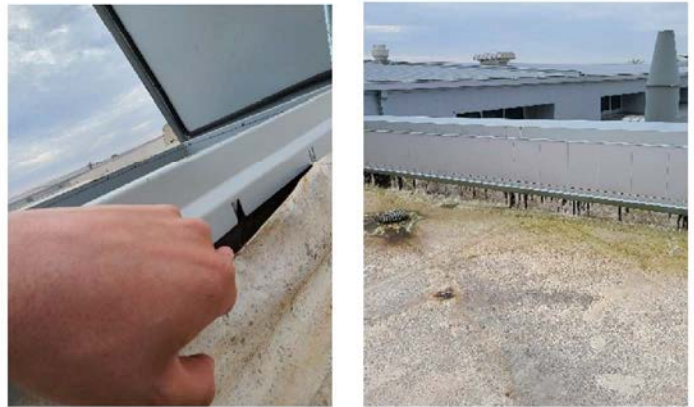
Oak Hills Junior High appeared to consist of various roof sections and levels including a main building with a single-ply roof system and standing seam metal roof system, a storage building, and a small press box for the athletic field. The roof systems of all of the buildings on the campus appeared to be in overall good condition with very few deficiencies observed. Deficiencies observed on the main building appeared to include an asphaltic substance in contact with base flashing at a parapet wall on the roof section above the gym, cracked sealant at vent pipes in the metal panel roof areas and single-ply roof sections, and lack of termination at the curb flashing installed to the roof hatch above the gym. With continued manufacturer recommended maintenance it appears that the standing seam metal roof areas appear to have a

minimum remaining effective service life roof fifteen years and the single ply roof areas appear to have a minimum remaining service life of approximately ten years with proper repairs and maintenance.

- + Cleaning of the asphaltic substance from the base flashing to prevent degradation of the membrane, replacing deficient sealant at vent pipes, and installing termination bar and sealant to the roof hatch curb flashing to prevent moisture ingress is recommended.

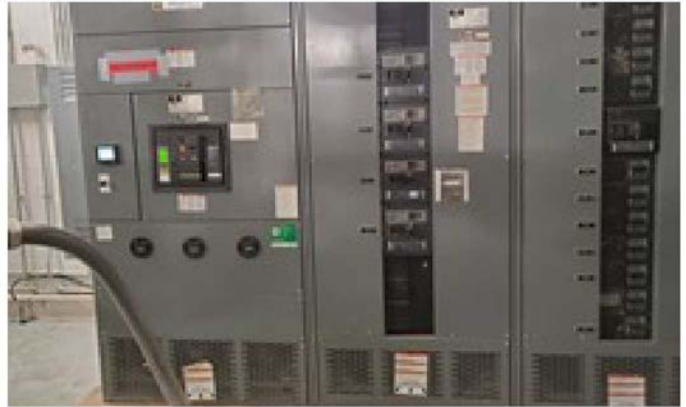
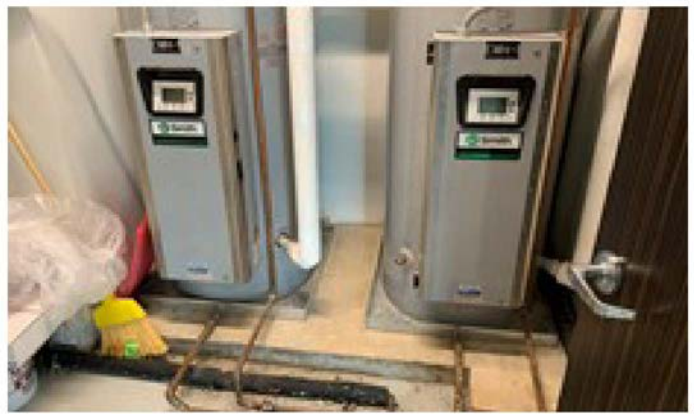
Existing plumbing fixtures (drinking fountains, toilets, flush valves, lavatories, faucets, sinks, etc.) are relatively new and in good condition. Electric water heaters are located throughout building. All are relatively new and in good condition. Sanitary waste and vent piping is cast iron and in relatively good condition. Roof was drained via gutters and downspouts. Roof drain piping is in good condition. Propane piping is black steel and in good condition. Wall hydrants around exterior of building are in good condition. Water piping is copper and in good condition. All lavatories have HW and thermostatic mixing valves. No water softener installed for kitchen HW system.

- + Add HW to gang restroom lavatories and mop basins in custodial closets.
- + Add hose bibbs in mechanical rooms.
- + Replace exterior gas piping (gas piping only for generator).
- + Disconnect HW at clinic sink and add instant hot water heater to provide HW to sink.
- + In Central Plant, re-route 4" CW above main electrical equipment.
- + Repair all corroded wall hydrants on exterior of building.

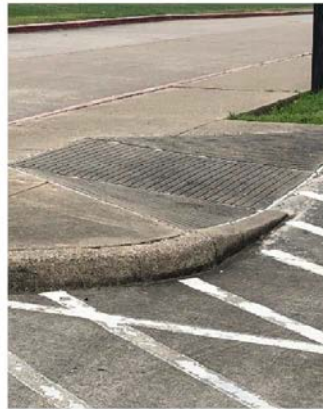
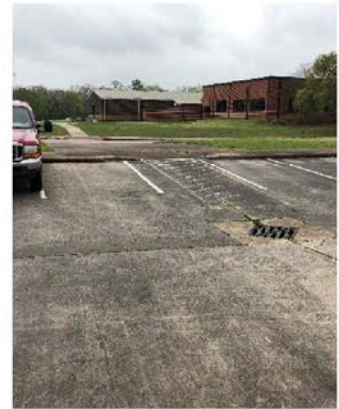
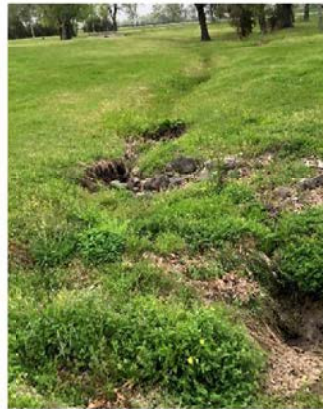
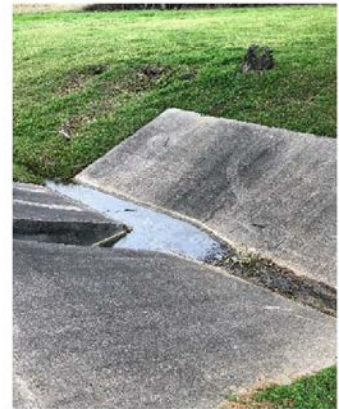
- + In 2020 Montgomery County began to require the provision of a radio response system testing of educational facilities which will be required by the Fire Marshal.
- + Re-stripping of ADA Access, and parking areas is recommended.
- + Fire lane striping should be re-finished.
- + Within the Main building and the 9th Grade Center it appears that the fire alarm system is an addressable system. It appears the system does not have voice evacuation. If an improvement is complete the AHJ may require a system upgrade.
- + There is a fire suppression system throughout the Main Building and the 9th Grade Center.

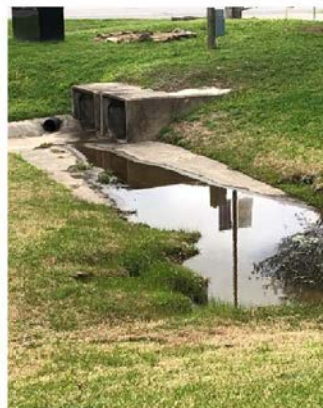
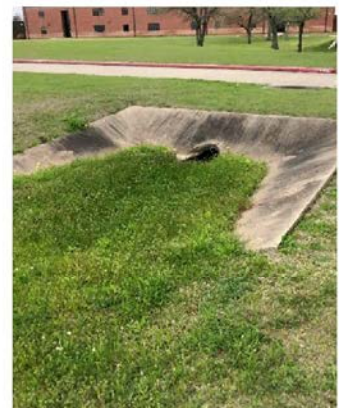
Upon review of the site conditions at Montgomery High School, it appears that the site is in a relatively good condition, but the drainage infrastructure on the site needs maintenance. There are areas in the detention ponds that are showing signs of sluffing and erosion which should be addressed to avoid continued wearing away of soil. Clean clogged inlet southwest of the building. Ponding water in the detention pond drainage channels leading to sedimentation buildup and overgrowth of grass. There is evidence of erosion around the acid separation tank along the north wall towards the northwest student classroom wing. This is allowing for water seepage to occur. Curb lines are cracking through the site. Spalling joints and cracking concrete are occurring at curb inlet sags along circulation drives. Roof drains splash on grade along the sidewalk of the north face of the building and are causing water staining on the sidewalk. There are offset cracks in the circulation lane in the northeast area of the site which could lead to deterioration of the paving in the drive. There are clogged drainage pipes connecting the different drainage areas along the southern side of the building. The southeastern parking lot has a drainage flume leaving that is leading to erosion of the grass drainage swale behind it. Concrete panels are heaving next to the drainage flume in the southeastern parking lot. Exposed sidewalk has ground eroding beneath it. Erosion occurring under parking slab in southeastern parking lot.

- + Clean sediment from the drainage swales in detention areas that are blocking drainage and repair areas that have eroded or washed out.
- + Address erosion areas throughout the site.
- + Take roof leaders that splash on sidewalk under the pavement and discharge either in landscape areas or to underground storm that is routed to a collection system.
- + Cut drainage swales in landscape areas on the south side of the building to help prevent water from draining back to the building.
- + Replace joint sealants throughout the parking areas.
- + Address pavement erosion undercut in the southeast parking lot that is causing heaving in the pavement slabs.
- + Patch spalling and cracking concrete at the joints.

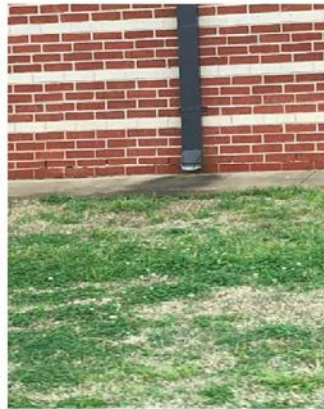
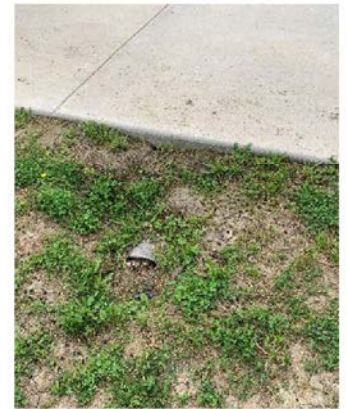
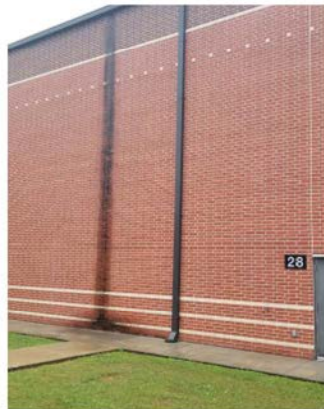
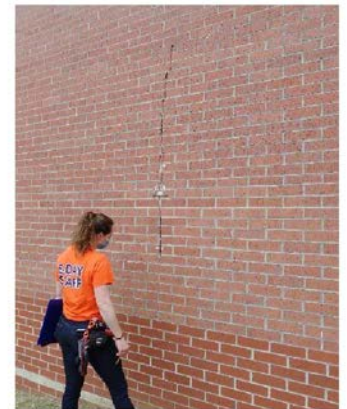
The exterior of the Montgomery High School and 9th Grade center is masonry and appears to be in good condition. There is an area at the south east side of the library where exterior cracking was observed. The concrete at a porch handrail was spalling off at the 9th grade center near the cafeteria and some brick movement was observed at the old original remaining D Hall in the 9th Grade Center.

Walls within the 9th Grade Center and High School seem to be in good condition. There are some areas within the 9th Grade center and the HS where settlement of the building has been observed and general maintenance of the walls is recommended. Further recommendations are made in the Structural portion of the assessment.

- + General patching and painting of interior wall damage is needed throughout the campus.
- + Gutter at the exterior of the building appears to be leaking and should be repaired.

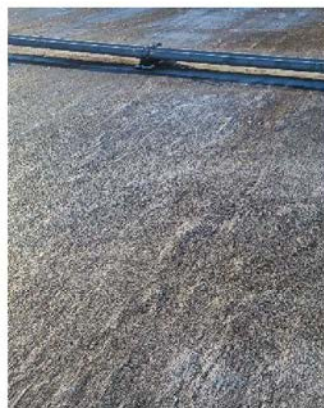
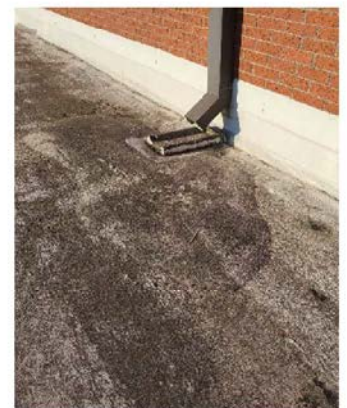
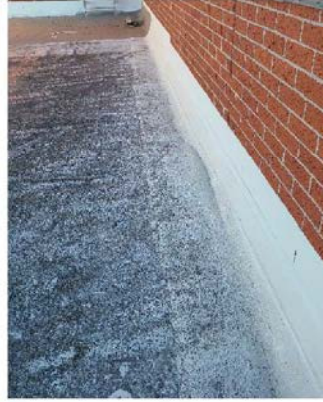
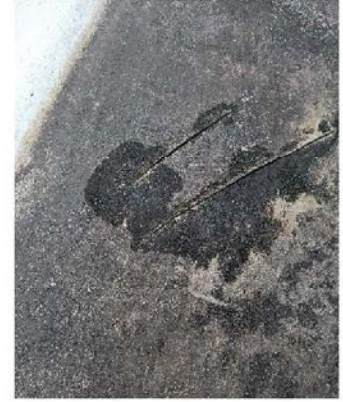
building near the tennis courts with a built-up roof system. The roof systems observed on the storage building at the practice field, the junior bear stadium, and the tennis concession building appeared to be in overall good condition with no deficiencies observed. The Hydrostop roof coating observed throughout the field of the various roof sections of the main building appeared to be in poor condition. Deficiencies observed throughout the main building appeared to include large blisters filled with water, small blisters consistently throughout the field of various roof sections, cuts into the coating near mechanical equipment in a low roof area, signs of ponding water, signs of moisture infiltration on interior ceiling tiles, and deteriorated coating near field drains. With continued manufacturer recommended maintenance the roof systems installed to the storage building, the tennis concession, and the junior bear stadium could have a minimum remaining service life of approximately eight years.

- + An infrared survey should be performed to determine the extent of subsurface moisture content beneath the Hydrostop roof system of the main building, depending on the extent of the subsurface moisture content the recommendation will be either repairing effected areas or replacing the existing roof system in the near future.

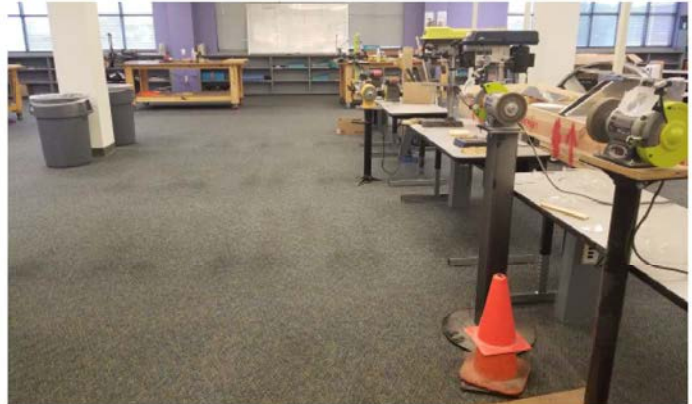
The flooring throughout the High School and 9th Grade Center appear to be in good condition with normal wear and tear. There are a few areas throughout he campus that require maintenance or replacement. There are some areas that have flooring that may not be appropriate for the use such as the wood shop with carpet finishes.

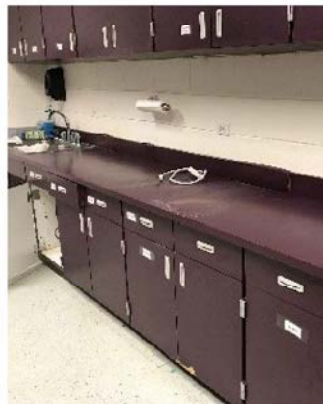
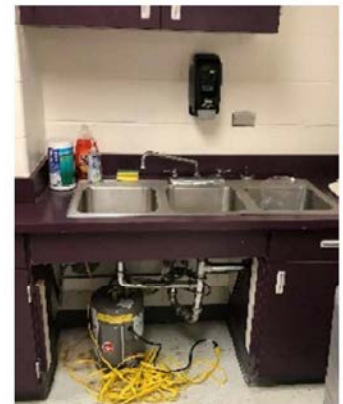
Millwork throughout the High School and 9th Grade Center appears to be in fair condition, and generally complies with current standards. A majority of the sinks within casework should be replaced. Within the basket ball concessions the casework does not appear to comply with TAS, and is damaged.

- + Replacement is recommended.

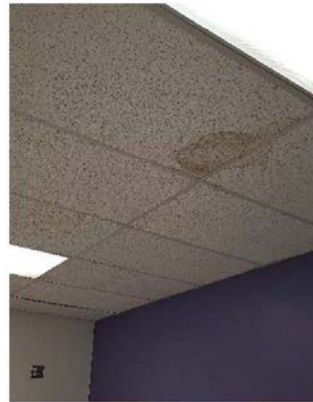
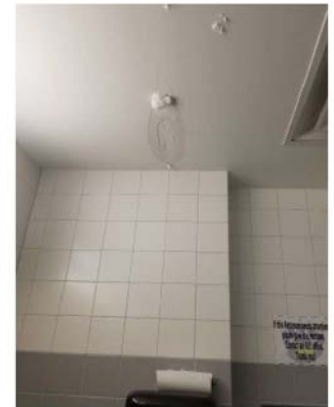
Ceilings and ceiling grid system throughout the High School and 9th Grade Center seem to be in good condition. There are areas of the building that encounter frequent damage due to what appear to be roof leaks. At basket ball concessions it was noted that there was significant damage to the ceilings .

- + Recommend roof investigation as noted in the Roof assessment, and the replacement of ceilings in areas that have been exposed to moisture. Replace Ceiling in basketball Concessions.

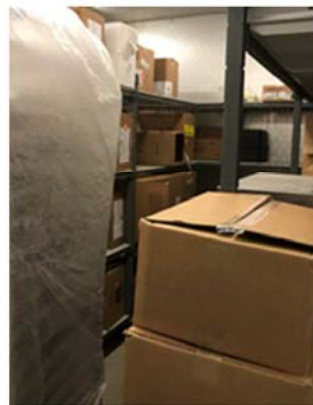
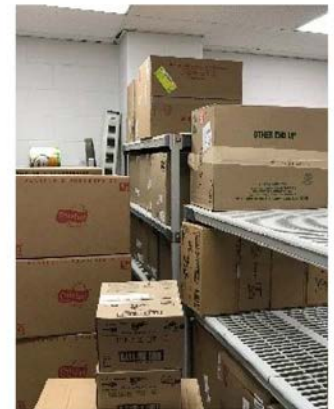
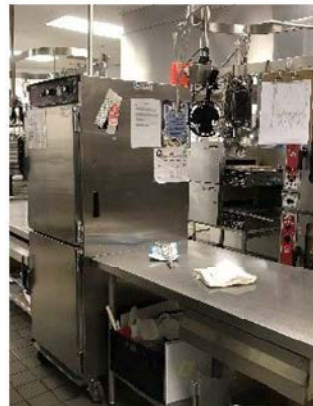
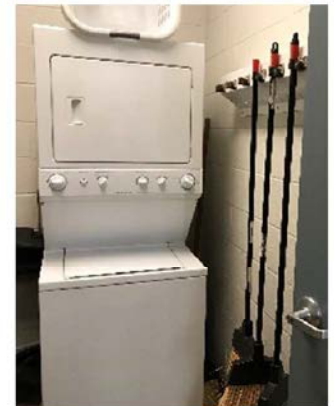
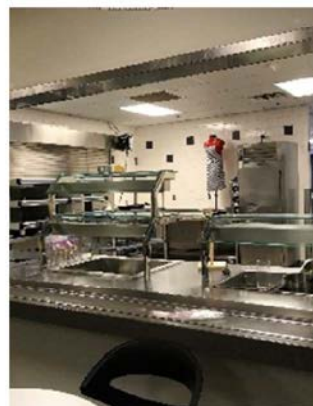
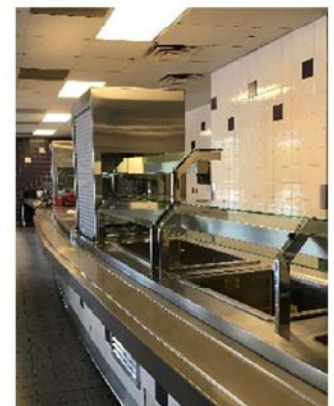
Within the kitchen and servery of Montgomery High School the floors, walls, and ceiling seem to be in general compliance with current health codes. The finishes within the kitchen and servery include Quarry tile and sealed concrete on the floors, CMU and Tile walls, as well as vinyl lay in ceiling tiles. The dry storage and the cold storage are undersized, and should be expanded as part of an addition to the kitchen and servery.

The 9th Grade Center former Kitchen and servery has been converted to a Culinary Arts CTE. There are some components missing from with the lab that are required to meet the curriculum such as drying racks. There are also pieces of equipment that are not required for curriculum such as the Pizza Conveyor, and Tilt Braising Pan. The Stackable washer dryer are used by students and are non compliant. Due to the conversion of the Kitchen to culinary arts, the serving lines and pass-through cabinets are not in use.

- + Increase Cold Storage to a minimum of 1094 sq. feet from 385 sq ft. Increase Dry Storage to a minimum of 740 sq. feet from 310 sq. Feet.
- + An expansion to the Kitchen, and Servery is recommended based on the student population and anticipated growth.
- + All kitchen equipment within the High School Main Kitchen is has met or exceeded its expected life cycle and should be replaced.
- + Consider the replacement of the stackable washer and dryer with a side by side to comply with TAS.

- + Remove equipment not needed for curriculum.
- + Renovate Snack Bar area to expand Teaching Classroom.
- + Replace non-functional equipment. Disposer, 3HP; (1) 6' Worktable; Double Stack Hobart Gas Convection Oven;
- + Replace existing student classroom tables with larger tables as required for class size and curriculum.

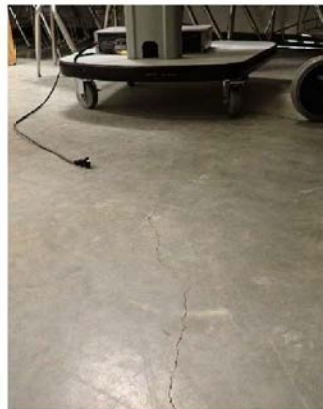
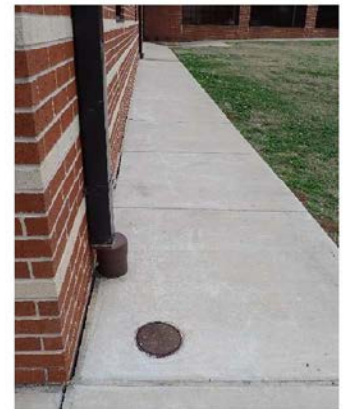
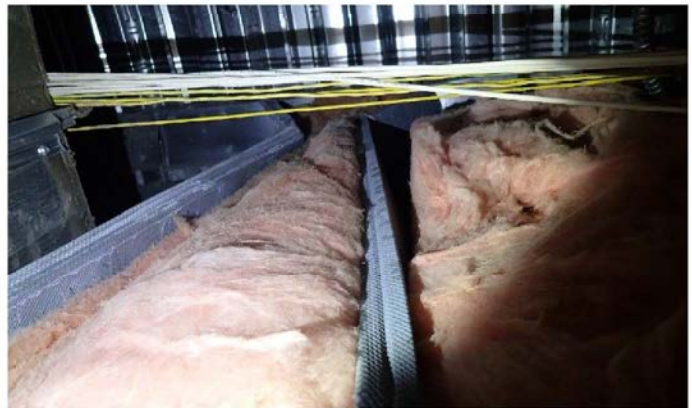
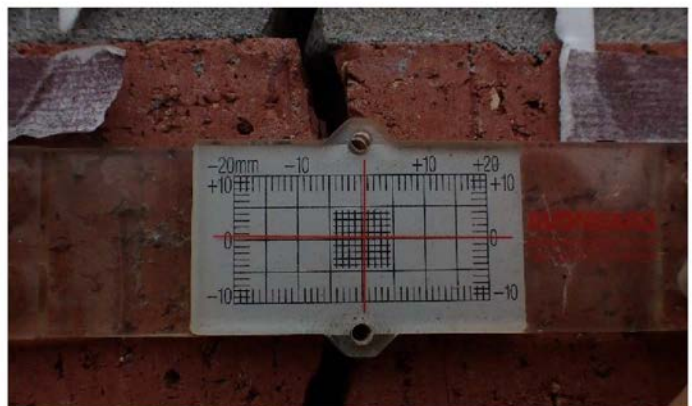
- + Foundation movement was apparent at that time; primarily apparent heave, primarily near the West Wing library and in the west wing of the ninth-grade center

- + The majority of the distress (e.g., cracked drywall, cracked brick mortar joints, separation at expansion joints, crushed drywall at joints, displaced ceiling tiles/ceiling grid) was associated with the foundation movement.

- + Soil samples obtained from the building demonstrated that the site is underlaid with fat clays with the potential for expansion/shrinkage due to moisture changes. Specifically, the fat clays below the area of the Ninth Grade Center exhibited the potential for additional heave of 2-1/2 to 3 inches based on the laboratory swell tests, and a Potential Vertical Rise (PVR) of about 1-1/2 to 2 inches based on test method TEX-124-E.

- + From our follow-up work in 2017, a small leak was detected in the first-floor bathroom plumbing. See Figure 3 for the area of the apparent leak. It was recommended to repair this minor leak; however, the heave present was unlikely caused by this leak.

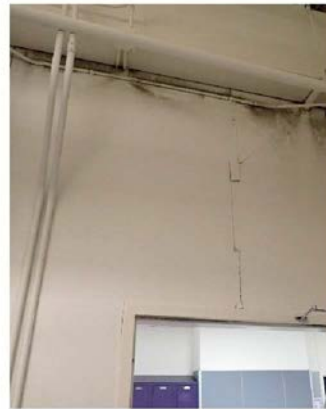
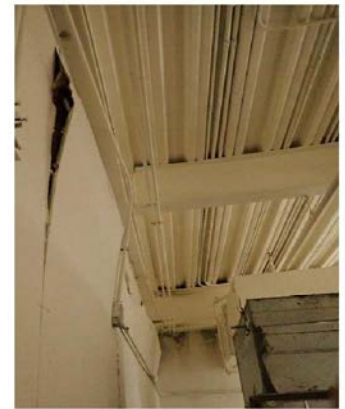
Distress related to foundation movement was observed throughout the western portion of the Ninth Grade Center. Distress such as cracking/buckling of drywall, displaced ceiling tiles and grids, and cracking in the slab on ground in the mechanical room, and buckled wall studs were observed in several areas of the west portion of the Ninth Grade Center. No structural concerns (e.g., floor beam connection distress) were observed.

- + Based upon the previous work performed by WJE and Terracon at the school, and the new findings from our work in this phase, we recommend that MISD consider repairs for the veneer at the West Wing which appears to be stable, and limited replacement of sealant joints between the concrete apron and the veneer wall. If the minor leak, identified in our 2017 report has not been addressed, we recommend that additional testing be conducted, and if the leak persists to perform that repair as required. Although the NGC appears to be prone to future slab-on-ground movement, the principal distress is associated with restraint of the walls at the underside of the second floor. If the partition walls were to be rebuilt, slotted deep leg tracks may be used to potentially allow for future vertical movement of the stud walls, mitigating risk of future damages; however, there is still the chance of additional damage to occur.

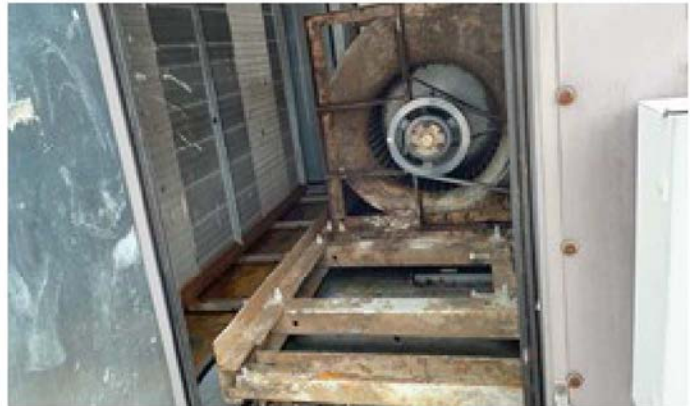
The building cooling system is provided by four (4) 8-year-old 200-ton Trane air-cooled chillers. The chillers appear to be in good condition. However, evaporator barrel insulations are compromised. The library, common, gym, and kitchen areas are served by 4-pipe single zone Engineered Air handling units. They are about 5 years old and are in good condition. The building heating system is provided by two (2) 8-year-old 3,350 MBH Sellers boilers. Boilers appear to be in poor condition. Hot water pumps are in bad condition. All the classroom spaces are served by 2-pipe fan coil units with electric duct heater. They are installed above the ceiling and are good condition. However, many supply and return air grilles are rusted and dirty. Outside air for the FCUs is being pretreated by three (3) roof mounted ERV units. They are in poor condition. Chilled water chemical pot feeder is rusted and is in poor condition. A few roof fans are in bad condition. The BAS is by Unify and the control modules are in good condition

- + Replace the chiller evaporator barrel insulations with new.
- + Replace existing boilers.
- + Replace the bad chilled water and hot water pumps.
- + Replace chemical pot feeder with a new one and insulate.
- + Replace outside air pretreatment ERVs on the roof.
- + Replace all rusted out supply and return air grilles.
- + Replace rusted and damaged roof fans.

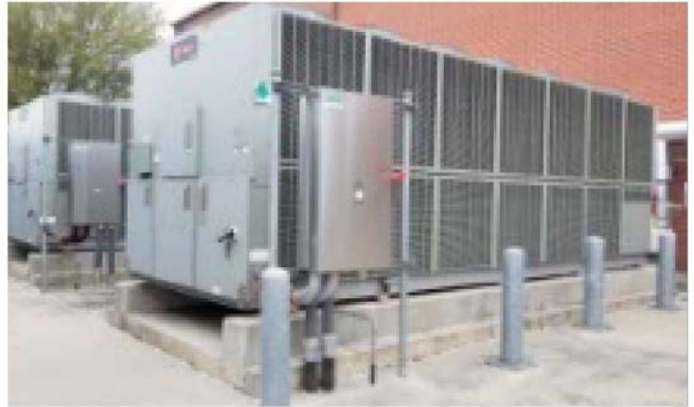
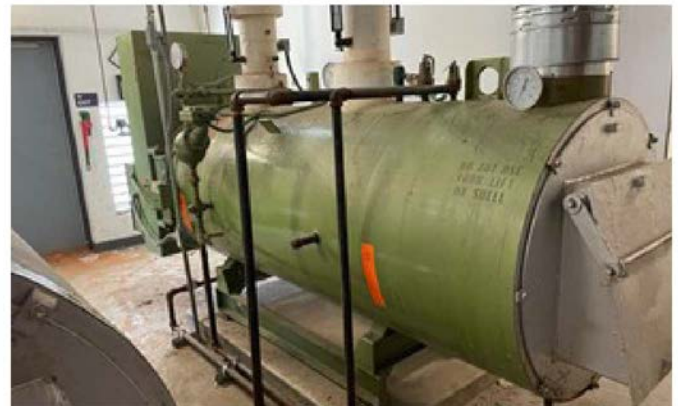
The building cooling system is provided by two (2) 1-year-old 280-ton Carrier air-cooled chillers. The chillers are in good condition. The library, common, and admin areas are served by one (1) 13-year-old 2-pipe VAV Carrier air handling unit with electric heat. They are in good condition, however the interior is dirty. All fan power boxes are in good condition. Classroom wing to the north of the gym is being conditioned by one (1) 13-year-old 4-pipe VAV Carrier air handling unit with hot water. They are in good condition, however the interior is dirty. All fan power boxes are in good condition. Kitchen, gyms, locker rooms and dancing areas are served by 13-year-olds 4-pipe Carrier rooftop units. Outside air is served by 100%OA 13-year-old 4-pipe Carrier rooftop units. They are in fair condition. Interior of unit is dirty and starting to rust. Heating is provided by two (2) 3348 MBH 13-year-old Sellers boilers. They are in good condition, however not compliant with current energy code. Chilled water piping insulation is fiberglass. There are signs of previous condensation issue at many locations and insulation at the central plant and mechanical rooms is in poor condition. Air separator and pot feeder insulation is damaged. Classroom wing to the east of the cafeteria is being conditioned by water source heat pumps units. Heating is provided by one (1) 13-year-old Safgard boiler. Boiler appears to be in fair shape, however not compliant with current energy code. Condenser water is provided by one (1) 13-year-old BAC cooling tower. Cooling tower appears to be in fair condition. Exposed hydronic piping's labels on roof are fading. ROAHU-2 hot water piping insulation is damaged. RAHU-4 hot water piping insulation is damaged. All mini-splits condensing units and dx condensing unit are in poor condition. Refrigerant piping insulation is damaged.

- + Replace the chiller evaporator barrel insulations with new.
- + Replace existing boilers.
- + Replace the bad chilled water and hot water pumps.
- + Replace chemical pot feeder with a new one and insulate.
- + Replace outside air pretreatment ERVs on the roof.
- + Replace all rusted out supply and return air grilles.
- + Replace rusted and damaged roof fan

- + Replace fans with new at the batting cages.
- + Slope properly drain pan to allow condensate water to drain inside RTU at the Field house.
- + Clean all dirty exhaust grilles on tennis facility.

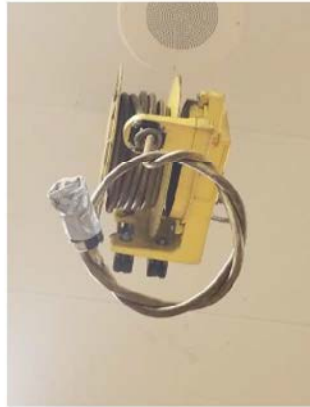
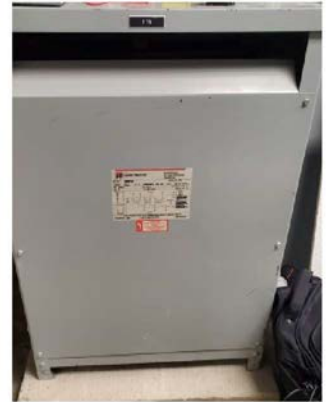
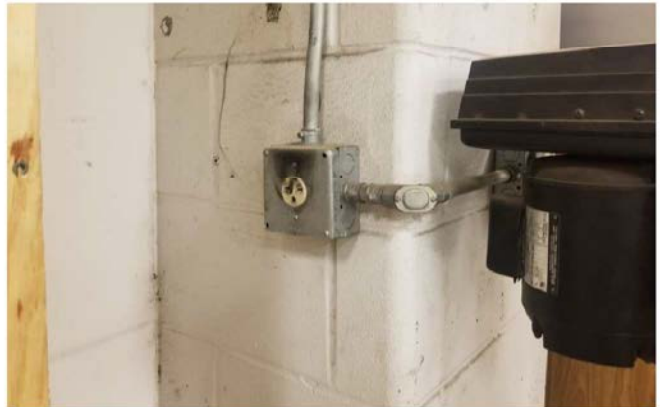
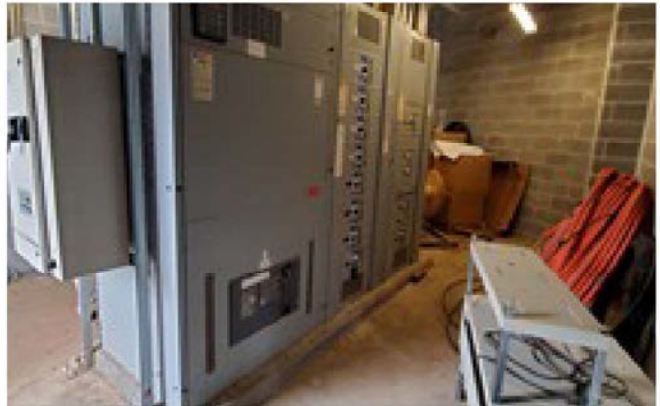
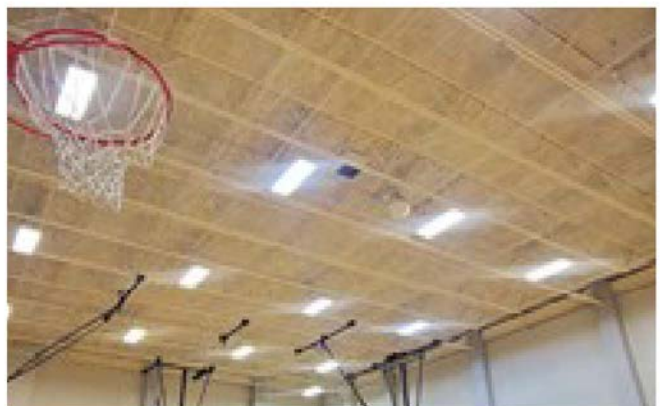
9th Grade Center

The electrical service is fed via pad mount transformer in the service yard of the building, which is connected to 2500A, 277/480V, 3-phase, 4-wire main switchboard located in the main electrical/mechanical room. This main switchboard feeds additional distribution boards and panelboards throughout the building. The distribution boards provide mechanical equipment circuiting. The 277/480V panelboards are utilized for lighting, small mechanical equipment, and feeding 120/280V panelboards via stepdown transformers. The 120/208V panelboards are connected to small mechanical equipment, receptacle loads, and miscellaneous loads throughout the building. Equipment is only a few years old and in perfect condition. There is an emergency generator, that appears to feed selected receptacle and lighting loads. Lighting on the interior of the building consists of fluorescent 2x4 fixtures, 1x4 fixtures, and recessed cans throughout, with strip fixtures in mechanical areas. Exit signs appear to be fluorescent. Exterior lighting consists of old surface mounted HID lighting at the canopy. Parking lot fixtures are old HID style fixtures. Lighting controls appear to be controlled via toggle switches and do not meet current energy codes.

- + Replace all outdated and damaged pieces of equipment throughout the buildings.
- + Replace all interior lighting with new LED fixtures.
- + Replace all remaining exterior lighting with new LED fixtures.
- + Replace all existing lighting controls with new controls in compliance with energy code.

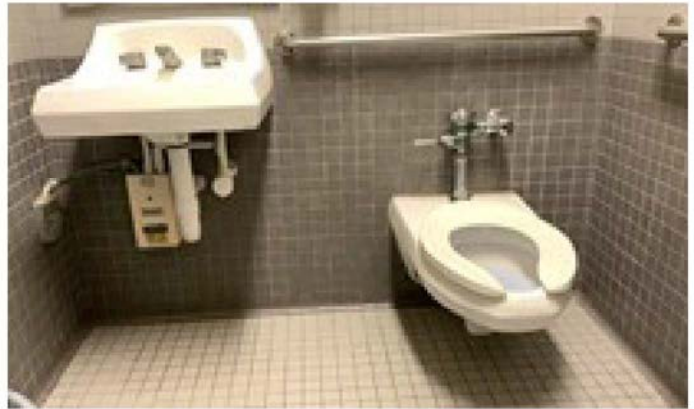
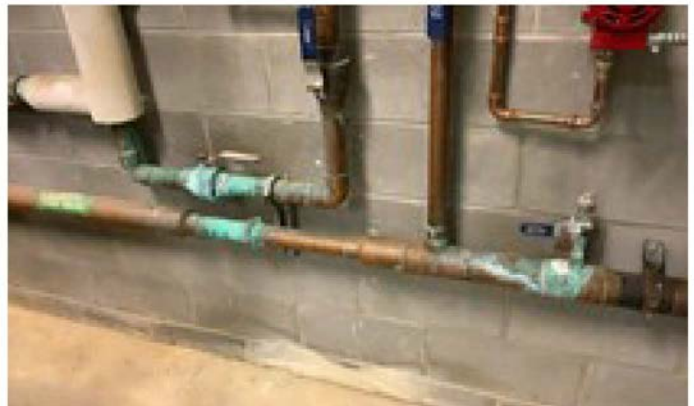
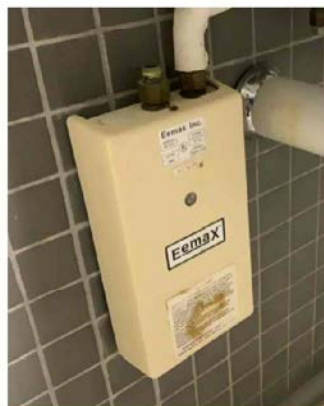
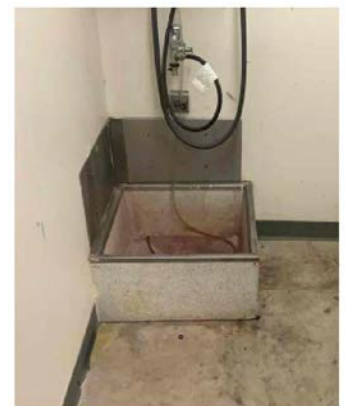
Existing plumbing fixtures (drinking fountains, toilets, flush valves, lavatories, faucets, sinks, showers, etc.) are old and in poor condition. Casework sinks are old and in poor condition. Mop sinks are old and in poor condition. Most are CW only. Gang restroom lavatories are CW only. A mixture of water heating systems. A lot of point of use electric water heaters at casework sinks and faculty restroom lavatories. Tank type electric water heaters for classroom and office areas. Gas water heater systems for athletics and kitchen areas. Some water heaters had recently been replaced. Most are old and in poor condition, some not working (i.e. point of use). Domestic water piping is copper. Evidence of many leaks and repair of piping. Gang shower areas do not have enough drains. Athletic training area does not have enough drains for equipment located in room. Also, fill faucets are old and in poor condition. Drinking fountains are not installed in close proximity to weight room. Refrigerator ice makers throughout building do not have CW connection. Solids interceptors are not installed for art sinks. In mechanical rooms, drains are badly corroded. In science labs, acid waste system is in poor condition and not draining properly. In science labs, emergency shutoff for gas is not provided. Backflow preventer for HVAC make-up water in Mech 1 is badly corroded. Greenhouse plumbing (water piping, gas piping, sink) in poor condition. Add HW to gang restroom lavatories and mop basins in custodial closets.

- + Replace all plumbing fixtures and associated piping and trim.
- + Replace all casework sinks.
- + Add solids interceptor at all art sinks.
- + Add HW to gang restroom lavatories and mop basins in custodial closets.
- + Install all new hot water heater systems. Building hot water systems should be re-designed to add hot water for gang lavatories and mop sinks. Installation of multiple circulated hot water systems should be considered in lieu of the multitude of different systems currently installed.
- + Replace all mechanical room and custodial room drains and associated waste and vent piping.

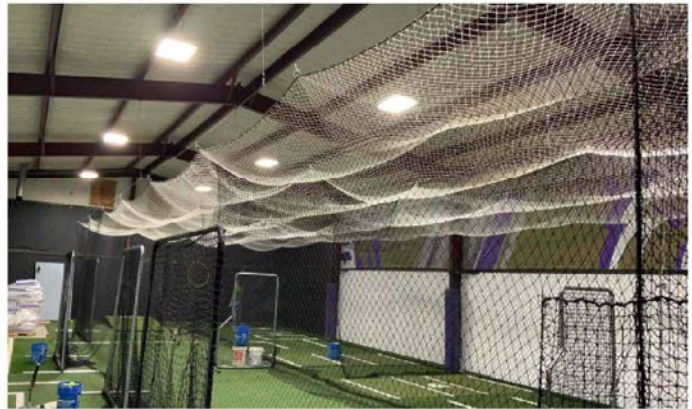
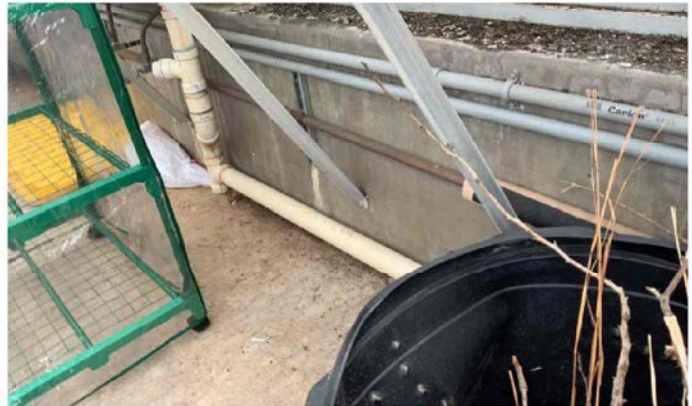
9th Grade Center

Some existing plumbing fixtures (drinking fountains, toilets, flush valves, lavatories, faucets, sinks, showers, etc.) are old and in poor condition. Mop sinks are old and in poor condition. Gang restroom lavatories are CW only. Domestic water piping is copper and in decent condition. Solids interceptors are not installed for art sinks. In mechanical rooms, drains are badly corroded. Electric water heaters are located throughout building. Existing heaters are in decent condition.

- + Replace all plumbing fixtures and associated piping and trim.
- + Add solids interceptor at all art sinks.
- + Add HW to gang restroom.
- + Replace mop sinks.
- + Replace all mechanical room and custodial room drains and associated waste and vent piping.
- + Replace all mechanical room and custodial room drains and associated waste and vent piping.
- + Install solids interceptor at all art sinks.

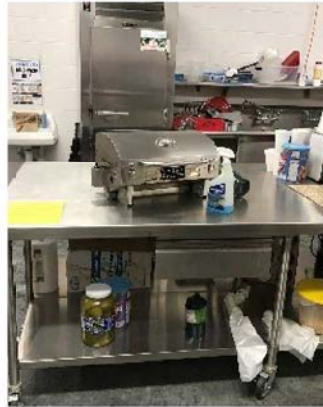
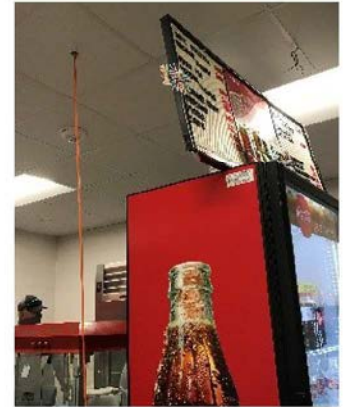
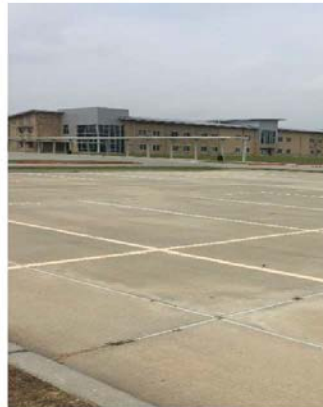
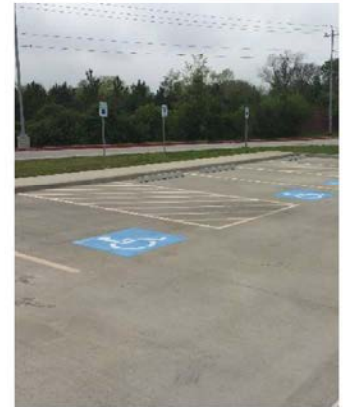
ACCESSIBILITY/CODE

Accessibility within Lake Creek High School seems to be in general compliance with TAS. The building is equipped with a fire suppression system and appears to be in good condition. The fire alarm system throughout the High School it is an addressable voice evacuation system.

- + In 2020 Montgomery County began to require the provision of a radio response system testing of educational facilities which will be required by the Fire Marshal.
- + A propane grill was present in the HS Football Concessions. A hood, and proper enclosure should be provided.
- + Extension cords were observed serving equipment within the HS Football Concession. Power should be run by a qualified electrician, and be compliant with National Electric Code.

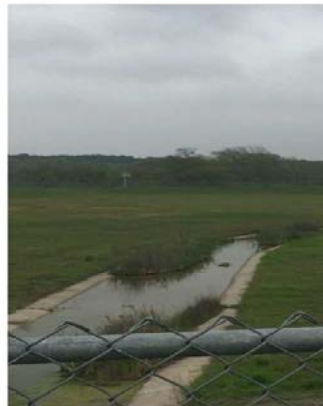
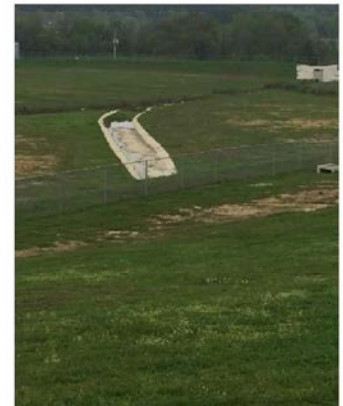
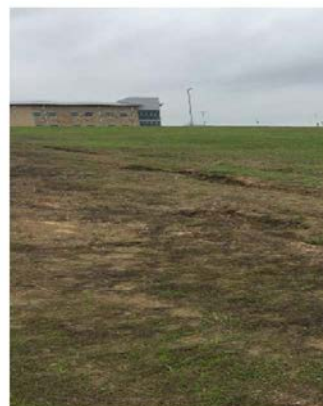
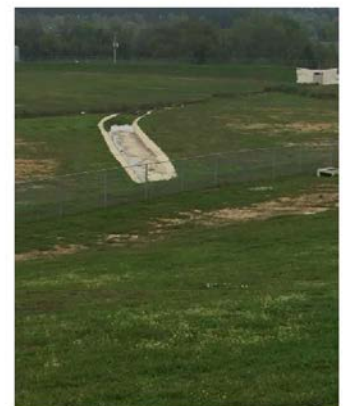
SITE CONDITIONS

Upon review of the site conditions at the Lake Creek High School, it appears that the site is in a relatively good condition. There are areas in the parking lots which show evidence of ponding water and sedimentation build up. There are minor accessibility issues and areas of exposed rebar in curb. There is also some erosion present along the side slopes of the pond and in pervious areas. Clean sediment from the drainage swales in detention areas that are blocking drainage and repair areas that have eroded or washed out. It is recommended that the grate top be changed to a junction box lid on the existing inlet on the north side of the building. It doesn't appear to be collecting any flow. There is erosion along the bank between the tennis courts and pond. There is an ADA ramp with no 5'x5' landing to the southeast of the building

- + Change the grate top to a junction box lid on the existing inlet on the north side of the building. It doesn't appear to be collecting any flow.
- + Repair broken curbs where exposed rebar is present.
- + Fill in eroded areas and add sod to detention pond.
- + Remove filter fabric from inlet south of the pond.
- + Add striping for the ADA parking spaces to connect to the sidewalk southeast of the building.
