MONTGOMERY
INDEPENDENT
SCHOOL DISTRICT

FACILITIES ASSESSMENT VOL. I

MAY 2021

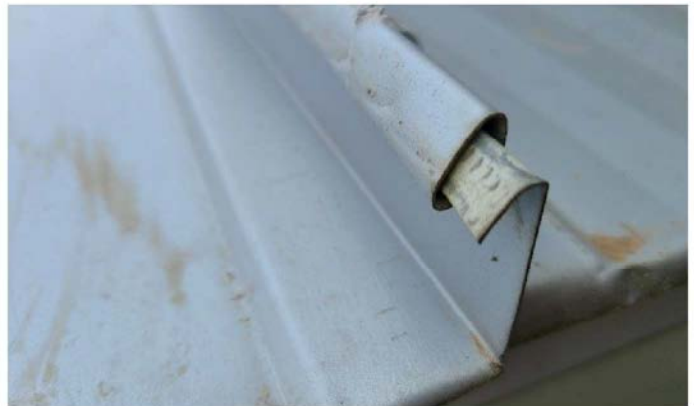
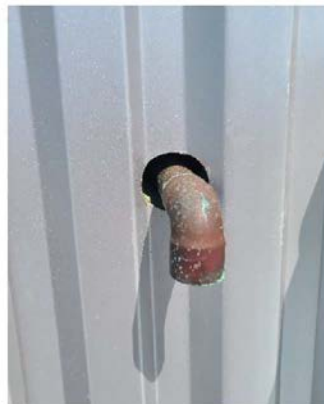
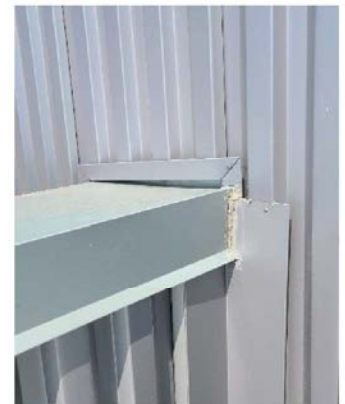
Lake Creek High School appeared to consist of a main building with various roof sections and levels consisting of a combination of modified asphalt and standing seam metal roofs, a baseball concession building with a metal panel roof system, a football locker and concession building with an asphalt and metal panel roof system, and a small tennis concession building with a metal panel roof system. Deficiencies observed at the main building roof areas appeared to include displaced counter-flashing in various locations on the low sloped roof areas, unsealed transitions between coping metal and adjoining metal panel clad walls, and unsealed penetrations through metal panel clad walls above the main gym. With continued manufacture recommended maintenance, the standing seam metal roof areas of throughout the campus appeared to have a minimum remaining service life of approximately fifteen years, and the modified asphalt roof sections appeared to have a remaining service life of approximately twelve years with proper repairs and maintenance.

- + Install counter-flashing to locations where termination bar was exposed, and applying sealant to the transitions and penetrations at the metal wall panels to prevent moisture ingress.
- + At the baseball concession there was a poorly crimped metal panel observed. Sealant should be applied to these locations.
- + At the storage building near the football concession and locker building appeared to include a poorly sealed transition at the perimeter of the roof. It is recommended that sealing this location to prevent moisture ingress.

- + Verify roof drainage system above Mech/Elect 12.28 is draining properly. Overflow drain is currently discharging large amounts of water during rainfall, which is of concern.

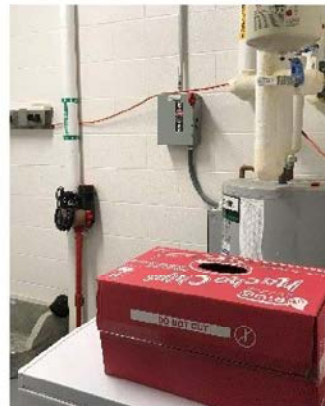
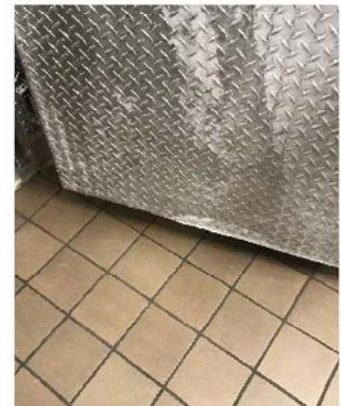
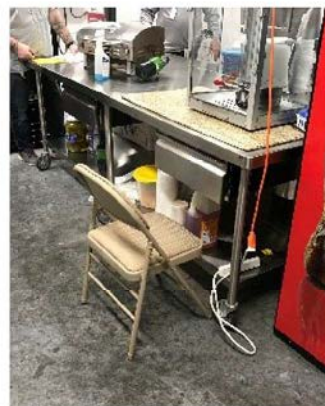
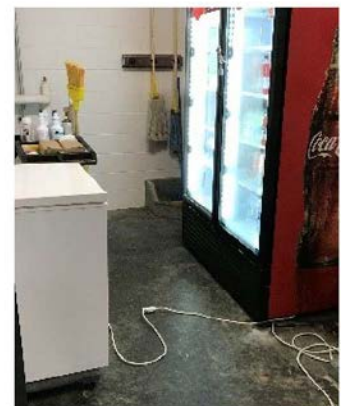
Within the kitchen and servery of Lake Creek High School the floors, walls, and ceiling seem to be in general compliance with current health codes. The finishes within the kitchen and servery include Quarry tile and sealed concrete on the floors, CMU and Tile walls, as well as vinyl lay in ceiling tiles. The dry storage and the cold storage are sized to serve 1600 Students. There is an additional Point of Sale that will accommodate the future additional line.

- + Review air leak at the Cooler and Freezer with manufacturer.
- + If there is an addition to the school to increase the number of students, the Dry Storage and Cold Storage sizes should be reviewed. In-lieu of increasing the site, delivery frequency can accommodate the needs.

- + At Football Concessions, provide Exhaust and Fire Suppression system for propane grill.
- + At Football Concessions, provide storage cabinet for propane cylinders.
- + At Football Concessions, provide code compliant electrical receptacles where extension cords are run.

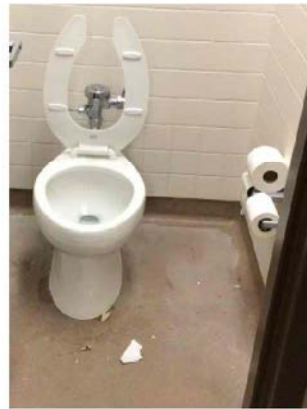
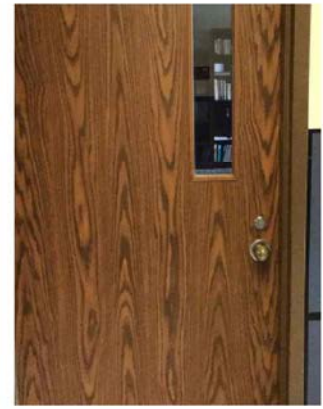
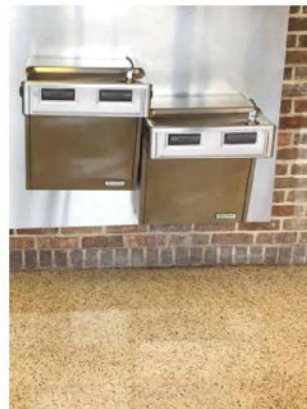
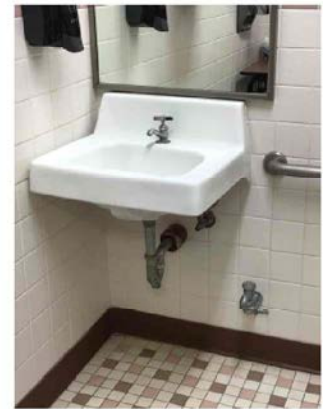
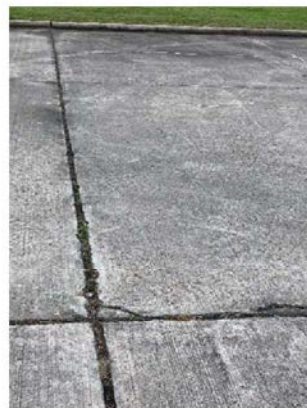
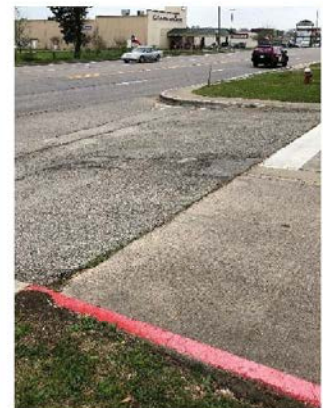
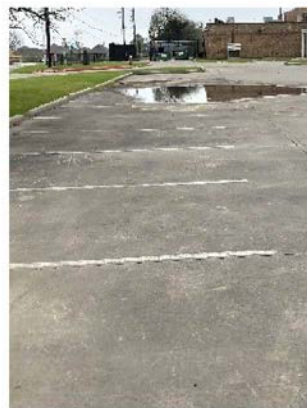
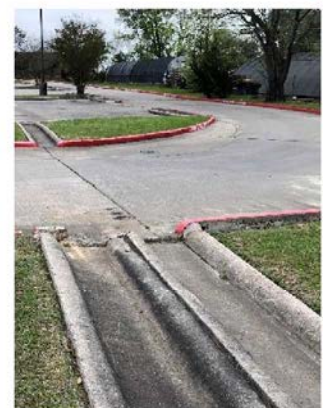
Primary/original building was built prior to accessibility standards. Therefore, there are many aspects of the building related to accessibility that are non-compliant. Exterior grades seem to be in general compliance and have been addressed through previous improvement projects. Interior deficiencies were noted. One of the most significant ADA deficiencies identified were in the existing toilet rooms. Existing toilet rooms should be modified to ensure adequate turning space, grab bars, ADA compliant stalls, and lavatories are provided. Within many of the classrooms, non-compliant sinks were observed and need to be brought into general compliance.

- + In 2020 Montgomery County began to require the provision of a radio response system testing of educational facilities which will be required by the Fire Marshal.
- + Due to fact that the building is not equipped with a fire suppression system, if an improvement is made the AHJ should be contacted. The AHJ will determine whether or not the a Fire Suppression System will be required as part of the renovation. The means by which the Fire Marshal can require the system is related to the value of the renovation or improvement.
- + Throughout the building there are multiple water fountains that are non compliant, and require the addition of cane detection
- + In some corridors of the building the door hardware provided was non-compliant and should be modified to comply with TAS.

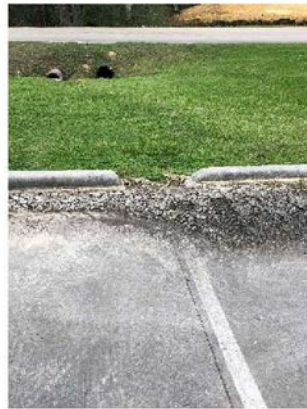
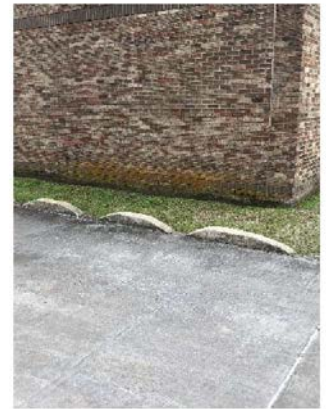
Upon review of the site conditions at the Education Support Center, it appears that the site is in relatively fair condition, but the drainage infrastructure on the site needs maintenance. There appears to be erosion at the drainage outfall into the south detention pond which can lead to ponding water and further erosion. There are areas in the northern and southern parking lots which show evidence of ponding water and sedimentation build up.

The concrete drainage swales appear to be sinking from undercut erosion of water eroding soil underneath the concrete. There seem to be areas around the building that are not graded in a way that promotes the flow of water away from the building, causing water to stand and create issues along the building perimeter. This can lead to water migrating under the building pad and cause issues within the building

- + Upgrade site lighting to LED fixtures and confirm proper foot candle coverage is provided.
- + Clean sediment from parking lots and cut drainage swales in landscape areas that are blocking.
- + Repair broken curbs.
- + Clear obstruction of the outfall pipe in the detention pond and fill in eroded areas.
- + Throughout the site, strip and regrade to achieve positive drainage away from the building. It is further recommended that a survey is completed to confirm the overall drainage of the site.
- + Restripe the parking lots and replace joint sealants.
- + Patch asphalt drives to fill potholes.

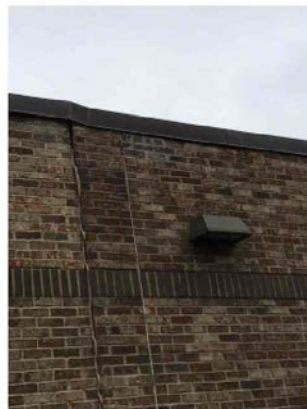
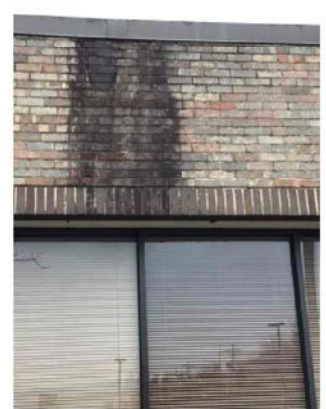
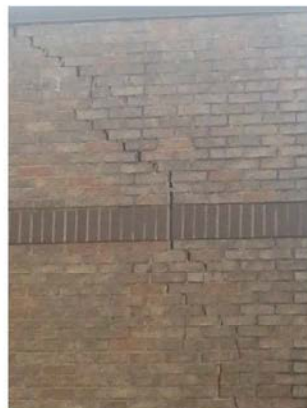
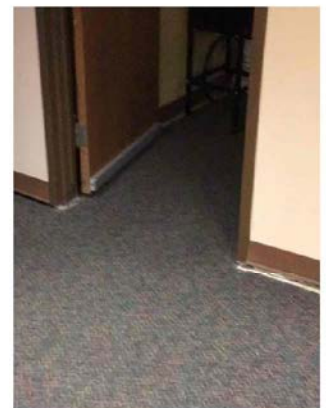
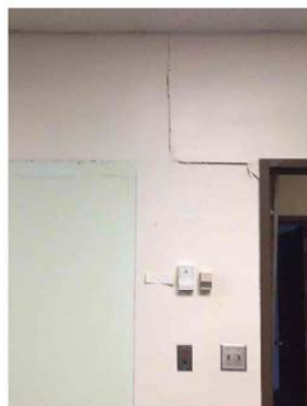
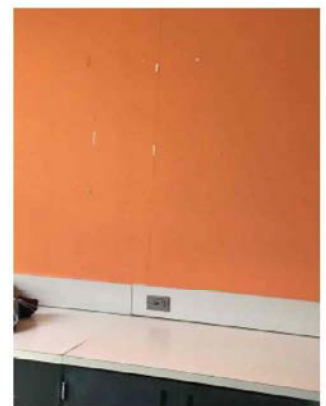
The exterior walls of the buildings have varying deficiencies. It appears that in locations where additions were made to the building there are dissimilar levels of settlement. There is evidence of water damage coming through the seams of the coping cap in multiple locations.

- + The existing exterior veneer brick walls seem to have inadequate vapor barrier for protection from water intrusion. There appears to be organic growth within the wall cavity, and remediation is recommended.

- + In areas that are not occupied, or that are currently used for storage, there is extensive damage to the gypsum board, VWC, and in some areas tile.

- + Pressure wash the facade and replace the exterior caulk.
- + Replace and re-flash the coping cap with a spring lock flashing system.
- + Reference the Terracon-produced geotechnical report dated July 21, 2017 for recommendations regarding the foundation which has caused cracking, and failure of the exterior wall system.

- + Where there is damage it is recommended that the walls are patched, repaired, and painted.
- + The impact resistant wall board seems to have been removed in various locations, and should be patched or replaced.

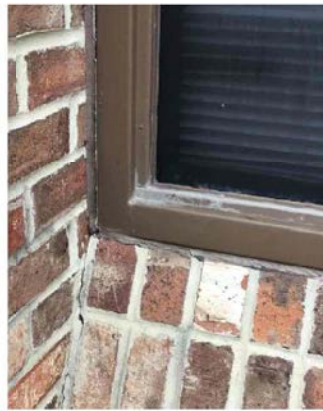
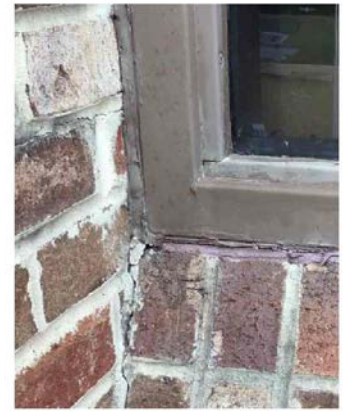
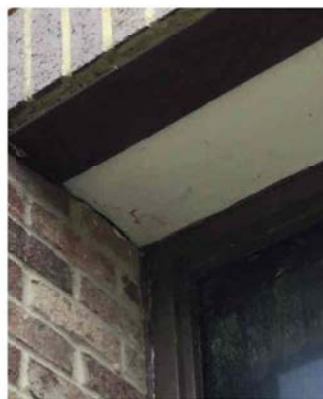
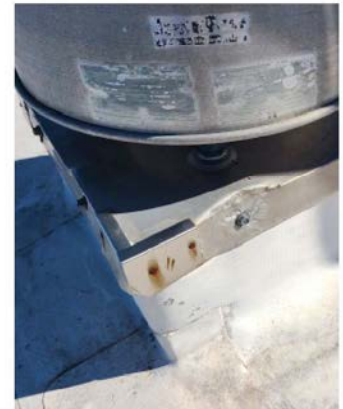
As noted in observation of exterior walls, there are areas in which the installation of the vapor barrier is inadequate. The vapor barrier ties into the window system and can lead to failure of the window system if improperly flashed. Water seems to be penetrating walls and leaking inside through deteriorated window sealant. Several windows have cracks at the corner of the lintels and along the EJs. Sealant at window control joints are in poor condition.

- + At a minimum, windows should be cleaned and new sealant should be applied around the system and within all adjacent control joints.
- + In order to maintain the integrity of the envelope it is recommended that the exterior window systems and associated flashing be removed and replaced.

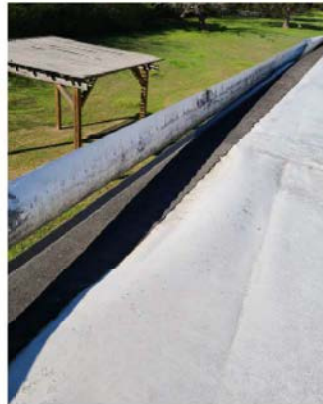
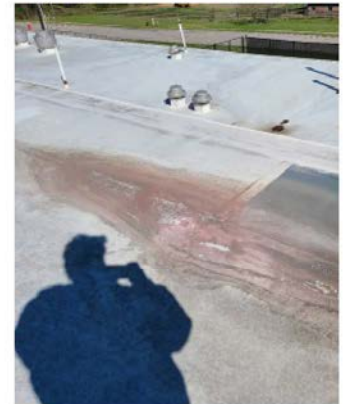
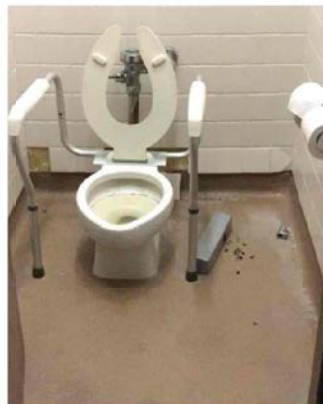
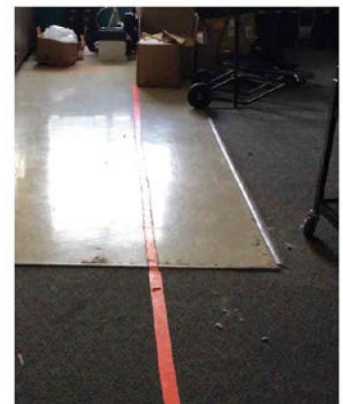
The Montgomery Education Support Center appeared to consist of a single-ply roof system with a coating applied to its surface. No cores of the roof were taken. The drainage of the roof is accomplished by primary and overflow field drains throughout the roof. Deficiencies observed throughout the roof area appeared to include disbanded perimeter strip-ins, rusted and damaged rooftop equipment, rooftop units lacking proper fasteners, cracked sealant at roof penetrations, and indications of ponding water on the high roof. Ponding of water can indicate that water is not flowing to drains properly and cause issues within the building.

- + Based on the age of the roof, repair of the roof in its current condition would extend the serviceability life by roughly six years.
- + Abandoned equipment should be removed and openings within roof patched.
- + There is evidence of multiple roof leaks within the building.
- + Exterior coping and flashing should be removed and replaced.

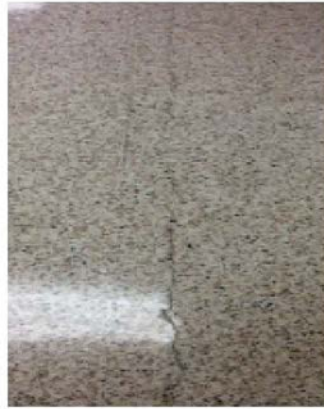
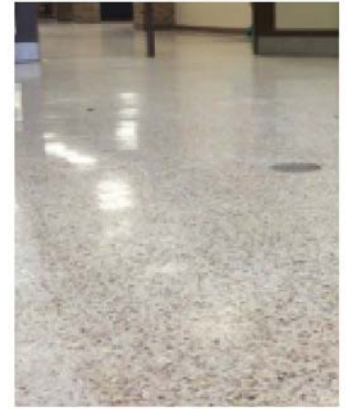
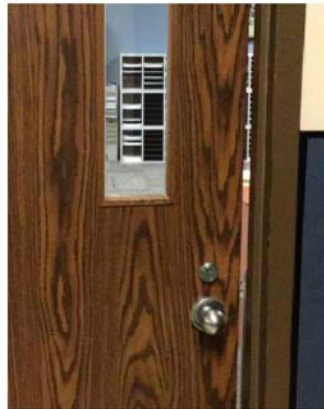
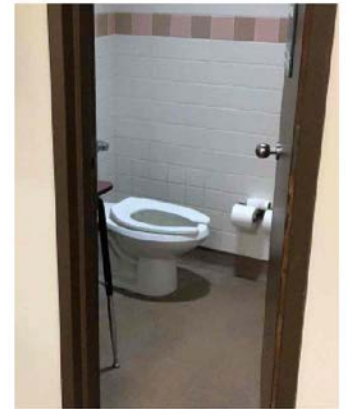
Throughout the building there are various conditions of each of the following flooring types: Rolled Carpet, VCT, Resinous Flooring, and Terrazzo.

- + Flooring on the south side of the building, where settlement has been observed, are in poor condition. Replacement or refinishing of flooring is recommended.
- + Rolled carpet throughout the building is stained or damaged. Replacement of carpet throughout the building is recommended.
- + VCT within classrooms is damaged and at the end of its life-cycle. VCT replacement throughout the building is recommended.
- + Resinous flooring within the toilet rooms should be replaced or refinished. In non-compliant toilet rooms the room and flooring should be brought into compliance with TAS.
- + In some corridors there seems to be bulging and cracking of Terrazzo. Some cross-slopes in corridors may need to be adjusted to comply with TAS.

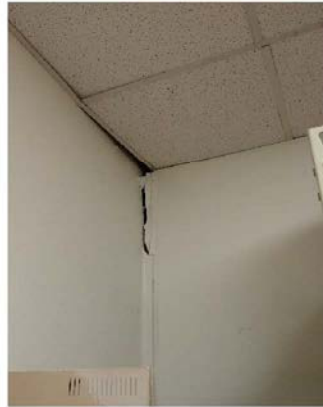
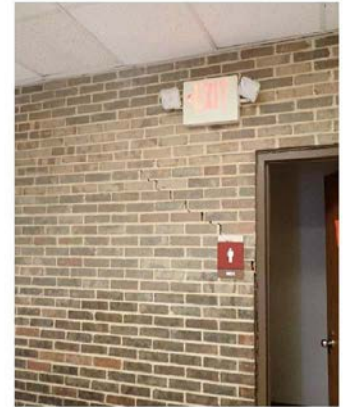
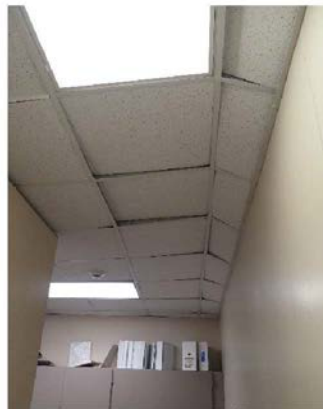
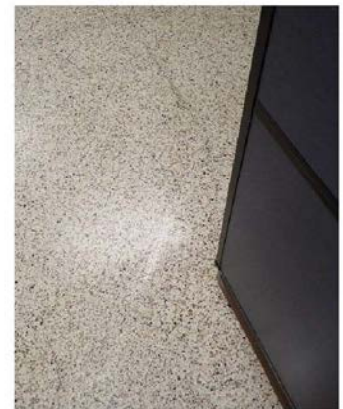
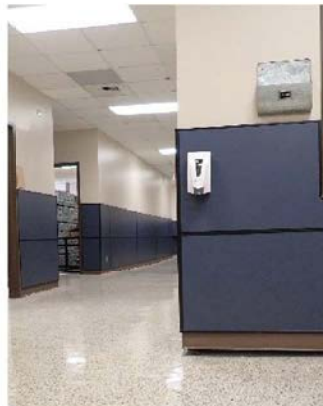
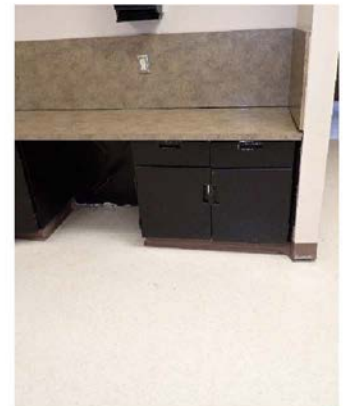
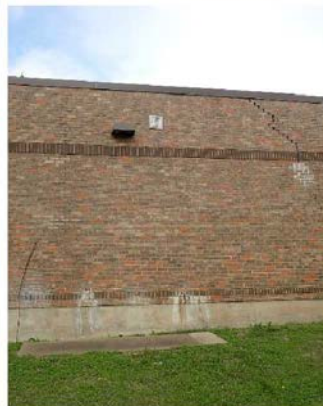
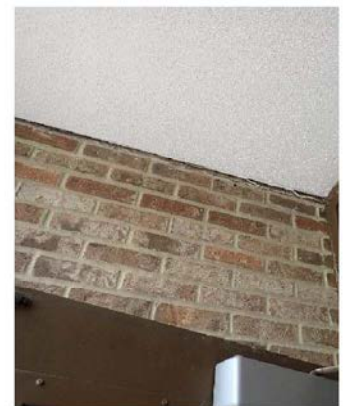
- + Foundation movement was apparent at that time; both settlement, primarily along the south edge of the school, and heave, particularly at the west, were present.
- + The majority of distress (e.g., cracked drywall, cracked interior brick mortar joints, gaps below partition walls, displaced ceiling tiles/ceiling grid) was associated with foundation movement; however, waterproofing and damp proofing details of the veneer walls, as observed through inspection openings, were inadequate for protection from water intrusion or corrosion protection of various steel elements, and appeared to result in organic growth on the interior/exterior gypsum board sheathing.
- + Soil samples obtained from the building demonstrated that the site is underlaid with fat clays with the potential for expansion/shrinkage due to

moisture changes. In general, testing of the samples in the location of apparent heave showed that the samples had higher moisture contents than those taken from the area of apparent settlement, which correlated well with the observed distress.

Distress related to foundation movement was observed throughout the southern portion of the school. Distress such as cracking/separation of interior partition walls and differential gaps in adjacent finishes, displaced ceiling tiles and grids, a crack in the slab-on-ground at a column blockout, and differentials in slab elevation were observed in several areas of the southern part of ESC. No loss of bearing in the steel joists was observed at the time of our investigation.

Additional minor distresses were consistently noted in the southern portion of the school, including visible gaps between the base of a partition wall and top of floor surface, and misalignment of cabinetry and doors. Several of the restrooms in the southern portion of ESC are no longer functional due to below grade plumbing damage due to slab movement. During our visual survey, a piezometer well in room 128 was opened and found to be dry. Exterior Facade distress was observed along the south elevation of the ECS building, primarily in the southeast corner. Conditions such as cracking in the brick facade and grade beam, joint sealant distress, and previously sealed cracks in the brick facade were observed (Figure 8 and Figure 9). A wooden frame has been erected by MISD staff to support the brick facade on the south face of the building.

Based upon the previous work performed by WJE and Terracon, and the new findings from our work in this phase, we recommend that MISD consider mitigation efforts to prevent future foundation movement. Based on the magnitude of foundation movement and the combination of settlement and heave, WJE would recommend a combination of efforts to provide supplementary foundation support and prevention of future moisture addition.

Following the foundation improvements, we would recommend repairs to the exterior wall and repair/replacement of interior finishes. While the recommended repairs would attempt to stabilize the foundation against future movement, there will remain risk for additional foundation movement to occur – in particular the areas where heaving has occurred, the risk for additional heave cannot be entirely eliminated, only mitigated by means of limiting additional moisture to the soil below the slab-on-ground foundation. Further detailed recommendation for mitigation including Underpinning, the addition of French drains, plumbing repairs, exterior wall repairs, and interior finish repairs can be reviewed in the appendix of this document.

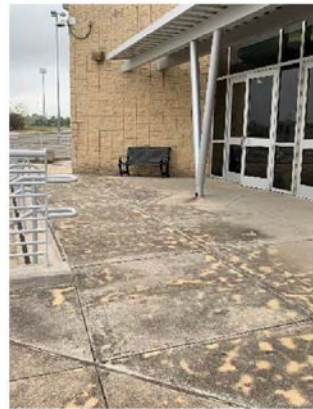
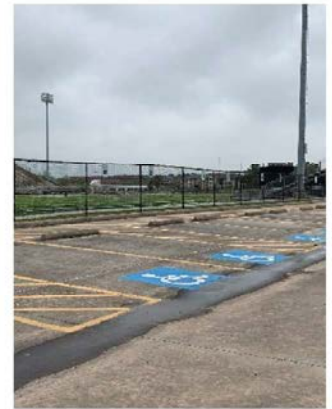
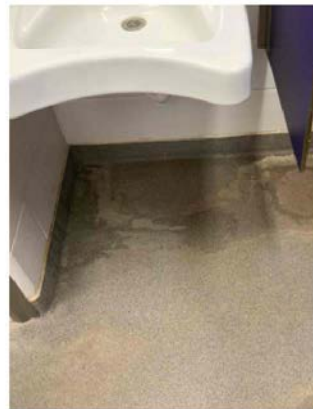
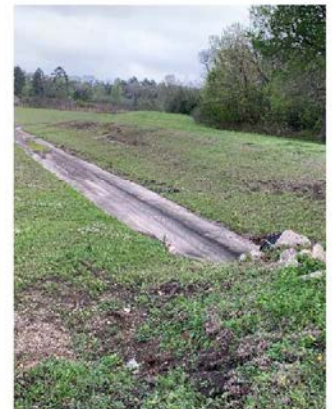
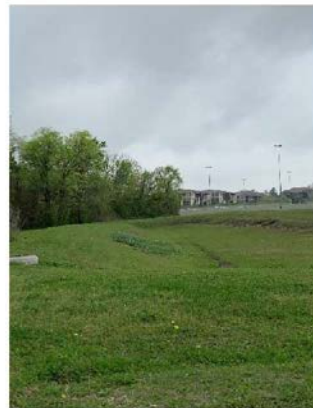
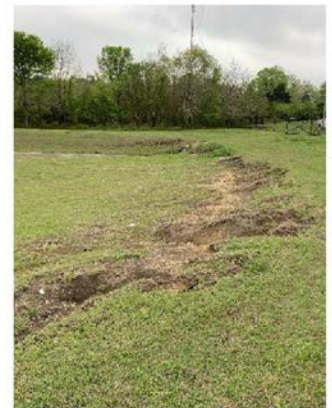
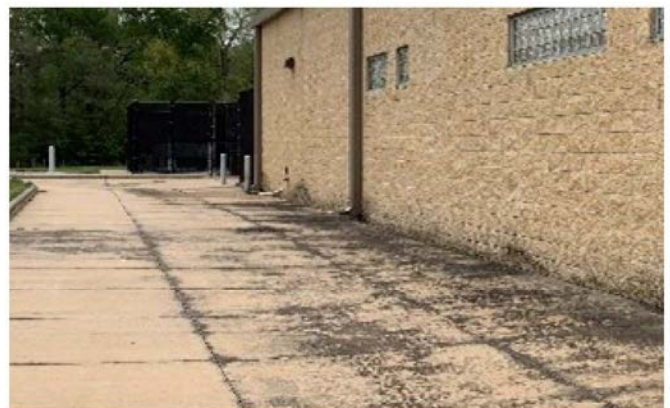
Upon review of the site conditions at the Sports Complex, it appears that the site is in a relatively good condition, but maintenance is required to attend to some erosion occurring in the drainage ditches along the south side of the site. The asphalt parking lots have sections in need of repair but are overall in a fair condition.

- + Perform maintenance on south drainage ditches to address sloughing issues, rebuild side slopes, and clear sedimentation and vegetative growth buildups in the concrete channel.
- + Perform maintenance on pond outfall drainage structures and conveyance paths to remove blockages obstructing pipes and clear sedimentation and vegetative growth buildups.

- + Establish better drainage patterns for paved areas near the football field concession entrances and near the west side of the aquatic center to help prevent against water buildup at the building walls.
- + Address ponding and poor drainage at the end of the ADA parking stalls in the northwest parking lot to minimize sedimentation buildup.
- + Power wash water stained sidewalk.
- + Mill and overlay asphalt pavement sections and repair any weakened subgrade to address potholing and deterioration. Seal and stripe the affected areas when done.
- + Address erosion areas throughout the site.

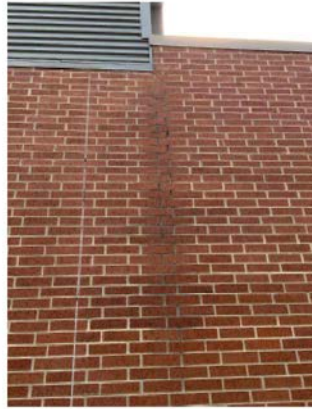
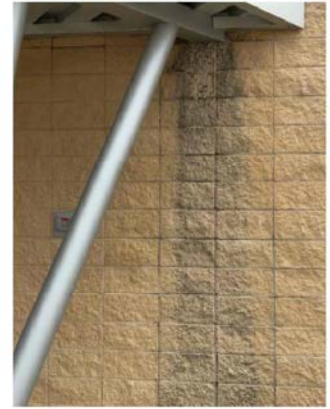
Aquatic Center

The exterior walls of the Aquatic center are in poor to fair condition. Exterior sealant was observed to be failing. At connections to canopies the flashing seems to have failed.

- + Remove and replace building sealant
- + Power wash the face brick and stone.

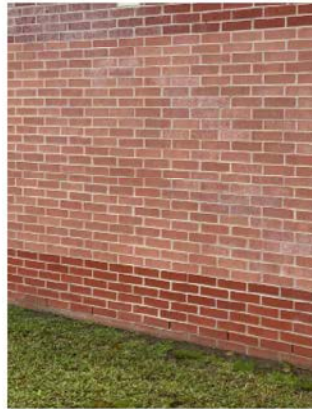
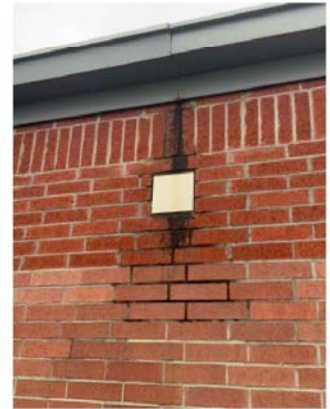
Field House

The exterior walls of the field house seem to be in poor to fair condition. Exterior sealant was observed to be failing, and brick appears to have collected sediment that should be cleaned. In some areas it appears as though there are issues with the weather proofing which is causing efflorescence.

- + Remove and replace building sealant
- + Power washing the face brick will temporarily improve the appearance, however the residue will likely return over time.

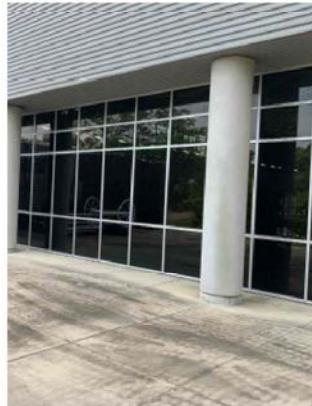
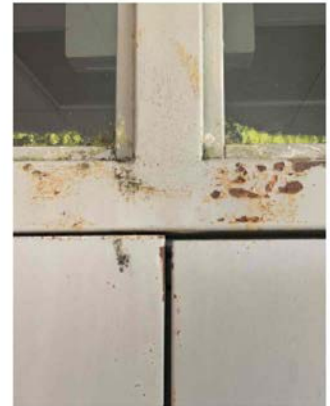
Aquatic Center

Window systems around the building are 1/4" Storefront systems that seem to be in fair condition. They do not comply with current energy code.

- + Replace exterior storefront system with new energy efficient glazing systems.
- + Remove and replace sealant

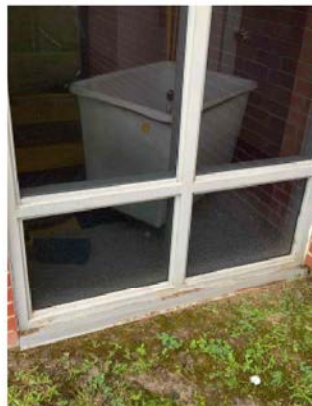
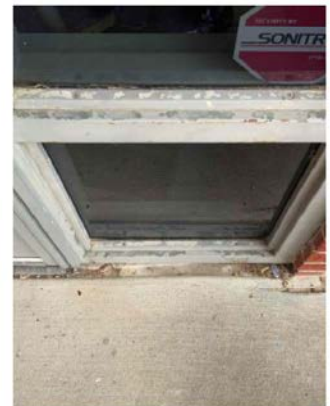
Field House

Exterior hollow metal frames seems to be in poor condition throughout the Field house.

- + Replace all hollow metal frames and glazing.

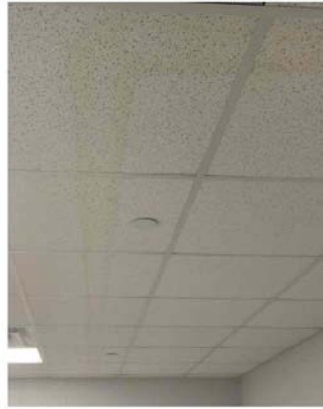
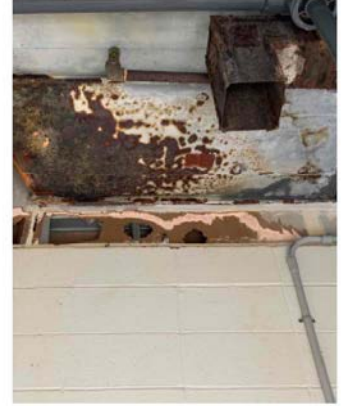
Ceilings and ceiling grid system throughout the Aquatic center are in need of repair and replacement. Pipe leaks above ceiling are apparent, and have caused damage to the tee-systems, and materials that are susceptible to corrosion.

- + Replace ceiling and ceiling grid system throughout the Aquatic Center.

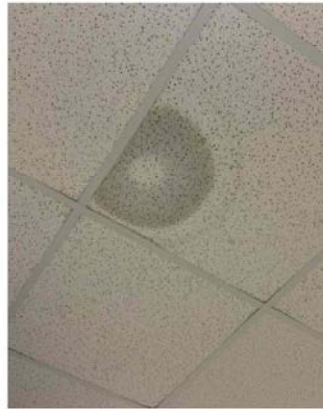
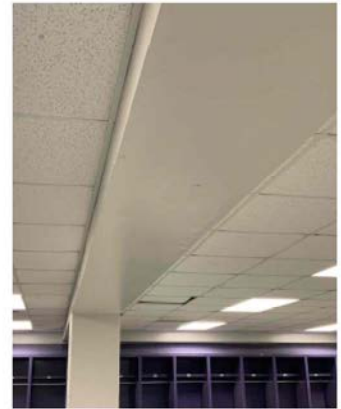
Ceilings and ceiling grid system throughout the Field House are in poor condition. There are areas above ceiling the leaks are apparent.

- + Replace ceiling and ceiling grid system throughout the Field House.

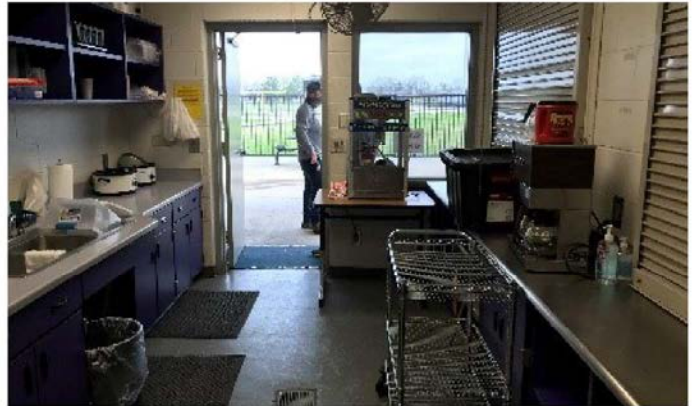
Within the concessions of the Field House the floors and walls seem to be in general compliance with current health codes. The millwork within the space is damaged. The 3 compartment sink is undersized.

- + Replace 3 Compartment sink to accommodate size and service of concession.
- + Provide code compliant electric connection for warming unit near hand sink.
- + Repair Refrigerated Merchandisers.

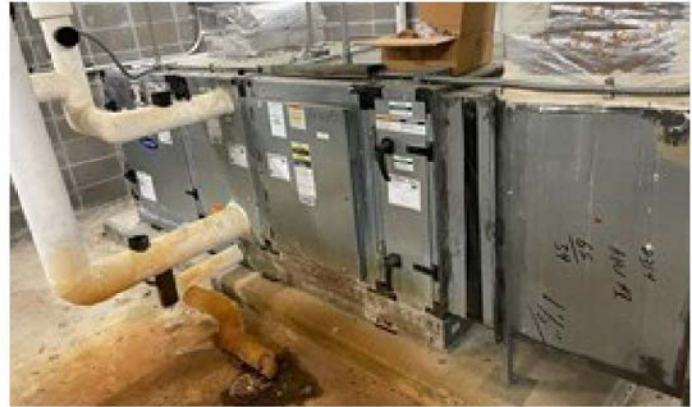
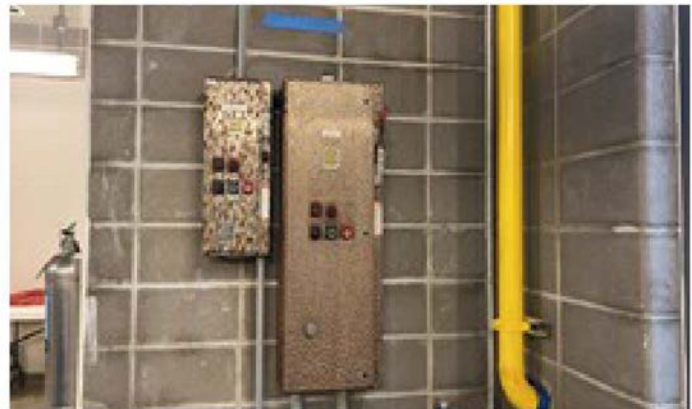
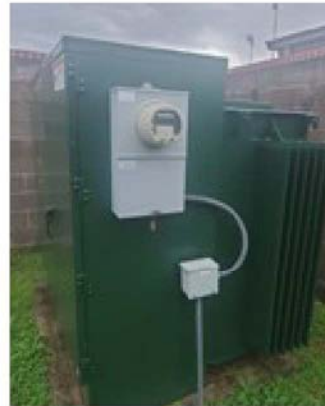
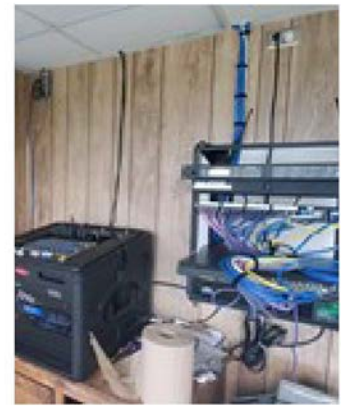
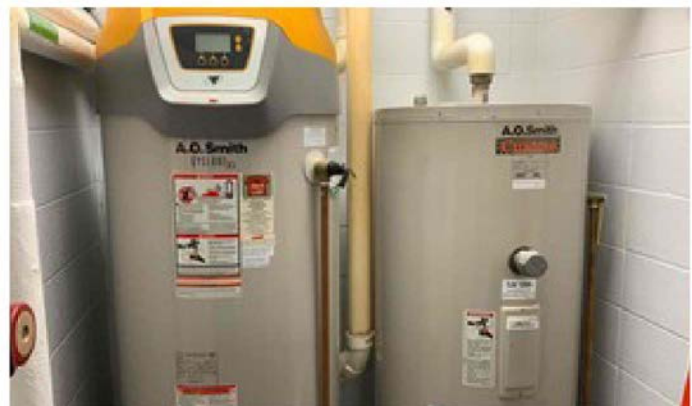
The electrical service is fed via pad mounted utility transformer at the exterior of the building, which is connected to 2000A, 277/480V, 3-phase, 4-wire main switchboard located in the main electrical room and has the maximum amount of NEC allowable service disconnects.

This main switchboard feeds additional distribution boards, panelboards and softball field, football field, baseball field, site lighting. The distribution boards provide mechanical equipment circuiting. The 277/480V panelboards are utilized for lighting, small mechanical equipment, and feeding 120/280V panelboards via stepdown transformers. The 120/208V panelboards are connected to small mechanical equipment, receptacle loads, and miscellaneous loads throughout the field house building. Equipment is aging and some require replacement. Generator was not seen at the field house building. Lighting on the interior of the building consists of fluorescent 2x4 fixtures, 1x4 fixtures, and recessed cans

throughout, with strip fixtures in mechanical areas. Exit signs appear to be fluorescent. Exterior lighting consists of outdated surface mounted HID lighting. Lighting controls appear to be controlled via toggle switches and do not meet current energy codes. IT racks appear to be in good working condition with aged equipment and outdated wireless access points. The camera system could not be observed but few cameras looked outdated.

- + Replace outdated portion of existing main switchboard. Replace all other outdated and damaged pieces of equipment throughout the buildings.
- + Replace all interior lighting with new LED fixtures.
- + Replace all remaining exterior lighting with new LED fixtures.
- + Replace all existing lighting controls with new controls in compliance with energy code.

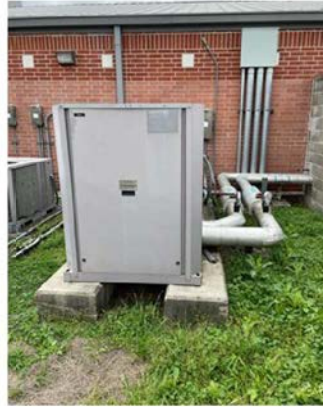
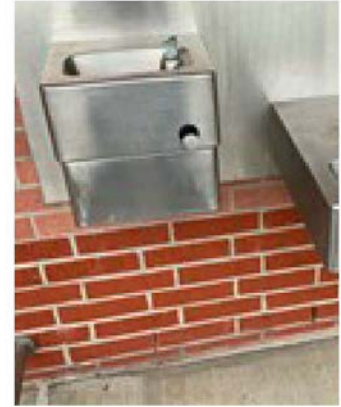
Field House

Existing plumbing fixtures (toilets, urinals, and lavatories) are in relatively good condition. Flush valves were not operating properly throughout facility. Sanitary waste and vent piping is cast iron and in relatively good condition. Roof was drained via gutters and downspouts. No roof drains. No natural gas for facility. There are two (2) 60-KW electric water heaters serving the building. The water heaters are relatively new (2019) and in good working condition. Pipe insulation is missing on piping at water heaters. There is some corrosion on piping at water heaters. Mechanical rooms do not have hose bibbs.

Casework sinks are stainless steel. Fixtures are old and in poor condition. Exterior drinking fountains are damaged and in extremely poor condition. Hose bibb was damaged in public men's restroom. Mixing valves not installed on lavatories in Coaches' restrooms. Several of the showers in the locker areas were damaged, leaking or in poor condition. There are not enough drains in the locker room shower areas. Water travels from one user over the feet of another user to get to a drain. Drain beneath ice maker in training room is damaged. Mop basin in custodial closet is old and in poor condition. Insulation for exterior CW piping is in poor condition. Locker room drinking fountains are single units. There is no bottle filler on drinking fountains in entire facility. No water softener.

- + Repair/replace all flush valves in entire facility.
- + Replace corroded piping at water heaters. Install insulation on all piping at hot water heaters. Install aluminum jacketing over all insulation at water heaters.
- + Add hose bibbs in mechanical rooms.
- + Replace all casework sinks and faucets.
- + Replace all exterior drinking fountains.
- + Replace damaged hose bibb at men's public restroom.
- + Repair damaged showers.
- + Rework drainage in shower areas. Add new drains, as necessary.
- + Replace floor sink at training room ice maker.
- + Replace mop basin in custodial closet.
- + Install new insulation on building CW entry. Install closed cell insulation with stainless steel jacketing.

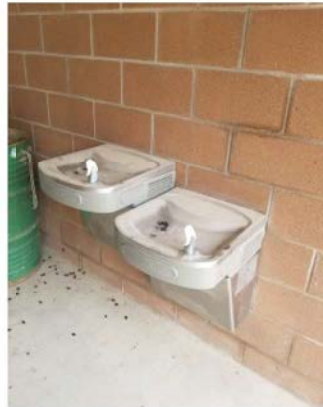
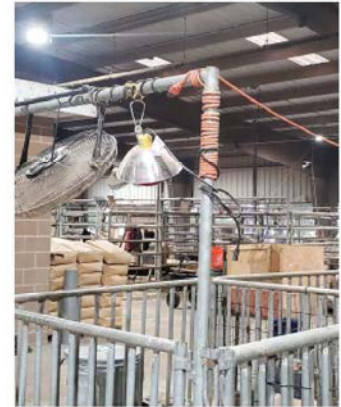
Accessibility in general seems to be in compliance with TAS.

- + ADA Parking and access should be provided.
- + Provide power which is adequate to the serve load required in all areas of the Ag facility.
- + Drinking fountains are compliant however they are Non-functional and should be repaired.

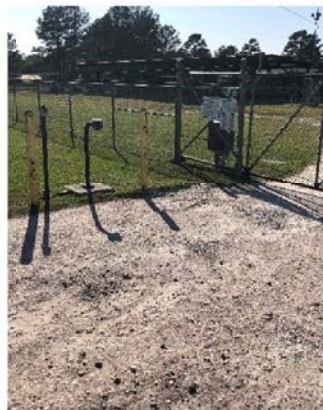
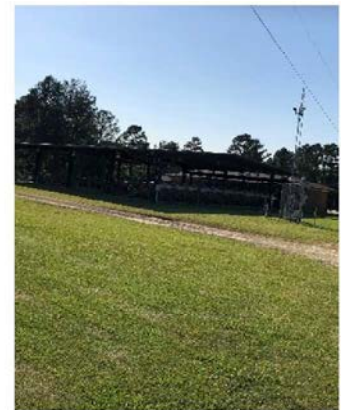
Upon review of the site conditions at the Montgomery High School Ag Barn, it appears that the site is in a relatively good condition overall. There are no major deficiencies observed.

There is some evidence of potholing beginning to occur at the entry drive that could be cause for concern in the future and the appearance of rutting in the rear parking area for the trailers.

- + Fill in the potholes at the entry drive.
- + Smooth out the rutting that is taking place on the site.

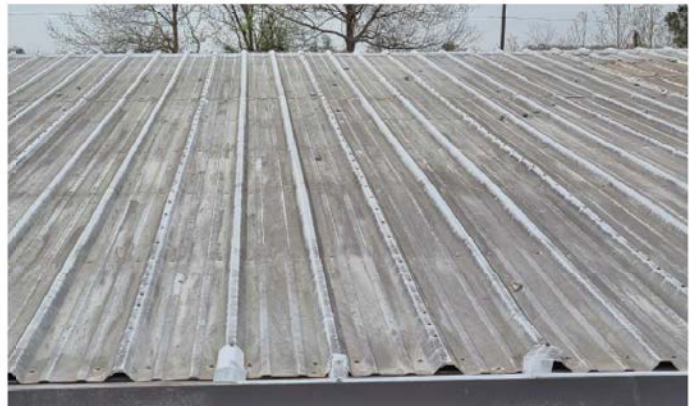
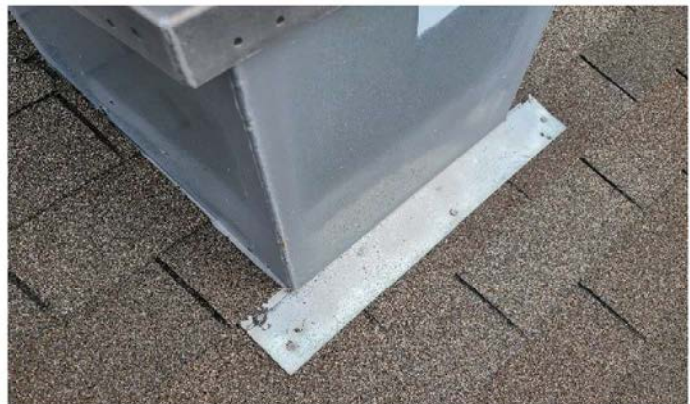
The Montgomery ISD agriculture facility appeared to consist of three main roof areas; one conditioned space with an asphalt shingled roof system measuring approximately 2,500 square feet, an open canopy metal panel roof area measuring approximately 8,500 square feet, and an unconditioned wildlife area with a metal panel roof system measuring approximately 22,000 square feet. Deficiencies observed on the shingled roof area appeared to include unsealed fastener heads at roof curbs and vent pipes, and buckled shingles. The shingled roof area appeared to be in fair condition and has a remaining effective service life of approximately three years. Deficiencies observed at the metal panel roof connected to the shingled roof area appeared to include rusted fasteners and stained panels. The canopy roof area appeared to be in fair condition and has a remaining effective service life of approximately three years with regular maintenance. The wildlife area metal panel roof system appeared to be in overall good condition and did not appear to require immediate repair

or replacement. The wildlife roof area appeared to have a minimum remaining service life of approximately ten years.

- + Recommend applying sealant to the fastener heads at roof penetrations and replacing the previously noted buckled shingles.

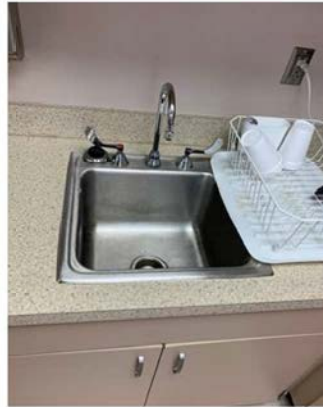
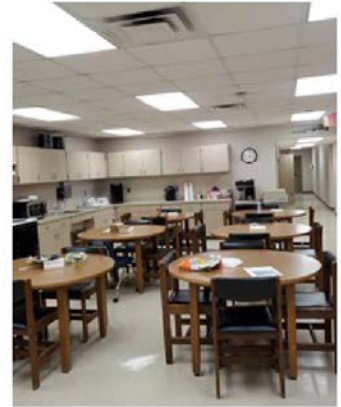
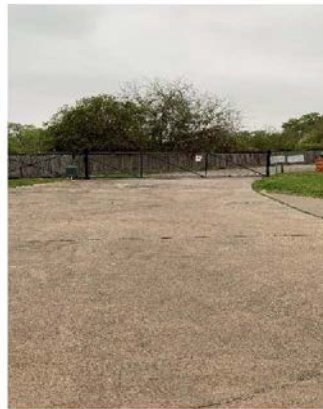
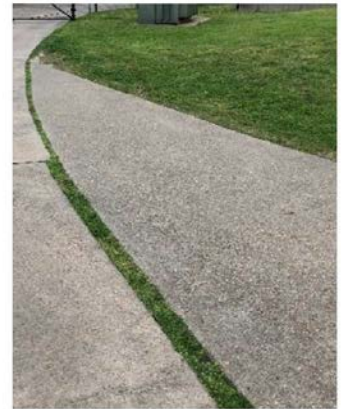
Accessibility within Maintenance Office seems to be in general compliance with TAS.

- + In 2020 Montgomery County began to require the provision of a radio response system testing of educational facilities which will be required by the Fire Marshal.
- + Sinks in millwork are non-compliant and should be replaced.
- + An ansul system is required above the range.
- + No fire alarm system was observed at the building. A fire alarm system should be added to this building, or tied to the existing Montgomery Elementary School.
- + Fire sprinkler was not installed within this facility. If a substantial improvement is completed with regard to this building the AHJ should be consulted.

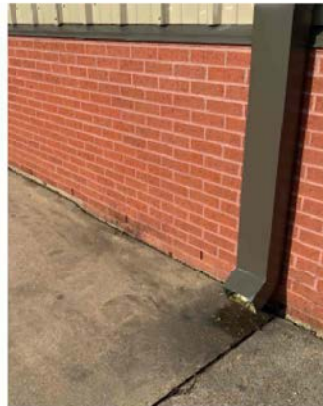
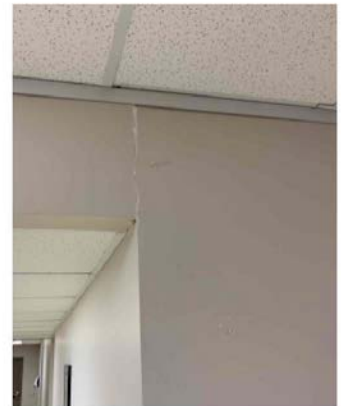
Upon review of the site conditions at the Maintenance Building, it appears that the site is in a relatively good condition overall. The pavement joint sealants are starting to wear away and there is evidence of vegetative growth coming through in areas that could lead to future cracking and spalling along the joints.

- + Reseal pavement joints.
- + Place gravel or some other longer-term material to help with future potential erosion or rutting under the trailer storage area.
- + Joint sealant between wall and building should be replaced.

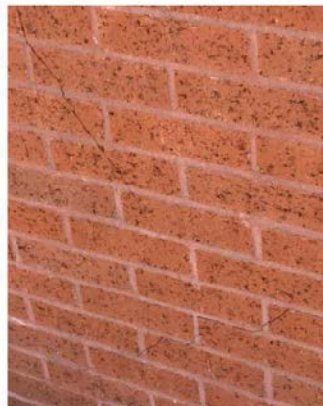
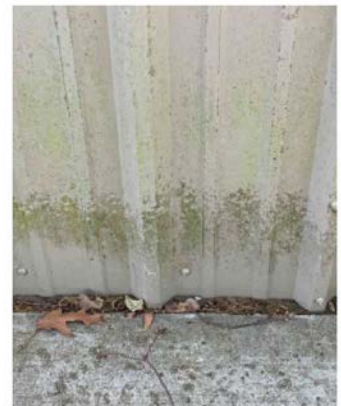
The exterior walls of the Maintenance Office is metal an metal R-Panel system, and some areas have a brick wainscot. Cracking of exterior brick was observed. It seems that the cracking is related to settlement of the building foundation. The base of some of the metal panel seems to show the initial stages of rust development. The exterior walls seem to in poor to fair condition. Interior walls have minor damages that should be patched and repaired.

- + Remove and replace areas of damaged brick.
- + Replace all building sealant.
- + Pressure wash the facility.
- + Seal areas of foundation that have exposed rebar.

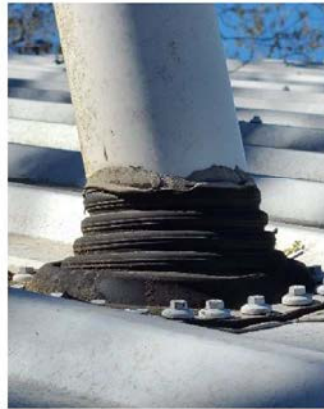
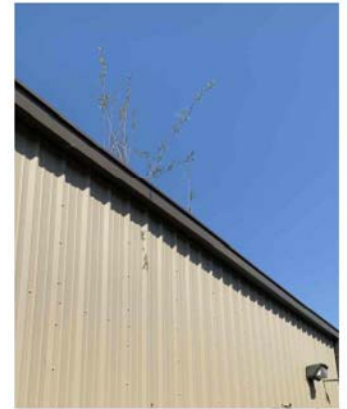
The maintenance building located behind the Montgomery elementary school appeared to consist of two small adjoining buildings consisting of metal panel roof systems with a combined measurement of approximately five-thousand square feet. Deficiencies observed at the maintenance buildings appeared to include a poorly detailed gutter system between the adjoining buildings that has reportedly caused interior leaks, and poorly sealed roof penetrations.

- + Gutter joints are loose allowing water to leak, thus staining concrete pavements and bricks below. Downspouts are missing splash blocks or drains to direct water away from the building. Due to water collecting under downspouts, concrete pavements and bottom brick courses are stained at several locations.
- + It appears that the gutters need to be cleaned, and plant-life removed.
- + Repair the roof penetrations to minimize potential points of moisture ingress, and perform a water leak test to determine the cause of the reported interior leaks to make repairs and prevent moisture ingress until plans can be made to replace the existing roof systems.
- + Install counter-flashing to locations where termination bar was exposed, and applying sealant to the transitions and penetrations at the metal wall panels to prevent moisture ingress.

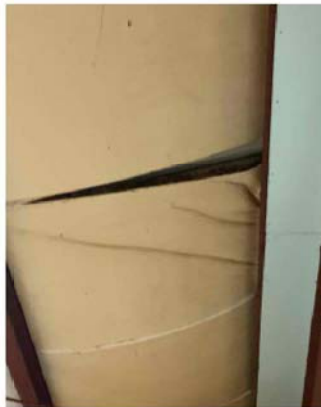
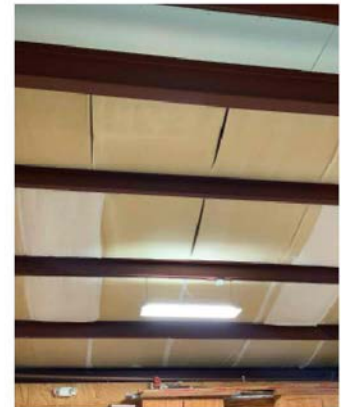
Ceilings and ceiling grid system throughout the Maintenance Office seem to be in good condition, and some seem to have water leak markings.

- + The hanging insulation throughout should be replaced.

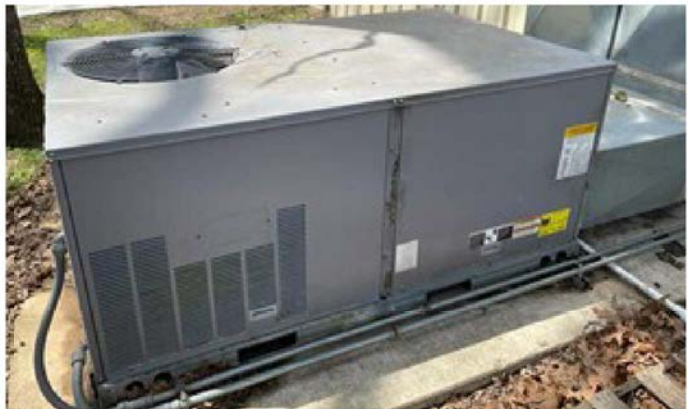
The building is being air-conditioned by two (2) 11-year-old Carrier floor-mounted rooftop units. They are in fair condition. The BAS is by Honeywell. The control modules are in good condition.

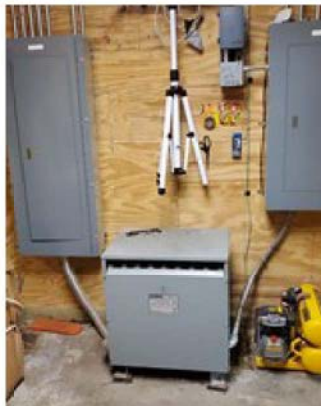
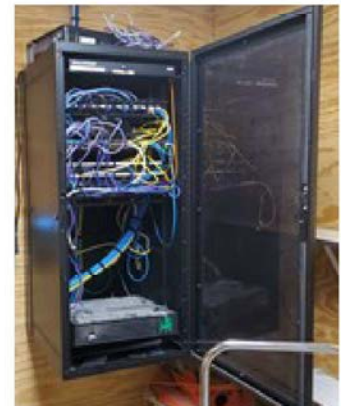
The electrical service is fed via pad mount transformer at the exterior of the building, which is connected to a wireway and 277/480V, 3PH, 4W service disconnect, feeding a 277/480V panel and steps down via a step-down transformer and then to 120/208V, 3PH panelboard. Lighting on the interior of the building consists of fluorescent 2x4 fixtures, with strip fixtures in mechanical areas. Exit signs appear to be fluorescent. Exterior lighting consists of old surface mounted HID lighting wall packs. Lighting controls are energy code compliant.

- + Replace existing main switchboard. Replace all other outdated and damaged pieces of equipment throughout the buildings.
- + Replace existing generator with a new commercial grade and re-feed all existing circuits, as well as all other life safety items.
- + Replace all interior lighting with new LED fixtures.
- + Replace all remaining exterior lighting with new LED fixtures.

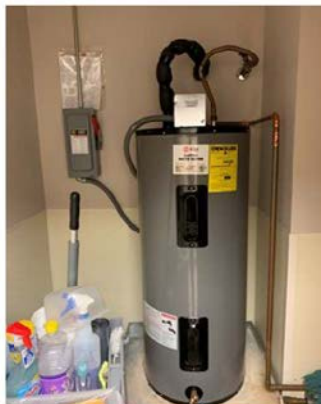
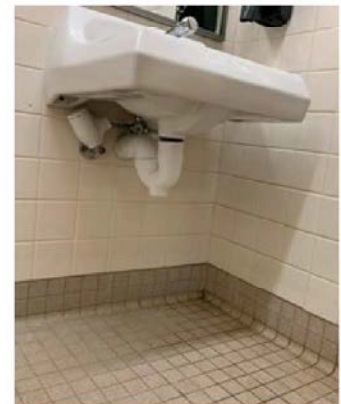
Existing plumbing fixtures (drinking fountains, toilets, flush valves, lavatories, faucets, sinks, etc.) are relatively new and in good condition. Electric water heater is relatively new and in good condition but does not have circulator pump. Sanitary waste and vent piping is cast iron and in relatively good condition. Roof was drained via gutters and downspouts. No roof drains.

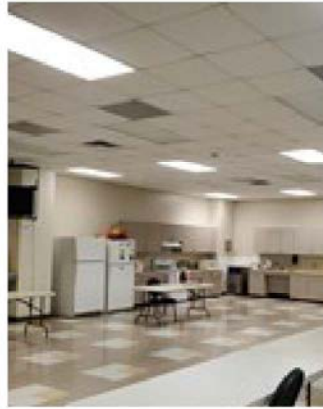
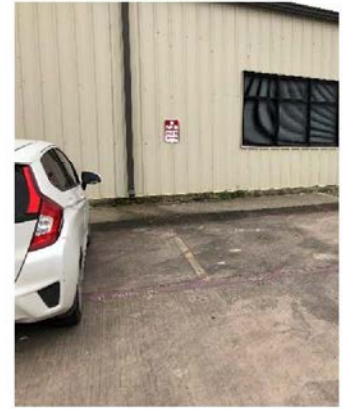
Accessibility within Transportation Center seems to be in general compliance with TAS.

- + There is no fire alarm system in this building, as it is not required.
- + An ansul system is required above the range.
- + ADA compliant parking, and accessible route should be provided. Parking within a Fire Lane is non-compliant.
- + Fire sprinkler is not installed within this facility. If a substantial improvement is completed with regard to this building the AHJ should be consulted.
