MONTGOMERY
INDEPENDENT
SCHOOL DISTRICT

FACILITIES ASSESSMENT VOL. I

MAY 2021

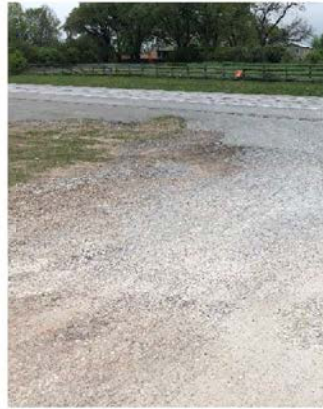
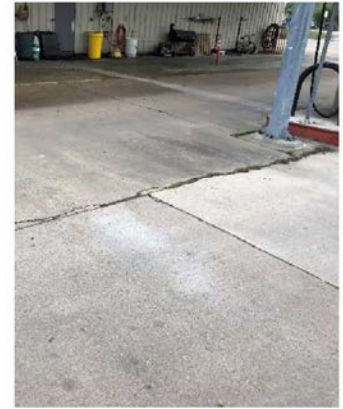
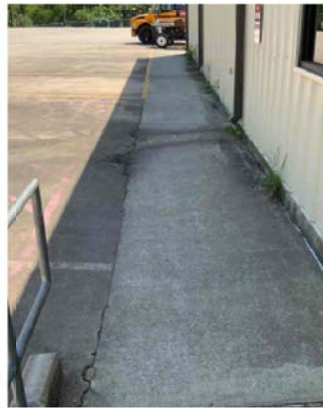
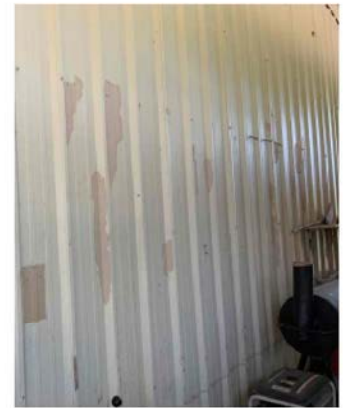
Upon review of the site conditions at the Transportation Center, it appears that the site is in a relatively good condition. Overall, there appears to be good drainage on the site and minimal issues with the bus parking. There are areas in the concrete parking that have joints that are beginning to spall and cracking and deteriorating pavement at the driveway entrances.

- + Repave driveway entry transitions from the shoulder to the driveway gate for the southern drive and the transition from asphalt to concrete for the northern driveway.
- + Treat cracks in the concrete and spalling joints to help prevent against future deterioration.
- + Consider the addition of gravel at the edges of the concrete bus parking to help attenuate storm water runoff from the paving to help alleviate future erosion at the transition from pavement to grass.

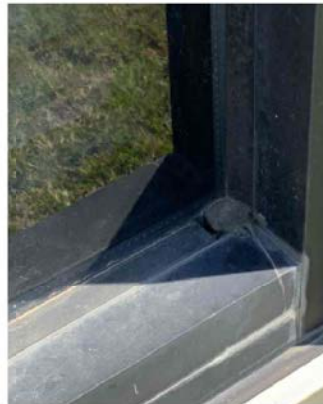
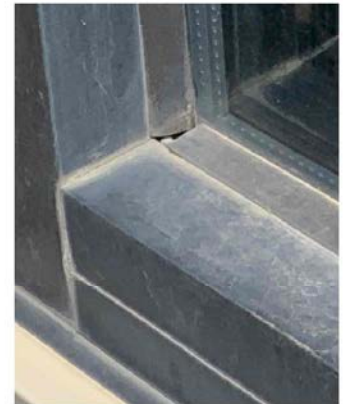
The exterior walls of the Transportation Center is metal an metal R-Panel system. The exterior walls seem to in poor to fair condition.

- + Sealants around the building envelope and between the building and paving should be replaced.
- + Exterior walls are showings signs of degradation and require repair or replacement.

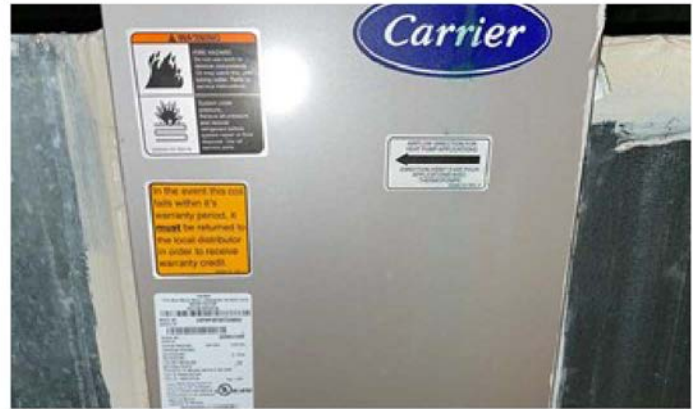
Conference room is served by two (2) 15-year-old Carrier vertical DX fan coil units with electric heat. They are in fair condition. Offices are served by two (2) 13-year-old Carrier horizontal DX fan coil units with electric duct heaters. They are in good condition. Bay area is served by two (2) Reznor gas unit heaters. Unit heaters appear to be in good condition.

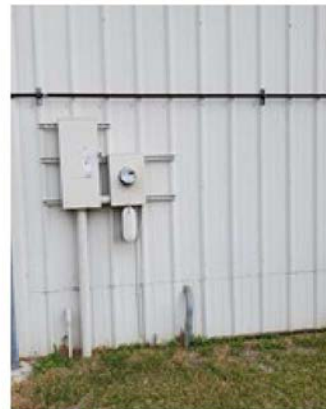
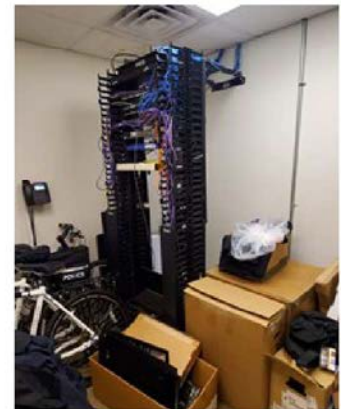
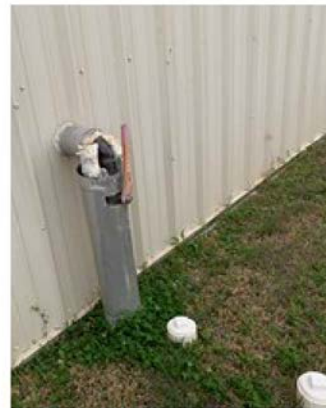
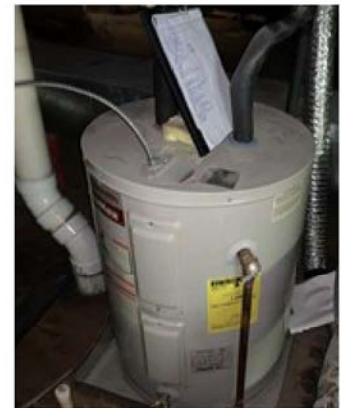
The electrical service is fed via pole mounted transformers 200A service disconnect at the exterior of the building, which is connected to 200A, 277/480V, 3-phase, 4-wire main panelboard located electrical room. This main panelboard feeds additional panelboards and an ATS via step down transformer. The 120/208V panels feed receptacle and mechanical loads throughout the building. There is a small residential grade emergency generator that feeds select loads. Lighting on the interior of the building consists of fluorescent 2x4 fixtures, strip fixtures in mechanical/storage areas, and fluorescent high bay fixtures in the shop area. Exit signs appear to be fluorescent. Exterior lighting consists of mix with old wall mounted HID fixtures at the building, surface mounted LED fixtures at the canopy, LED flood lights, and LED fixtures for parking lot lighting. Lighting controls are controlled via toggle switches and do not meet current energy codes. The access control and security system appear to be up to date and functioning properly.

- + Replace all interior lighting with new LED fixtures.
- + Replace all exterior lighting with new LED fixtures.
- + Replace all existing lighting controls with new controls in compliance with energy code.

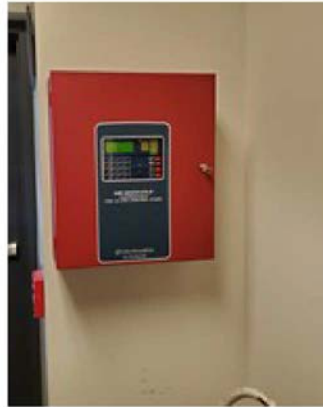
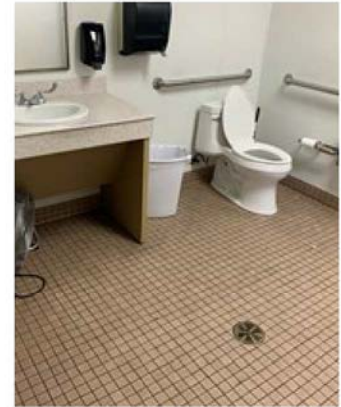
Accessibility within Transportation Satellite seems to be in general compliance with TAS.

- + There is a Fire Alarm however it is not functioning properly. Replacement with a compliant system is recommended.
- + Fire sprinkler is not installed within this facility. If a substantial improvement is completed with regard to this building the AHJ should be consulted.

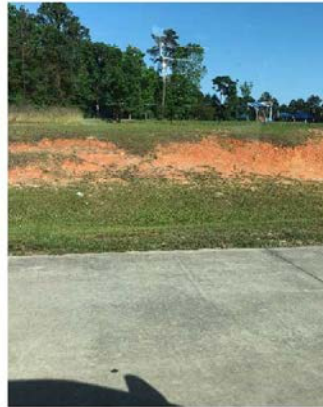
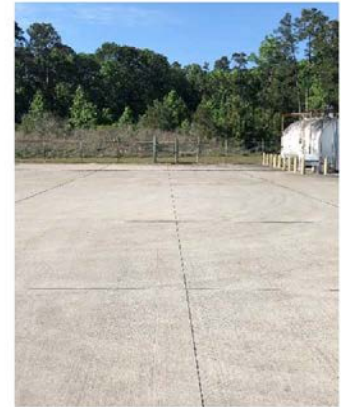
Upon review of the site conditions at the Satellite Transportation Center, it appears that the site is in a relatively good condition overall. There are no major deficiencies observed upon review. There is some evidence of sloughing along the service road leading back to the site but it is not an item that appears to be of concern at this time.

- + Level out the gravel bus parking area at the entrance of the site.
- + Regrade the side slope of the sloughing area along the entry drive and reestablish vegetative cover.

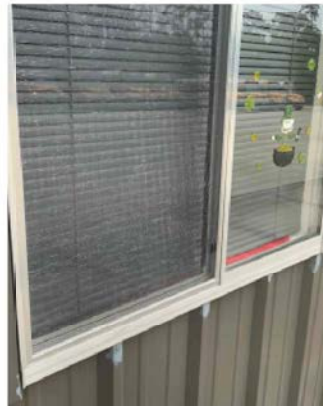
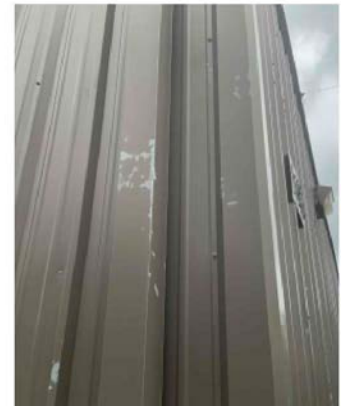
There are limited window systems around the building and they seem to be in good condition. Widows appear to be 1/4" glazing which is not compliant with current codes.

- + Replace window system with code compliant assembly.

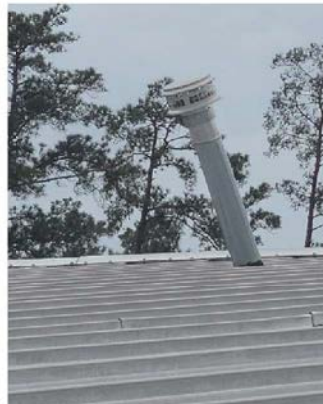
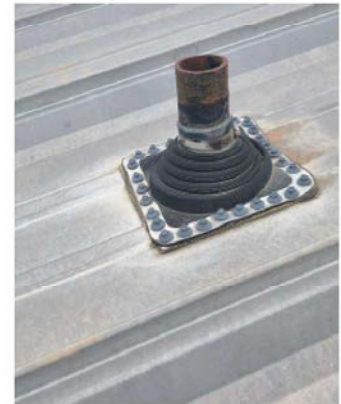
The Montgomery ISD satellite transportation center appeared to consist of one single-story building with a metal panel roof system measuring approximately seven-thousand square feet. Deficiencies observed throughout the metal panel roof system appeared to include poorly sealed roof penetrations, a displaced exhaust unit, and interior signs of moisture infiltration.

- + The existing roof system appeared to be near the end of its effective service life and should be coated or replaced in the near future.

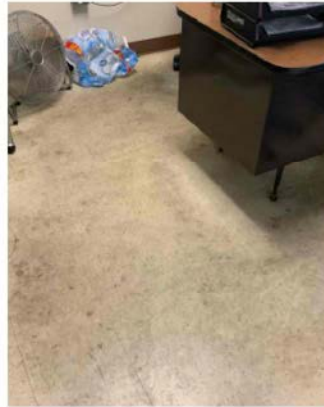
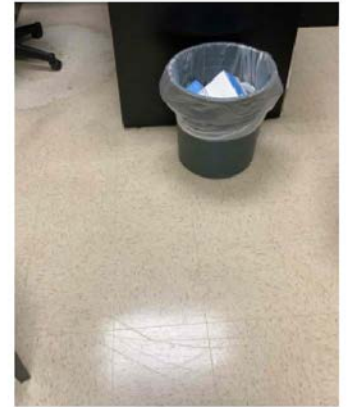
The VCT flooring throughout the majority of the flooring is in good condition. There are several places where VCT has been damaged due to high traffic, chair dragging, and lack of maintenance.

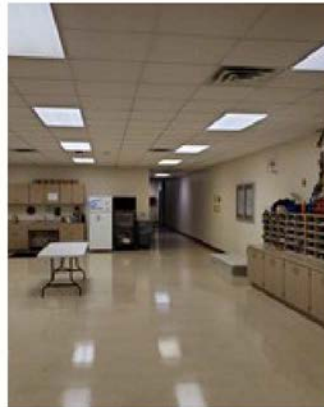
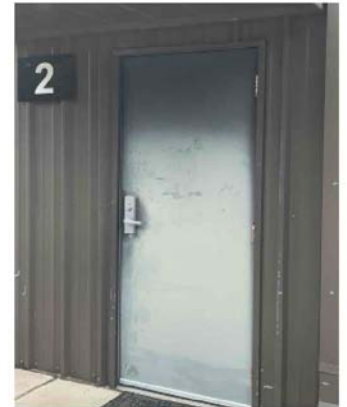
The doors, and frames throughout the building seem to be in compliance with TAS. The exterior doors should be re-finished.

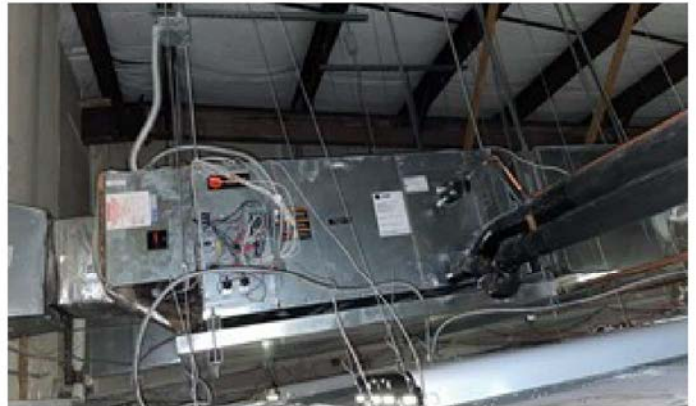
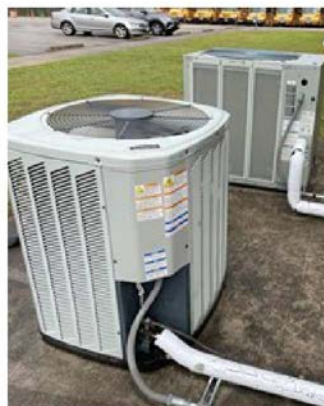
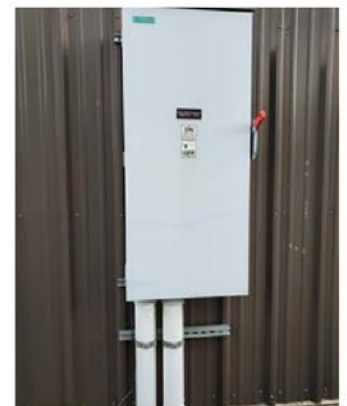
Building is served by two (2) 11-year-old Trane horizontal dx fan coil units with electric duct heaters. Indoor and outdoor units are in good condition. Exhaust fan in restroom is loud. The BAS is by Trane and the control modules are in good condition.

- + Repair restroom exhaust fan.

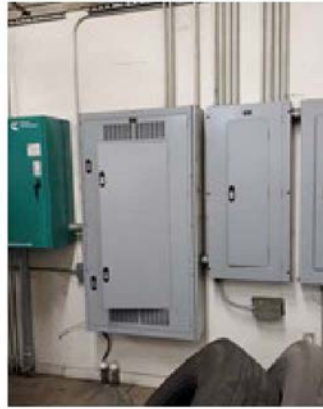
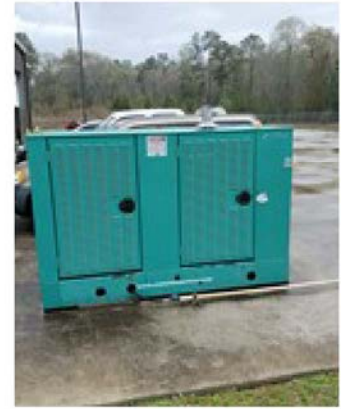
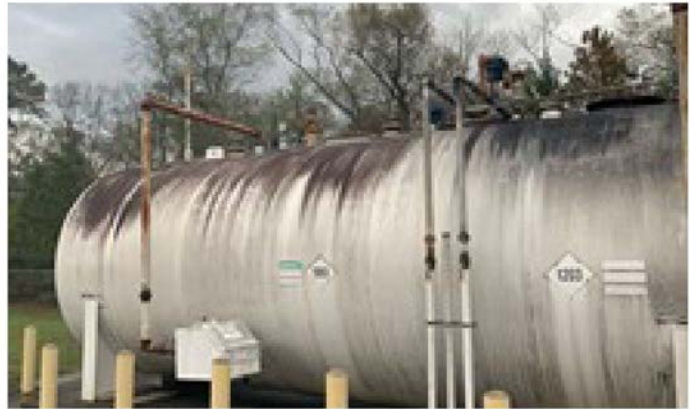
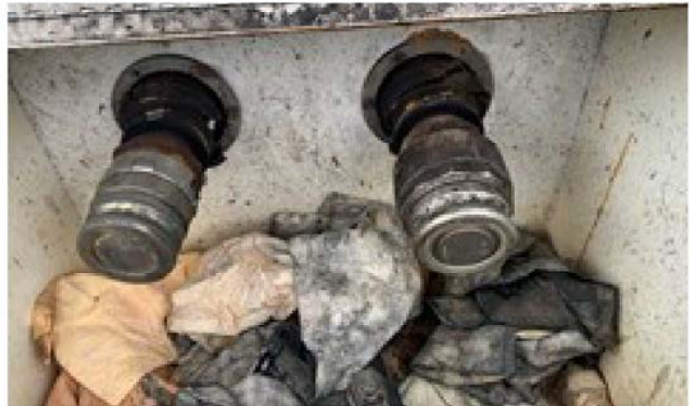
The electrical service is fed via pole mounted transformers to a 600A service disconnect at the exterior of the building, which is connected to 600A, 120/208V, 3-phase, 4-wire main distribution board located in the shop area. This main distribution board feeds additional panelboards and an ATS. The panels feed receptacle, lighting, and mechanical loads throughout the building. There is an emergency generator that feeds emergency lighting and select receptacle loads. Lighting on the interior of the building consists of fluorescent 2x4 fixtures, wall mounted linear fixtures, and recessed cans throughout, with strip fixtures in shop and mechanical areas. Exit signs appear to be fluorescent. Exterior lighting consists of old wall mounted HID fixtures at the building, surface mounted HID fixtures at the pump station, and old show box HID fixtures for parking lot lighting. Lighting controls are controlled via toggle switches and do not meet current energy codes. The fire alarm system is an addressable system and did not appear to be functioning properly as the LCD screen was displaying random patterns and no legible words or numbers.

- + Replace all interior lighting with new LED fixtures.
- + Replace all exterior lighting with new LED fixtures.
- + Replace all existing lighting controls with new controls in compliance with energy code.
